Unaware That They Have Encountered a Microburst, DC-9 Flight Crew Executes Standard Go-around; Aircraft Flies Into Terrain

The approach was continued into severe convective activity and the crew failed to recognize a wind-shear situation in a timely manner. The failure of the air traffic controller to report radar data and other pertinent weather information to the crew was a contributing factor to the accident, the official U.S. report said.

ACCIDENT PREVENTION

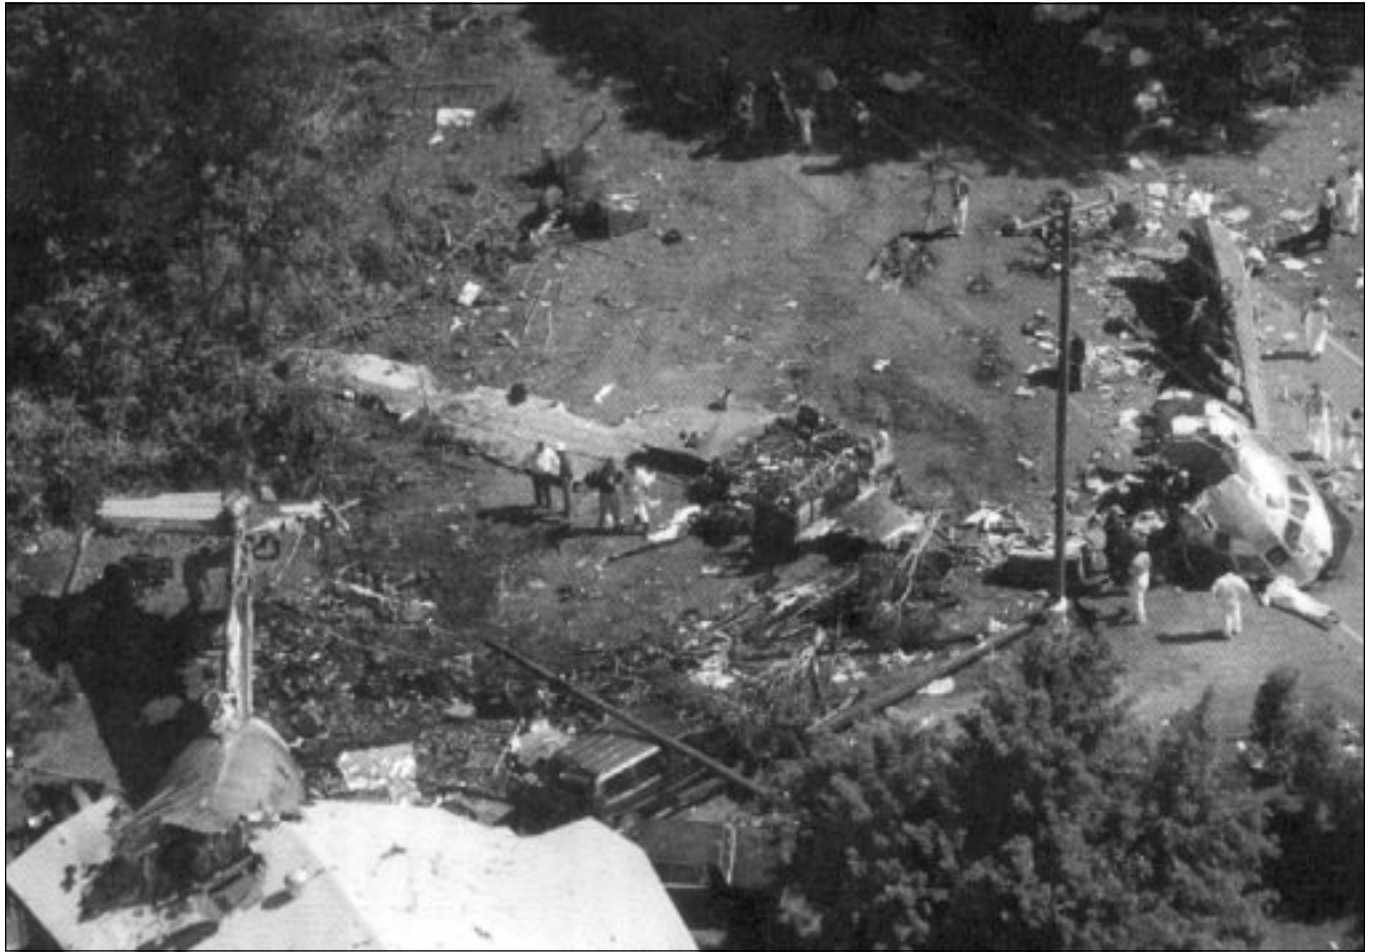
An aerial view of the crash site shows the wide displacement of the aircraft's tail section and nose section.

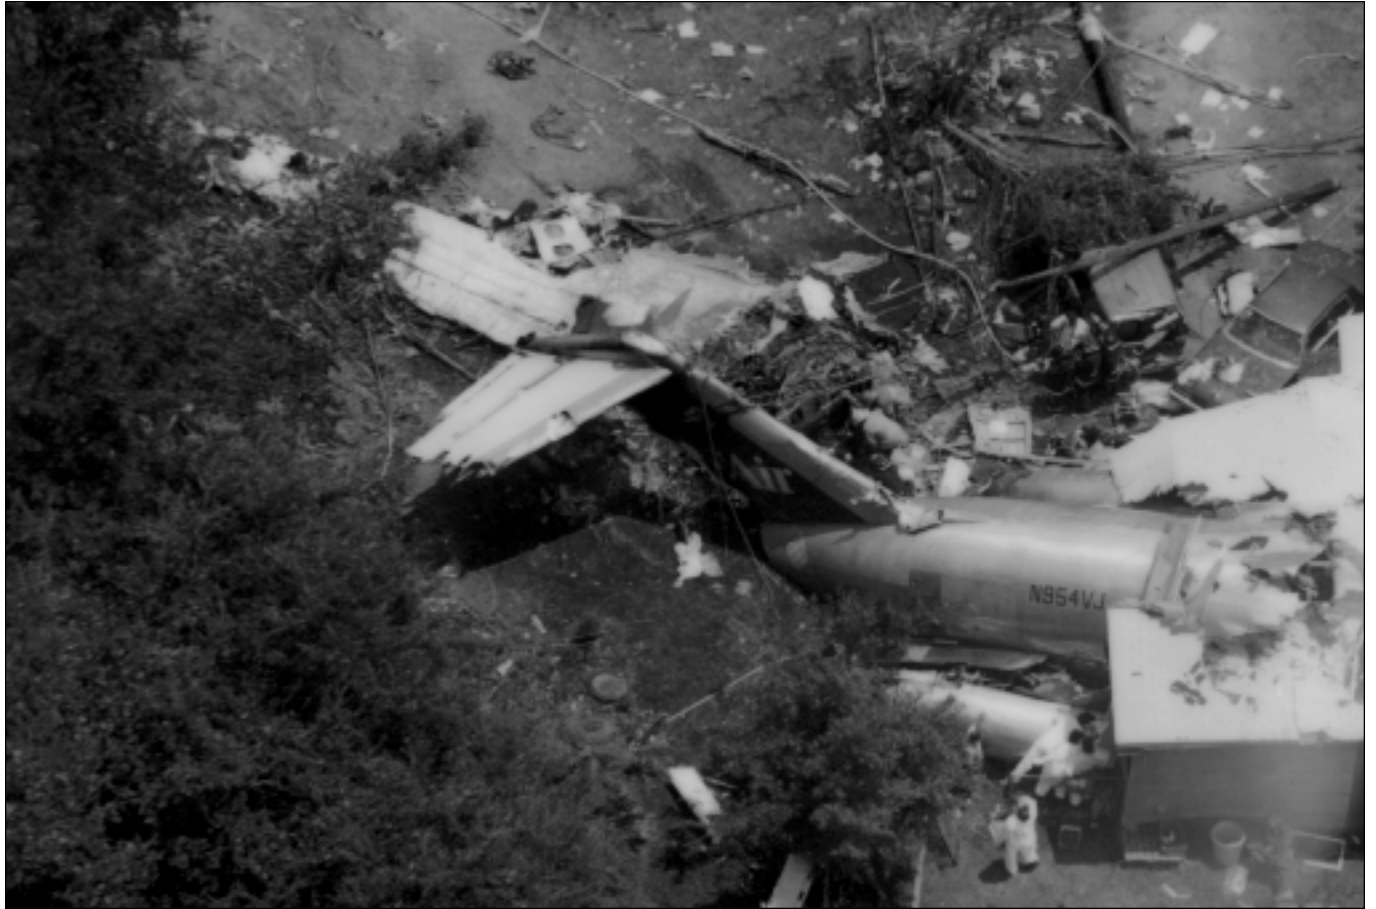
Investigators sift through the wreckage of Flight 1016's tail section, which lodged in the carport of a house.

The aft section of the airplane, which was embedded in the carport, included the “passenger cabin area and seat rows 17 through 21,” the report said. “The seats in rows 17 through 19 had separated from their respective floor track mounts, and were found under the seats in rows 20 and 21 (which were intact). The fuselage tailcone area sustained impact damage along the floor, and the cabin flooring was deformed upward. The deformation prevented the tailcone door from opening,” the report said.

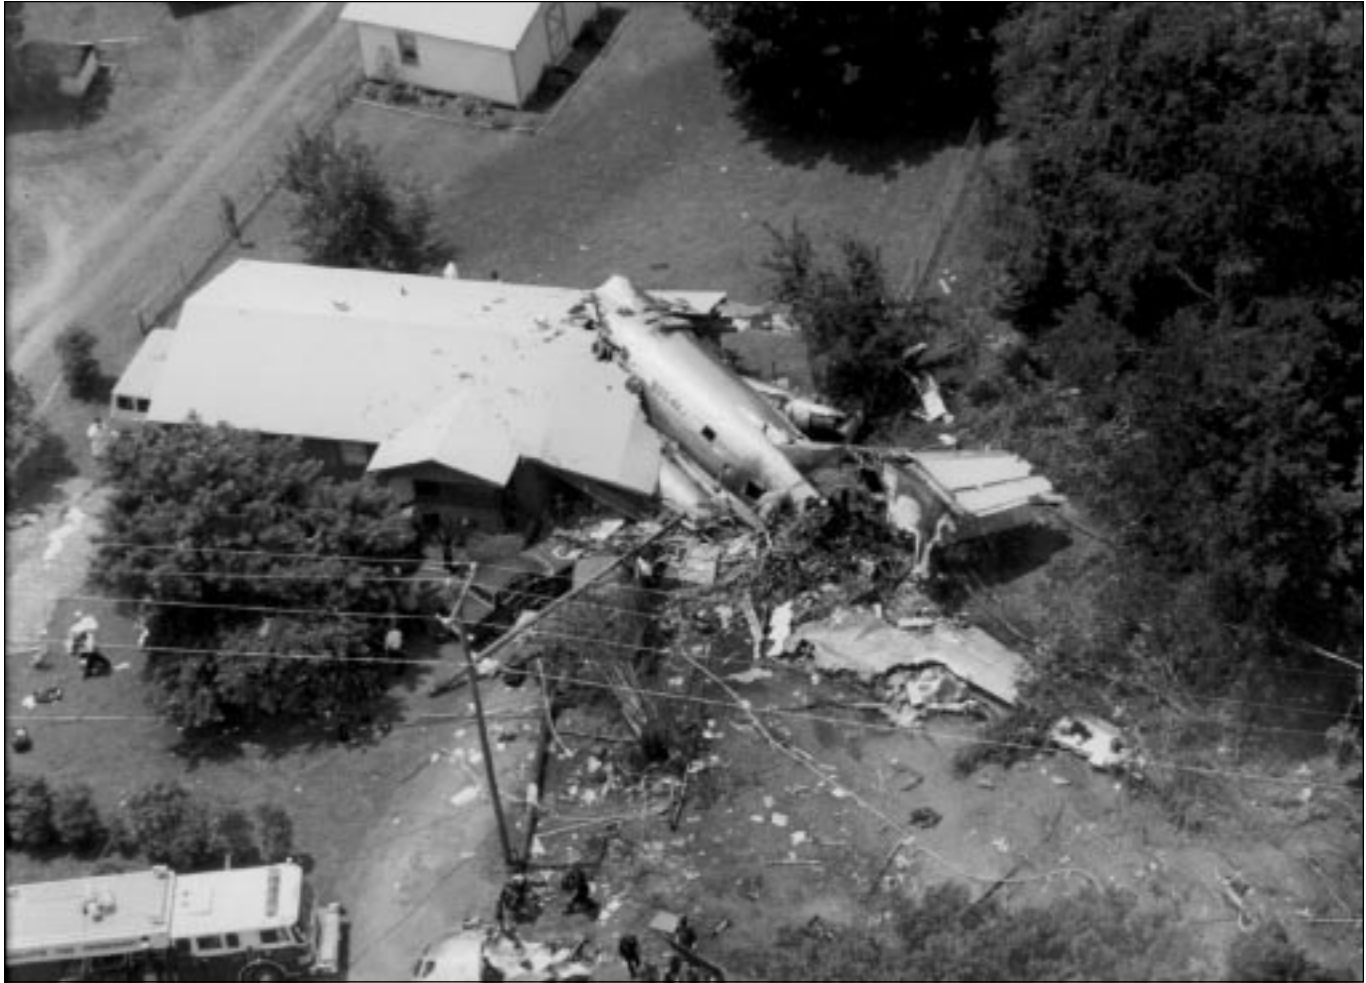
The tail section of Flight 1016 lodged in the carport of a house. The nose section is in the lower left, to the right of the fire truck. A third section of the fuselage is not visible.

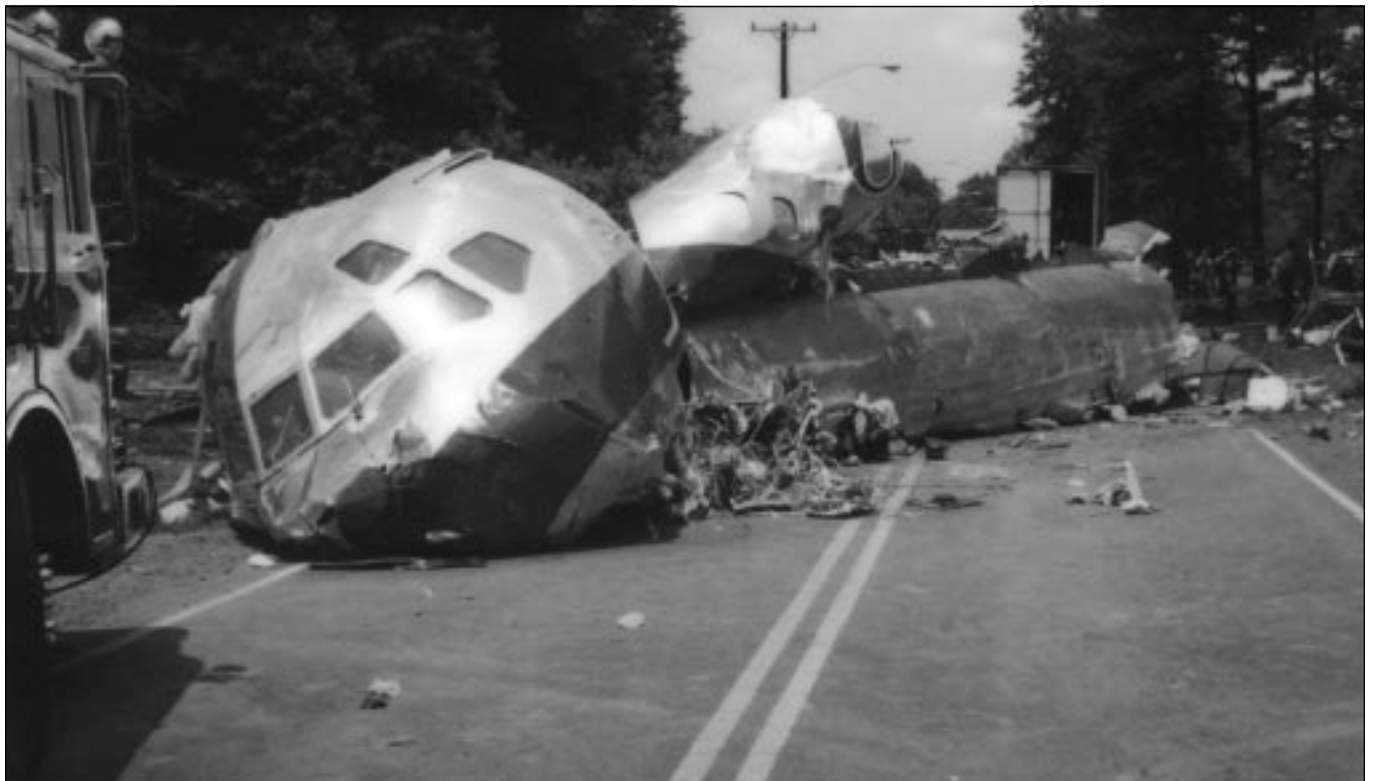
The cockpit was found severely deformed. “The captain, first officer and observer seats were partially detached from their anchor points,” the report said. “The right-side cockpit floor was crushed upward and aft, and both the captain and first officer seats were resting against the lower instrument panel.”

The nose of Flight 1016 sheared off on impact with trees and skidded down a residential street. Another section of the fuselage is behind the nose section.

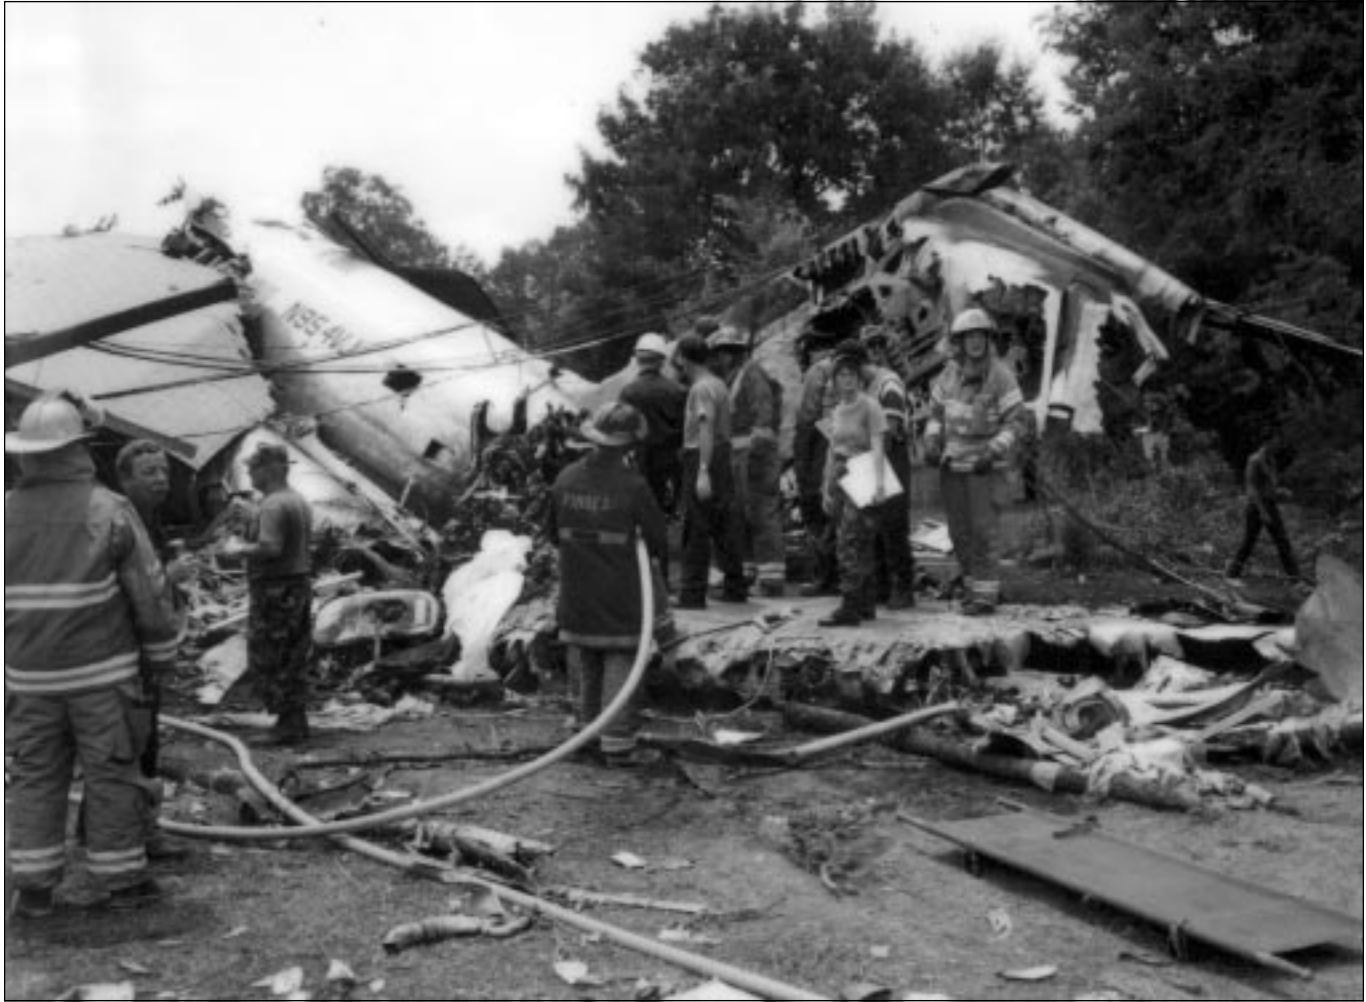
A postcrash fire consumed the portions of the aircraft in which fuel was present, the report said. “There was also evidence of flash-over fire in the immediate vicinity of the debris area,” the report said. “The crew members, passengers and ground witnesses stated that they observed fire after the aircraft came to rest in various locations around the accident site. The large portion of the empennage that had separated and contained numerous survivors was heavily damaged by fire on the exterior, but the interior cabin was not adversely affected by heat or flames.”

Firefighters examine the tail section of Flight 1016. This section was engulfed by fire.
