Operations and Maintenance Audit Failures Cited as Factors in Two Fatal Accidents

The New Zealand Transport Accident Investigation Commission said that Civil Aviation Authority audits of two commercial operators failed to detect and/or correct conditions that might have contributed to a de Havilland Canada Dash 8 controlled-flight-into-terrain accident and a Beechcraft Baron 58 loss-of-control accident.

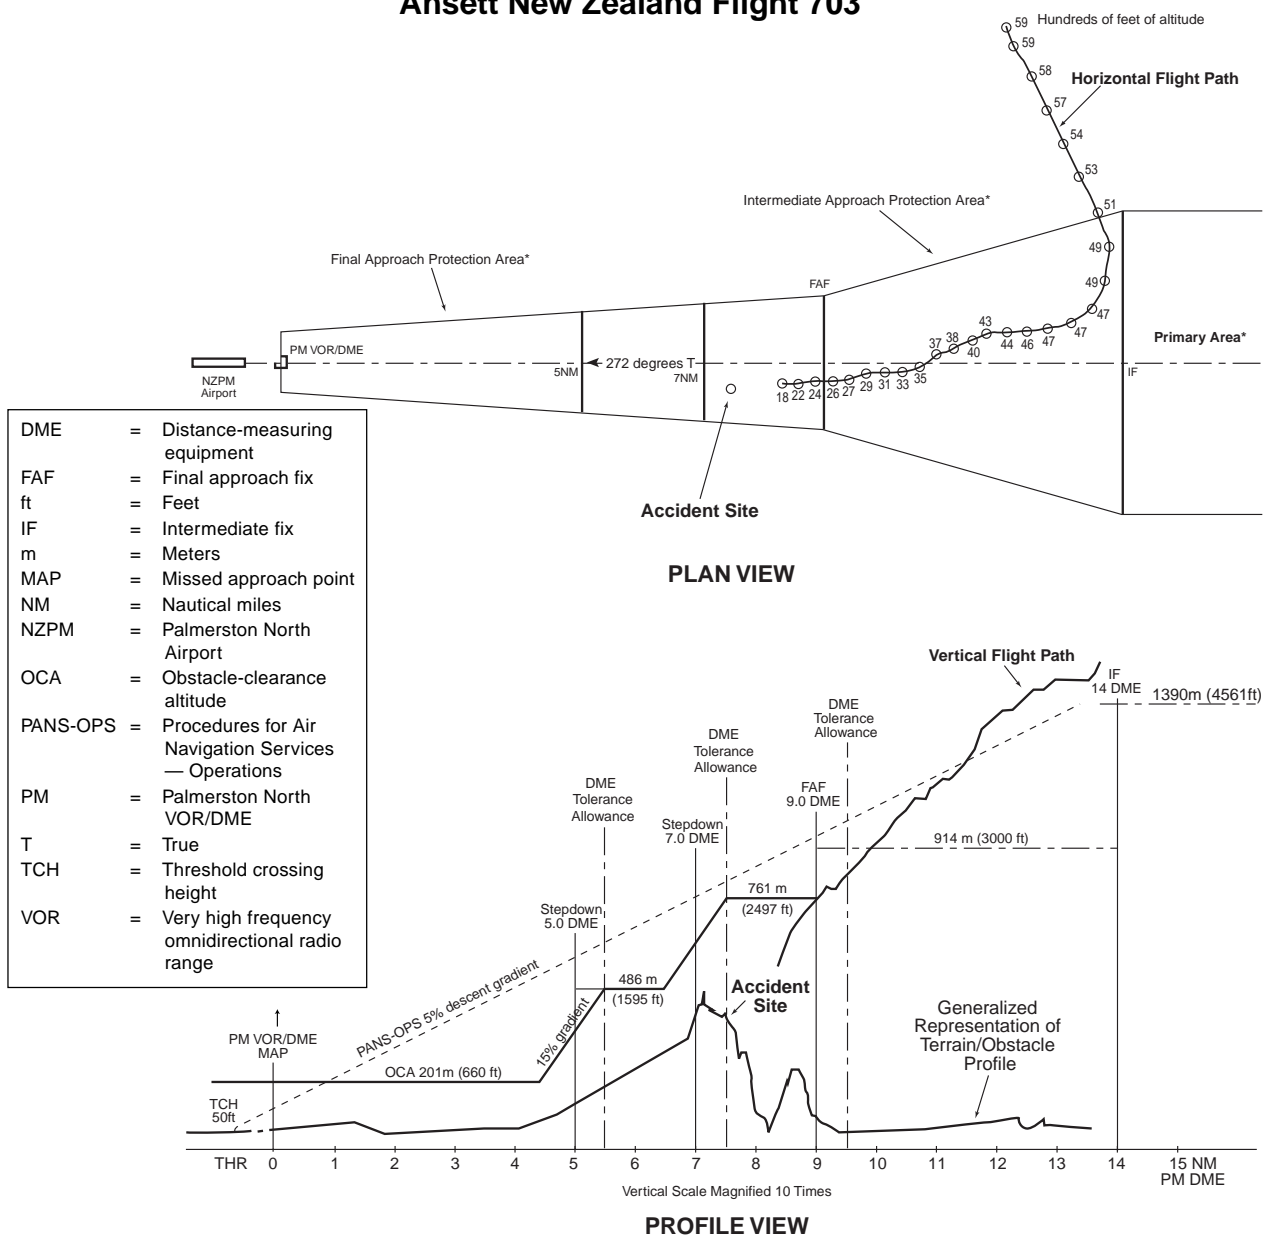
The descent rate was excessive. When the first officer said, "and on profile," the aircraft was slightly above the appropriate profile-descent altitude. The TAIC said, however, that the aircraft was descending at an excessive rate. Air traffic control radar showed that the steep descent continued until shortly before impact. Figure 1 shows the aircraft's descent path.

Simplified VOR/DME Runway 25 Approach and Radar Tracks of Ansett New Zealand Flight 703
