Pilot of Cessna 441 Incorrectly Taxis onto Active Runway and Aircraft Is Struck by McDonnell Douglas MD-82 on Takeoff Roll

FSF Editorial Staff

The U.S. National Transportation Safety Board (NTSB) concluded in its final accident report that the probable cause of this accident was “the Cessna 441 pilot’s mistaken belief that his assigned departure runway was Runway 30R, which resulted in his undetected entrance onto Runway 30R, which was being used by the MD-82 for its departure.”

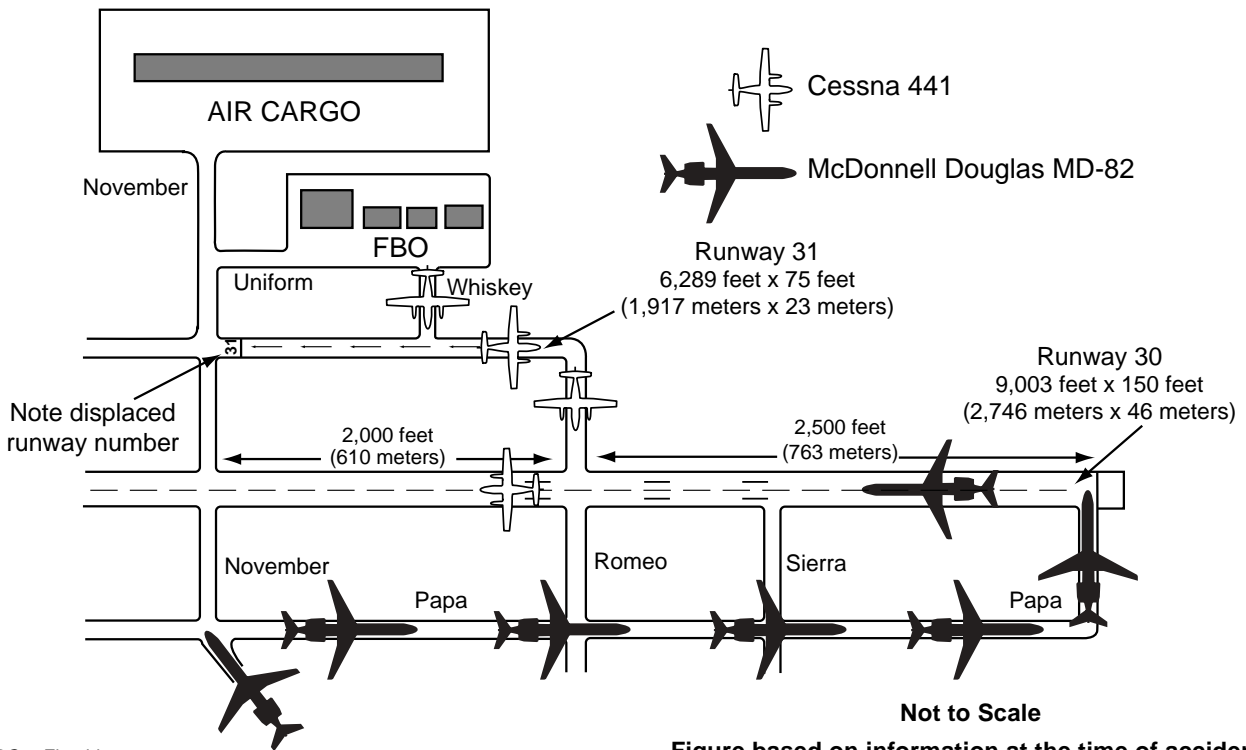
Figure 1

Paths of Accident Aircraft, Lambert–St. Louis International Airport

At 2201:23, the crew of a Trans World Airlines (TWA) MD-82 that was holding short of Runway 30R was cleared for takeoff by STL tower, the report said. The first officer of the MD-82 acknowledged the takeoff clearance, and the flight taxied onto Runway 30R. At 2202:29, the Cessna pilot told STL tower that he was “... ready to go on the right side,” the report said. The tower replied, “Roger, I can’t roll you simultaneously with the, uh, traffic departing the right. Just continue holding in position. I’ll have something for you in just a second,” the report said. The Cessna pilot had taxied onto Runway 30R from an intersecting taxiway that was 2,500 feet (762 meters) from the runway threshold (Figure 1).

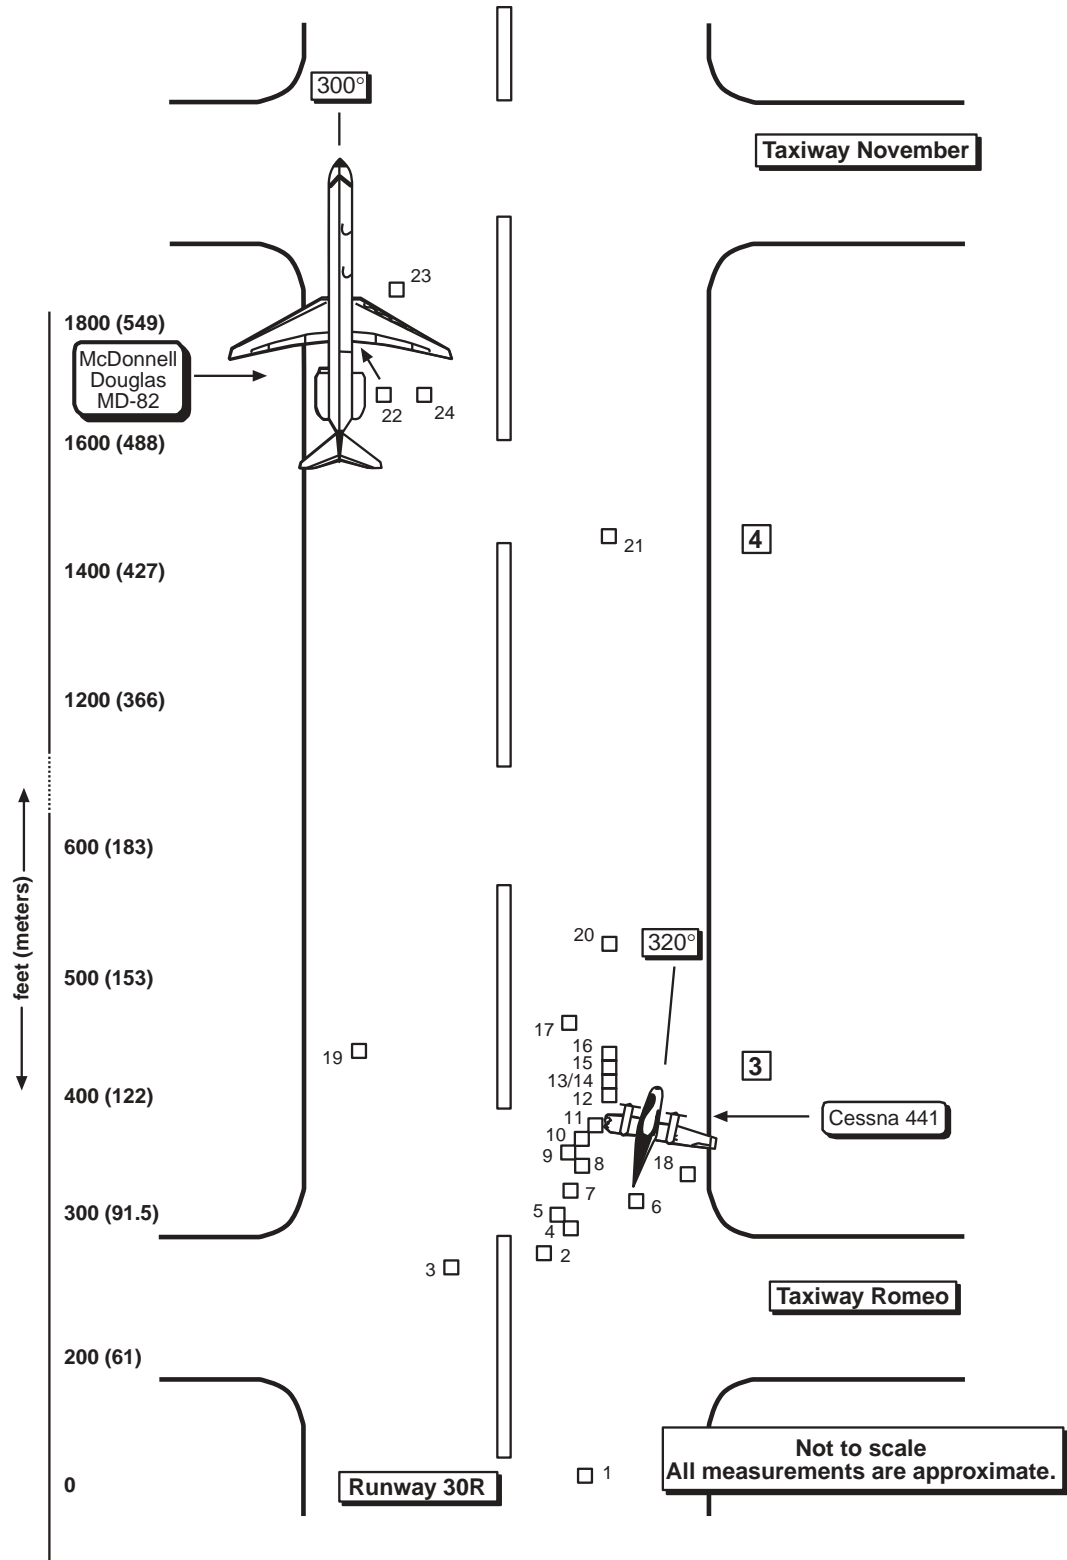
Figure 2

Examination of the Cessna wreckage indicated that it was almost directly on the runway centerline when the collision occurred, approximately 2,500 feet (763 meters) from the approach end, the report said. The wreckage path (Figure 2, page 5) began with a two-foot (0.6-meter) section of the

Location of Wreckage* Following Accident, Lambert–St. Louis International Airport

Cessna's rudder. The main portion of the Cessna was located on the north edge of the runway, approximately 350 feet (107 meters) farther, the report said.
