Escape From a MICROBURST

The PIC conducted a go-around after the 747 was slammed onto the runway.

This article is based on ATSB Transport Safety Report AO-2007-001: "Microburst Event; Sydney Airport, NSW; 15 April 2007; VH-OJR, Boeing Company 747-438."

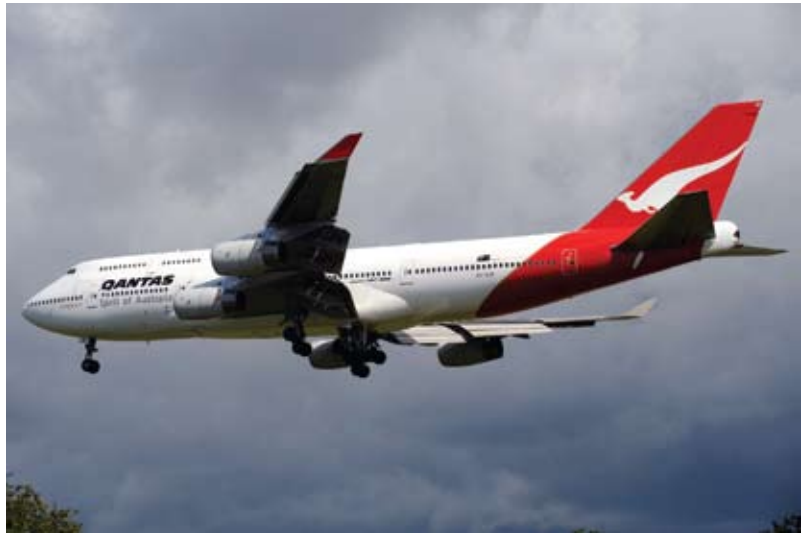
The report said that the crew could not have prevented the hard landing. The recorded sink rate was 820 fpm, and vertical acceleration was 2.34 g when the main landing gear contacted the runway at 1923. The aircraft then apparently bounced.

After the incident, Qantas maintenance technicians reattached five cabin ceiling panels and two emergency lights that had dislodged, and conducted a structural inspection of the aircraft. "That inspection did not reveal any abnormalities," the report said.

This Boeing 747 experienced the microburst event.
