Windshield Weakness

The S-76 crashed, killing eight people, after a hawk shattered the windshield and curtailed fuel flow to both engines.

A Sikorsky S-76C++ that crashed into a Louisiana marsh after an en route bird strike was equipped with lightweight acrylic windshields — installed in place of the original bird-strike-resistant laminated glass, the U.S. National Transportation Safety Board (NTSB) said in its final report on the Jan. 4, 2009, accident.

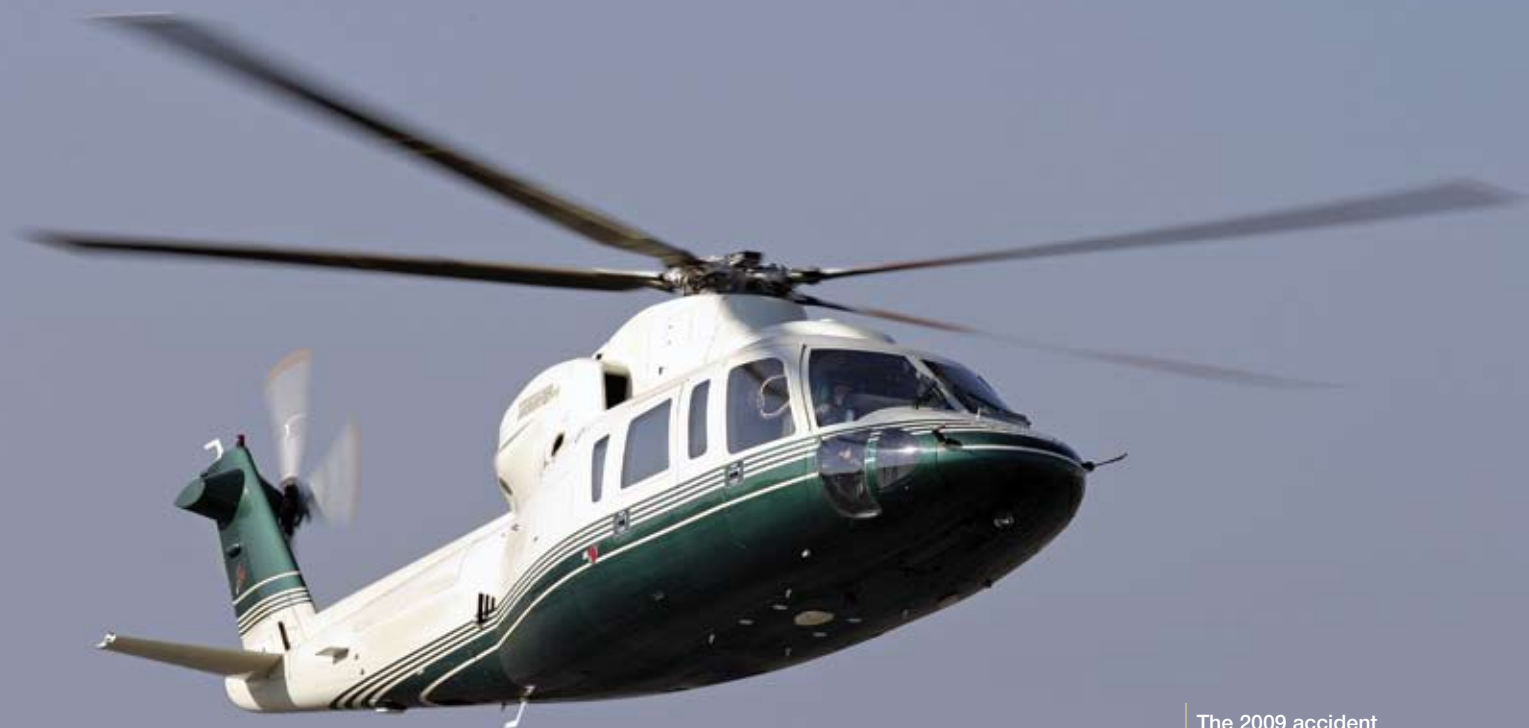
The 2009 accident resulted in a slew of safety recommendations from the NTSB.

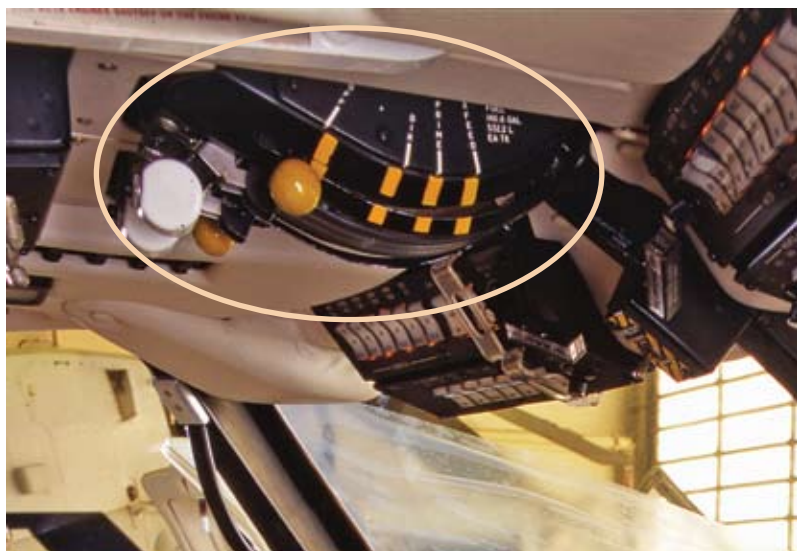
In addition — noting that the impact had initiated a chain of events that jarred the T-handles that held engine fire extinguishers in place and pushed the engine control power levers (ECLs) aft, reducing fuel flow to the engines — the NTSB cited the “lack of protections that would prevent the T-handles from inadvertently dislodging out of their detents” and the “lack of a master warning light and audible system to alert the flight crew of a low-rotor-speed condition.”

The T-handles were located about 4 in (10 cm) aft of the windshields. The NTSB said that the handles are “normally in the full-forward position during flight and are held in place by a spring-loaded pin that rests in a detent; aft pulling force is required to move the handles out of their detents.”

The impact of a bird strike caused a chain reaction that forced the engine control power levers — shown at the top of the photo — aft and reduced fuel flow.

Other recommendations called on the FAA to “require that Sikorsky redesign the S-76C++ model helicopter fire extinguisher T-handles and/or engine control quadrant to ensure that the T-handles do not inadvertently dislodge out of their detents due to any external force on the canopy or windshields that could cause unintended movement of the engine power control levers.”

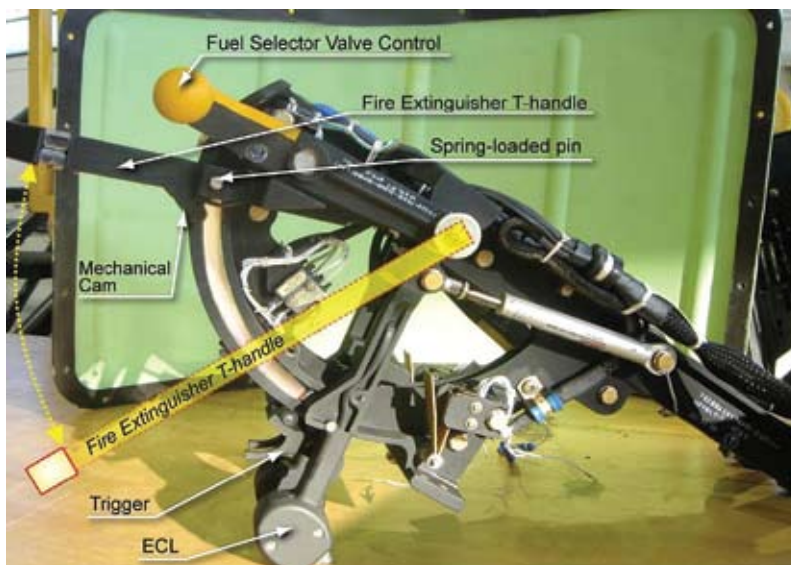
In the event of an in-flight engine fire, the pilots are told to move the T-handle for the affected engine full aft, “so that a mechanical cam on the T-handle pushes the trigger on the ECL out of the wedge-shaped stop, allowing it to physically move aft with the T-handle,” the NTSB said. “Fuel to the affected engine is then reduced.”

The fire extinguisher T-handle and ECL on an S-76C++
