Short on Speed

An ATR 42 with split flaps stalled during an unstabilized night approach in icing conditions.

BY MARK LACAGNINA

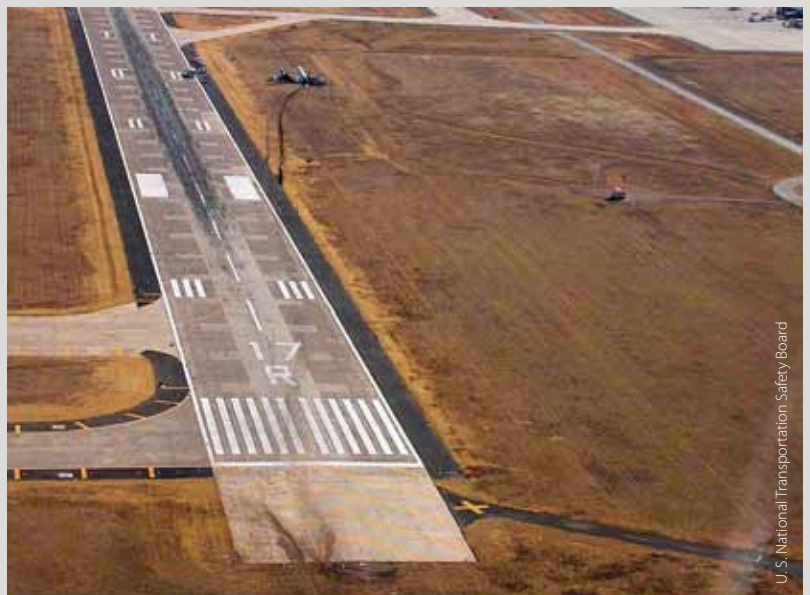
The airplane struck the ground short of the threshold of the runway and came to a stop off the right side of the runway

The airplane was at about 200 ft AGL and airspeed was 124 kt at 0436:19, when the captain called for maximum propeller speed and increased engine torque. The airplane then entered a series of roll oscillations before striking flat, grassy terrain short of the runway and coming to a stop off the right side of the runway at 0436:27.

The right main landing gear separated on impact, and the right wing and a large section of the upper fuselage were destroyed by fire. The right engine and propeller also were damaged by the impact and fire.

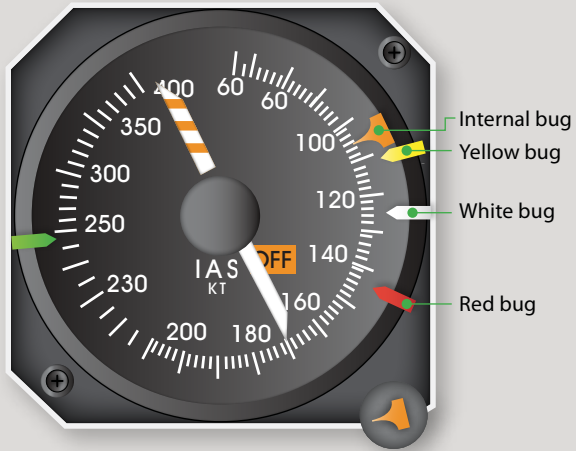
Figure 1

Notes: The ATR 42 pilots had set the red bugs on their airspeed indicators to 143 kt, the minimum airspeed for an approach in icing conditions with flaps retracted. The white bug references the minimum approach speed in non-icing conditions with flaps retracted; the yellow bug references the target approach speed plus 5 kt with full flaps. These three bugs are on the outside of the instrument's glass face and are manually slid into place. The orange "internal" bug, set with the knob, references the minimum approach speed in icing conditions with full flaps; this reference speed drives the fast/slow scales on the pilots' attitude director indicators.

This error was inconsequential, according to the report, because the captain had correctly briefed the minimum airspeed for a no-flap approach in icing conditions as 143 kt. This airspeed provided "sufficient reference to maintain the minimum safe airspeed" during the approach, the report said, noting that the pilots set the red bugs on their airspeed indicators accordingly (Figure 1).
