North American pilots on overnight flights across the Atlantic are especially at risk for fatigue and related problems.

Struggling With Sleep

This article is based on TSB Accident Investigation Report A11F0012: Pitch Excursion, Air Canada, Boeing 767-333, C-GHLQ; North Atlantic Ocean, 55°00’N 029°00’W; 14 January 2011.

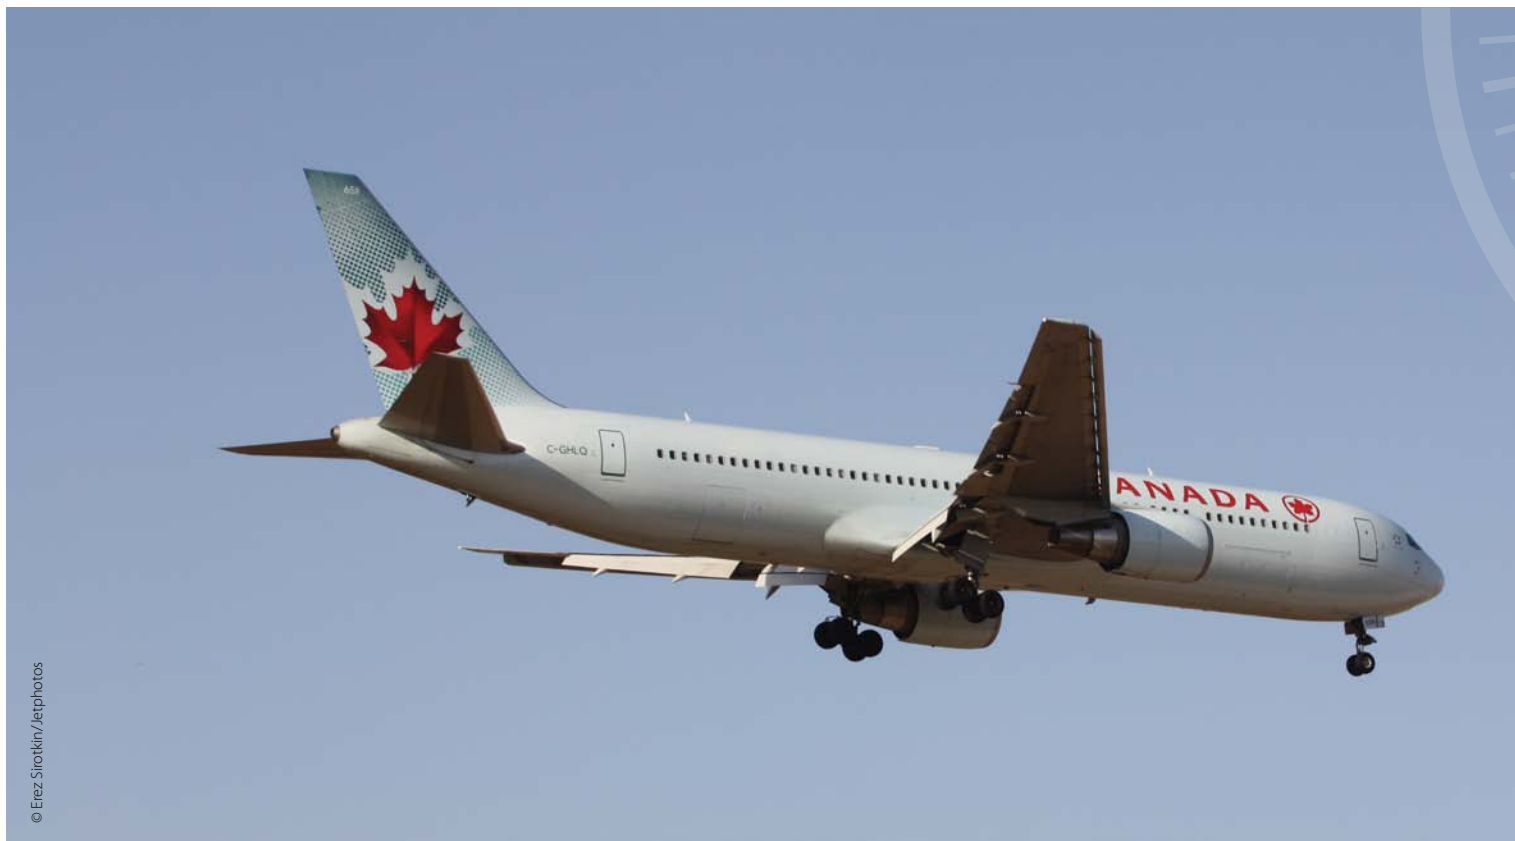
Incident investigators say the first officer on a trans-Atlantic Air Canada flight probably was experiencing “strong effects of sleep inertia” after a nap when he misinterpreted the position of another airplane.
