FATAL V₁ CUT

Simulated engine failure during a check ride led to a loss of control.

A training and checking captain who was administering an instrument proficiency check to a line captain in an Embraer EMB-120ER Brasilia performed a “V₁ cut” — a simulated engine failure on takeoff — “at a speed that did not allow adequate margin for error,” said the Australian Transport Safety Bureau (ATSB) in its final report on the March 22, 2010, accident at Darwin Airport.

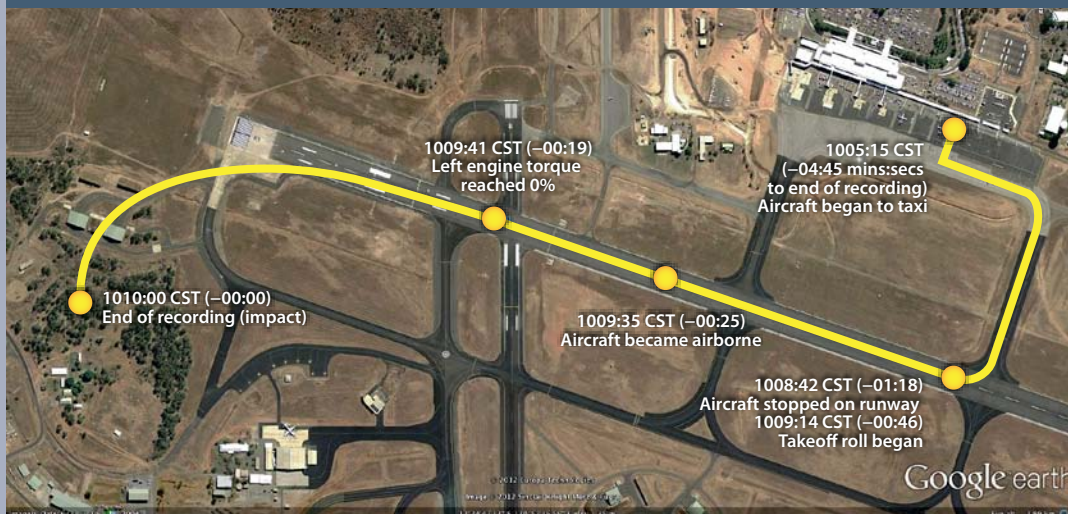
Figure 1

Before beginning the takeoff at 1009 local time, the PIC advised the airport traffic controller that an engine failure would be simulated on departure. The takeoff was begun from the point where the taxiway leading from the civilian ramp, Taxiway E2, intersects Runway 29 (Figure 1).¹ The aircraft's takeoff weight was about 20 percent below maximum, and the center-of-gravity was near the forward limit. V_1 had been calculated at 100 kt, and V_2 , the takeoff safety speed, was 113 kt.

"Witnesses reported that the takeoff appeared 'normal' until a few moments after the aircraft became airborne, when it was seen to roll and diverge left from its takeoff path," the report said. "They watched as the aircraft continued rolling left into a

steep nose-down attitude. The witnesses lost sight of the aircraft behind trees to the south of the upwind end of the runway, from where a column of black smoke was seen shortly afterwards. ... The aircraft had descended

through the surrounding trees and impacted terrain in a steep 65-degree nose-down, partly inverted, right-wing-low attitude.”

The accident had occurred 51 seconds after the takeoff was initiated. The Brasilia struck terrain about 500 m (1,641 ft) south of the departure threshold of Runway 29.
