BY MARK LACAGNINA

The 737 captain continued
an unstabilized approach
despite numerous warnings.

Fatal

The Air India Express aircraft was very high and fast during an approach to Mangalore, India.

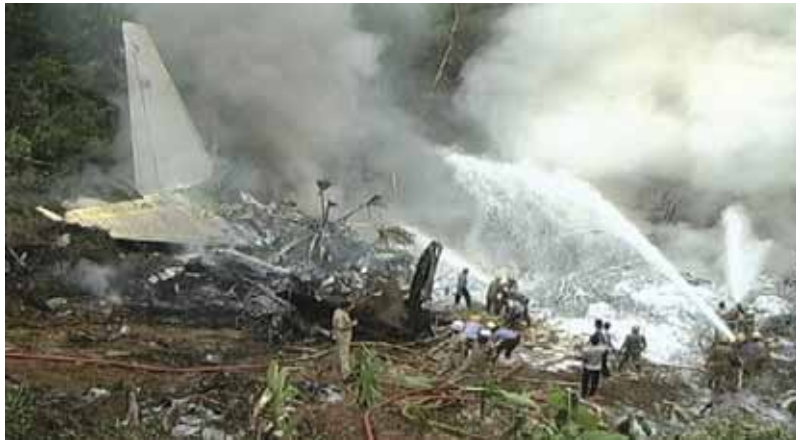
The 737 was in pieces and engulfed in flame when rescuers arrived. Only eight passengers survived.

The aircraft overshot the runway and the 300-ft/90-m runway end safety area (RESA). The right wing “sheared into pieces” and the right engine separated when they struck the non-frangible, concrete localizer antenna mounting structure 279 ft (85 m) from the end of the RESA, the report said. “The remaining portion of the aircraft fell into the gorge, broke into three parts and caught fire.”

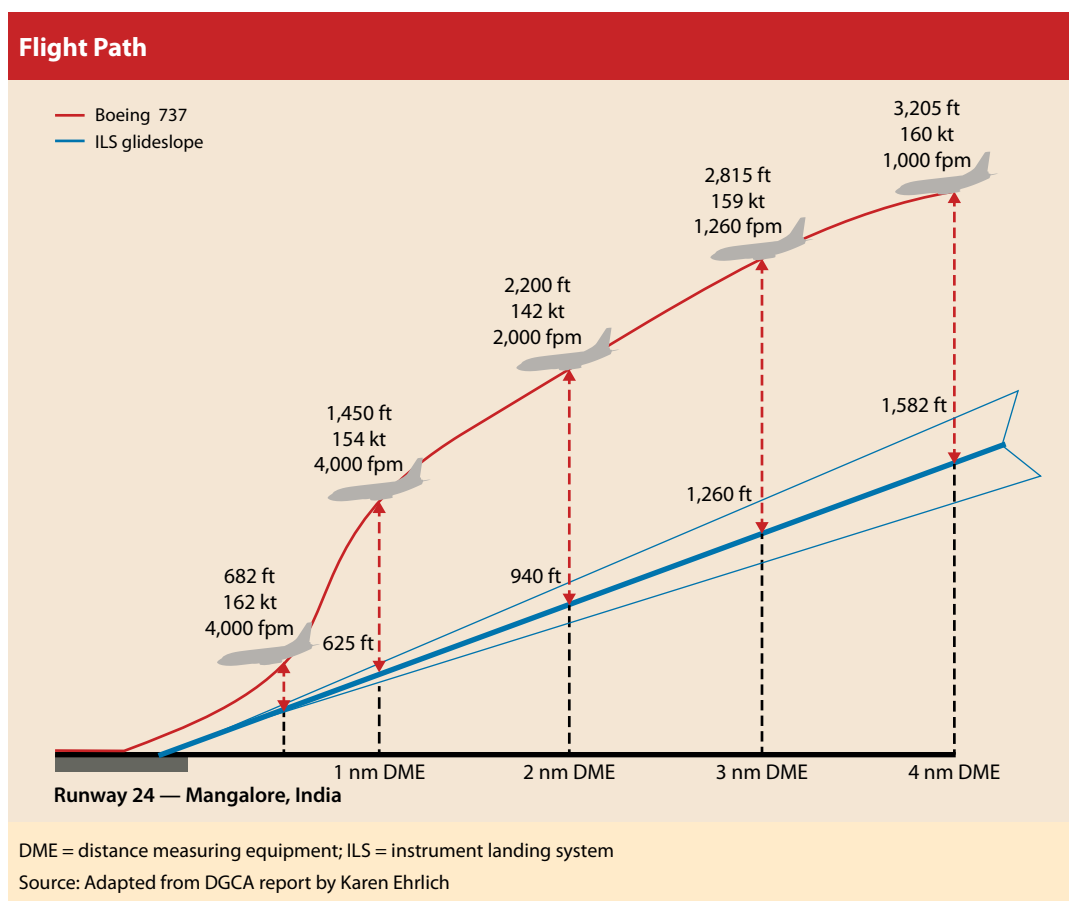
Figure 1

At 0601 and at a DME distance of 6.7 nm (12.4 km), the aircraft was descending through 4,630 ft with the speed brakes still deployed, when the captain told the first officer to extend the flaps to 15 degrees. The captain called for flaps 25 and then retracted the speed brakes as the aircraft was descending through 3,465 ft at 4.3 nm DME (7.9 km). At 2.5 nm DME (4.6 km), the EGPWS called out a height of 2,500 ft (Figure 1).

“It is too high,” the first officer said. “Runway straight down.”

“Oh, my God,” said the captain. He disengaged the autopilot, called for flaps 40, re-deployed the speed brakes and moved the control column forward to increase the rate of descent. At 165 kt, the airspeed was above the 162-kt limit for flaps 40, and the flap load-relief system automatically reduced flap extension to 30 degrees.

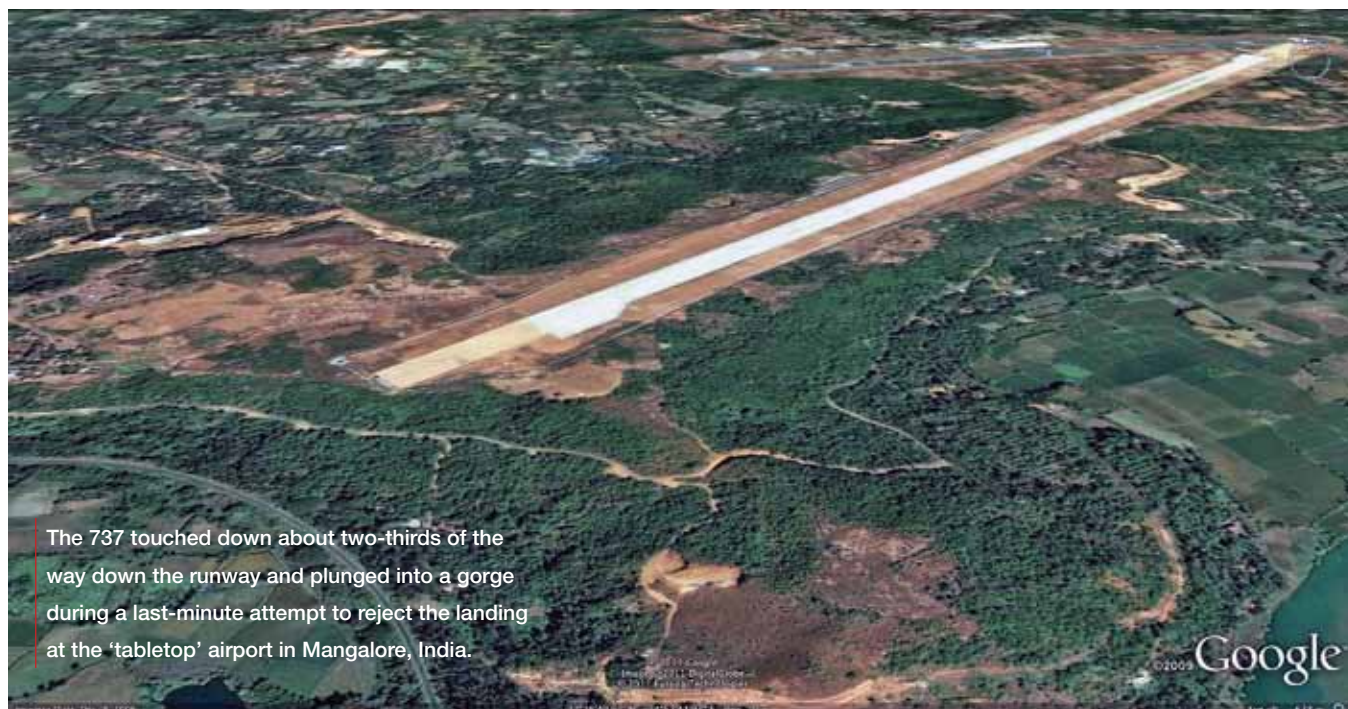
The aircraft touched down about 5,200 ft (1,585 m) from the approach threshold of Runway 24, with about 2,800 ft (853 m) of runway remaining.

The 737 touched down about two-thirds of the way down the runway and plunged into a gorge during a last-minute attempt to reject the landing at the 'tabletop' airport in Mangalore, India.

Six seconds later, the captain “made the grave mistake” of stowing the thrust reversers and applying full thrust to initiate a go-around, the report said. Shortly thereafter, he exclaimed, “Oh, my God. ... Aww, big one.”
