HELICOPTER SAFETY

Vol. 23 No. 6

November–December 1997

NTSB Investigates Loss-of-control Accidents Among Lightweight Helicopters

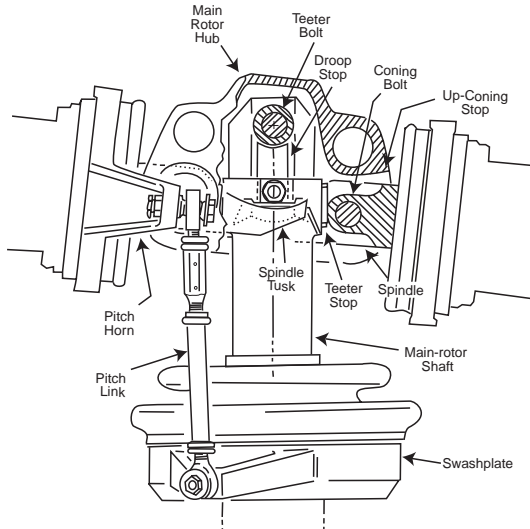
Figure 1

ruled out, and no evidence of a precipitating flight-control failure was found.” All of the control- and rotor-system components revealed evidence of overload failures; however, no component showed evidence of fatigue failure, inadequate materials or improper maintenance causal to the in-flight rotor-to-fuselage contacts (Figure 1, page 6 and Table 3, page 7).

R22 Main-rotor Hub and Assembly
