FLIGHT SAFETY FOUNDATION
Aviation Mechanics Bulletin

JANUARY–FEBRUARY 2003

Turbine-disk Corrosion Cited in HS 748 Engine Failure and Fire

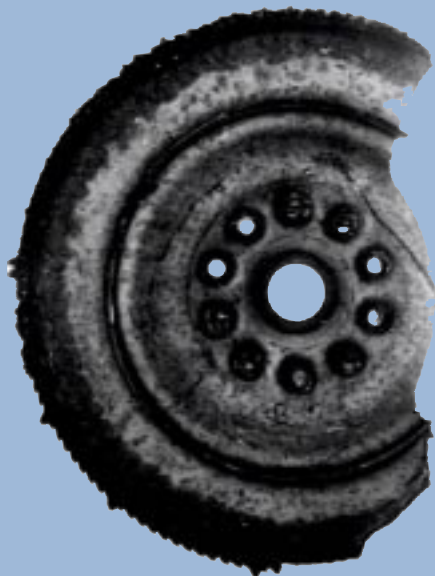
On the cover: The high-pressure turbine disk from the no. 2 engine of a Hawker Siddeley HS 748 was recovered in pieces from the runway area at London (England) Stansted Airport after an uncontained engine failure. (Photo: U.K. Air Accidents Investigation Branch)

The investigation revealed that the disk failure followed the development of a fatigue crack in the inner-blend radius between the diaphragm of the HP turbine disk and the rear-seal ring. The fatigue crack progressed through about 40 percent of the circumference of the disk and about 80 percent of its thickness.

The fatigue crack originated at an area of surface corrosion with corrosion pits up to 0.004 inch (0.102 millimeter) deep. The report said that the corrosion was “reportedly quite usual” and probably had reduced the fatigue strength of the HP disk but was not the sole cause of the disk failure.
