Engineering and Metallographic Aspects of Gas Turbine Engine Failure Investigation: Identifying the Causes

*Robert E. Dundas, Principal Engineer
Factory Mutual Engineering & Research*

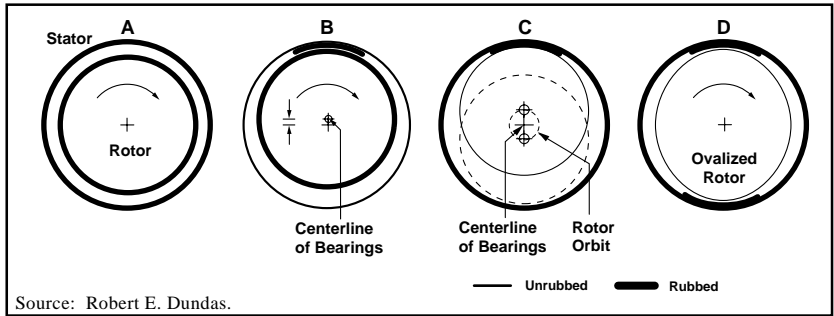
Figure 9. Usual rubbing patterns associated with turbine engine failures.

- A 360-degree rub on both rotor and stator. The rotor and stator have bound radially at some time during operation, probably during startup or shut-down. There is insufficient radial clearance between rotor and stator;
- A 360-degree rub on rotor, local rub on stator. The stator is misaligned (offset) relative to the rotor bearings;
- A 360-degree rub on stator, local rub on the rotor. This is caused by excessive rotor whirl; and,
- A 360-degree rub on stator, local rub at two diametrically opposite locations on the rotor. The rotor has become ovalized by creep.
