FLIGHT SAFETY FOUNDATION  
**Aviation Mechanics Bulletin**

JANUARY-FEBRUARY 1997

# FAA Airworthiness Directive Requires Inspection of Wiring And Conduits to Boeing 747 Fuel Pumps

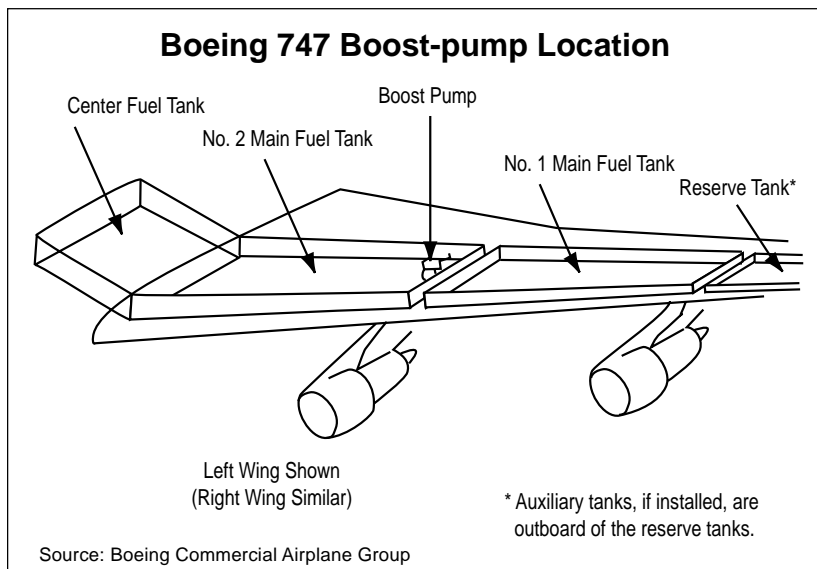
**Figure 1**

On the B-747, the no. 1 and no. 4 (outboard) main fuel tanks each have two boost pumps that are located in dry bays (for which the slang term is “dog houses”) inside the no. 2 (left inboard, Figure 1) and no. 3 (right inboard) main fuel tanks. Electrical wiring, routed through aluminum conduits inside the no. 2 and no. 3 main fuel tanks, supplies power to the boost pumps. The wire bundles are separated from the conduits by two Teflon sleeves.

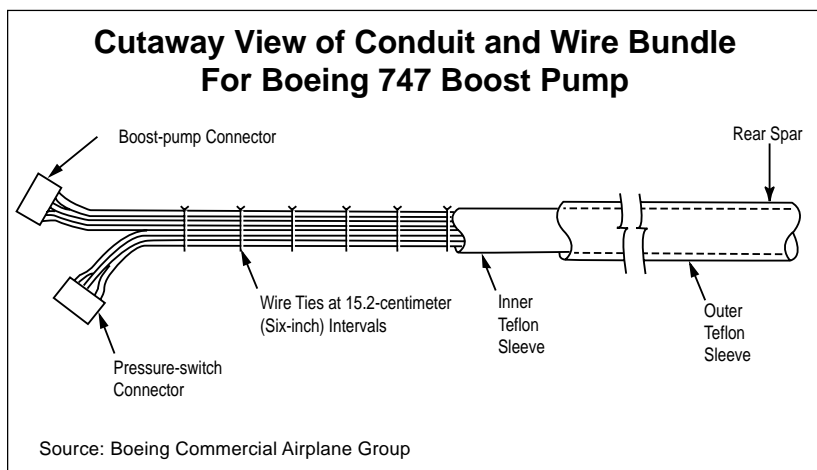
**Figure 2**

As a result, the FAA issued AD 79-06-02. The AD required an inspection of the wires under consideration and replacement of any chafed wires. In addition, wires were to be tied together every 15.2 centimeters (six inches), and two concentric Teflon sleeves were to be installed over the wire bundle (Figure 2, page 4).

“Vibration of the conduit and wire bundles can cause abrasion of the Teflon sleeving, which could lead to abrasion of the wires in the bundles,” the FAA said. “Such abrasion, if not corrected, could result in electrical arcing between the wires and the aluminum conduit and subsequent fire or explosion of the fuel tank.”

- “If any damaged sleeving is found, prior to further flight, replace the sleeving with new sleeving ... ;
- “If any damaged wire is found, prior to further flight, repair or replace the wire with new wire ... ; [and,]
- “If any burned wire is found, prior to further flight, perform an inspection to detect damage of the conduit ... . If any damage is found, prior to further flight, replace the conduit with a serviceable conduit ... .”
