FLIGHT SAFETY FOUNDATION
Aviation Mechanics Bulletin

JANUARY-FEBRUARY 1999

Loose Connection On Battery Shunt Involved in Boeing 767 Emergency-landing Incident

January–February 1999**Vol. 47 No. 1**

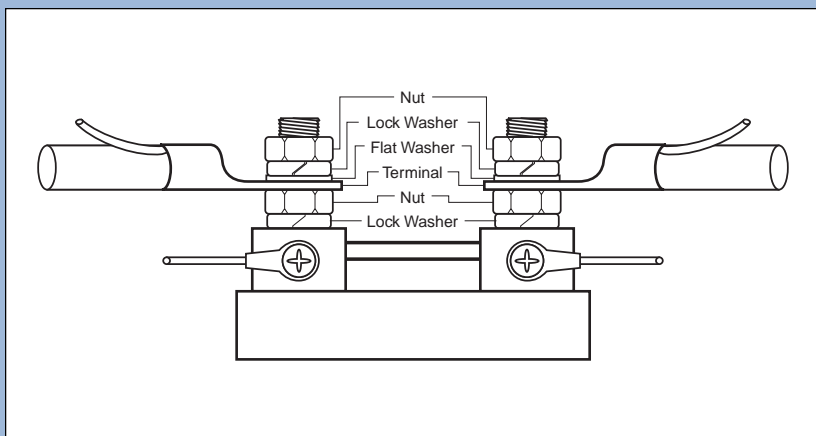
Cover illustration: Martinair Holland Boeing 767 main-battery shunt buildup (i.e., arrangement on studs of washers, terminals and nuts) used during tests by incident investigators. The buildup shown may not be the buildup specified in the Boeing 767 maintenance manual. (Source: U.S. National Transportation Safety Board)

Nevertheless, the investigation revealed a loose connection on the main battery shunt and that the shunt was not assembled according to Boeing's specifications.

"The investigation revealed that the negative cable for the main battery was not positively secured to the main battery shunt [because] of stripped threads in the jam nut area on the stud," said the report. "Additionally, the main battery shunt was not built up [that is, the placement of the bottom and top nuts, flat washers and lock washers on the studs was not] in accordance with Boeing specifications. An examination of other [B-767s] in the Martinair fleet
