FLIGHT SAFETY FOUNDATION
Aviation Mechanics Bulletin

JULY–AUGUST 2003

Fatigue Cracking Cited in Boeing 777 Engine Failure

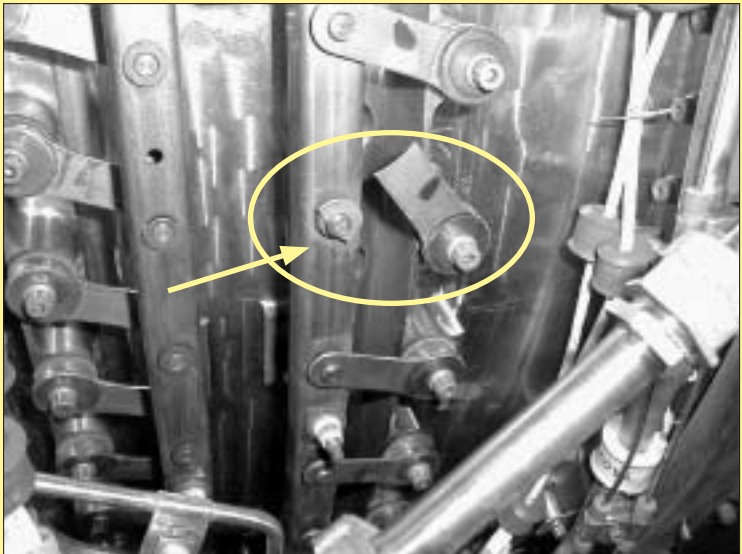
On the cover: An investigation by the Australian Transport Safety Bureau identified a fractured variable-stator-vane control lever as the cause of a Boeing 777 in-flight engine failure. The arrow points to the fractured control lever. (Photo: Australian Transport Safety Bureau)

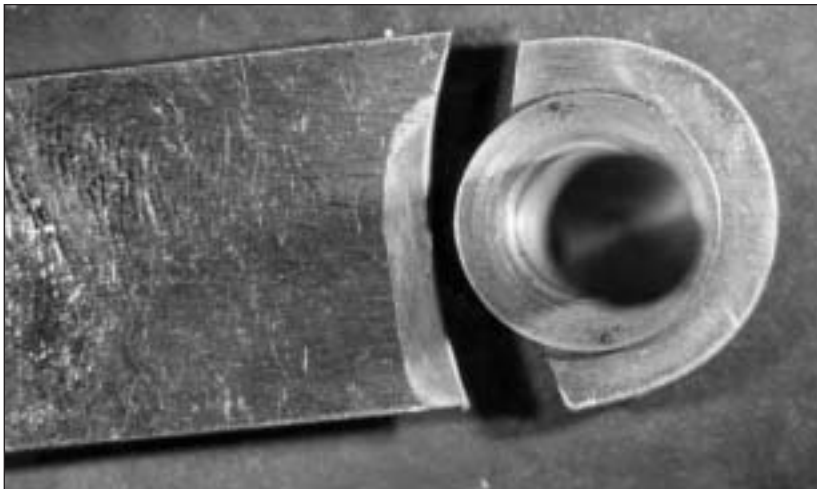
The underside of the broken variable-stator-vane (VSV) control lever shows the curved fracture path and wear that was attributed to in-service movement after the fracture. (Source: Australian Transport Safety Bureau)

The technical analysis report said that an ATSB metallurgical examination of the no. 28 VSV-1 control lever revealed that the control lever “had fractured transversely through the end of the arm section, at a location coincident with the riveted connection to the actuator pin. The fracture path followed a uniform arc, extending from one side of the arm to the opposite [side] and intersecting the pin connection at the center.

“A prominent track mark had developed on the underside of the arm where the relative movement between the separated arm and the pin flange had produced appreciable wear. The effects of wear extended to the fracture surfaces themselves, which were heavily eroded and all fracture surface detail obliterated. ... The fracture path appeared to intersect the bore of the rivet hole, with slight upward dishing of the arm section beneath the rivet head.”

from progressive fatigue cracking that originated from the rivet hole.

“The examination found evidence of distortion of the arm section by the forces used to rivet the control pin to the arm body,” the technical analysis report said. “During riveting, the expansion of the rivet shaft could induce tensile stresses within the bore of the rivet hole if the diameter was insufficient to allow for the expansion. Tensile stresses of this nature would be expected to predispose the lever arm to the initiation and propagation of fatigue cracking.”

- The operator replaced “all VSV levers of the same manufacture as the failed item”; and,
- Rolls-Royce “amended the IPC tip-bend acceptance criteria text in the aircraft maintenance manual and issued a revision to Service Bulletin RB211-72-D516 extending the range of the inspection to include all VSV-1 [levers] and VSV-2 levers. The engine manufacturer has also designed a strengthened VSV lever that has been certified for use under Service Bulletin RB211-72-E042.”
