FLIGHT SAFETY FOUNDATION
Aviation Mechanics Bulletin

JULY–AUGUST 2005

Fatigue Cracks Trigger Failure of TPE331 Propeller Gearbox

Vol. 53 No. 4

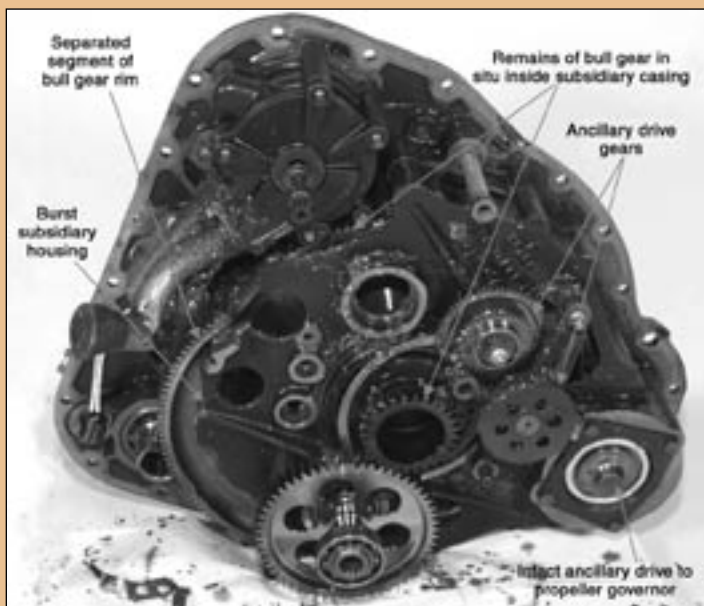
On the cover: Post-incident tear-down inspection of the Honeywell TPE331-12 engine revealed extensive damage inside the propeller-reduction gearbox that was precipitated by a fractured bull gear. (Photo: U.K. Air Accidents Investigation Branch)

All the gear teeth on the pinion had been stripped, and the engine shaft had sheared from the pinion coupling. No signs of deterioration or damage were found on the sun gear and planet gears. The bull gear had fractured.

“A large segment of the bull-gear rim, comprising approximately one-third of the gear’s circumference, had separated [from the web (the relatively thin section of the bull gear that connects the hub with the rim) and had burst out through the side of the subsidiary housing and had become jammed hard up against the starter-generator shaft, fracturing and crushing the hollow shaft,” the report said.

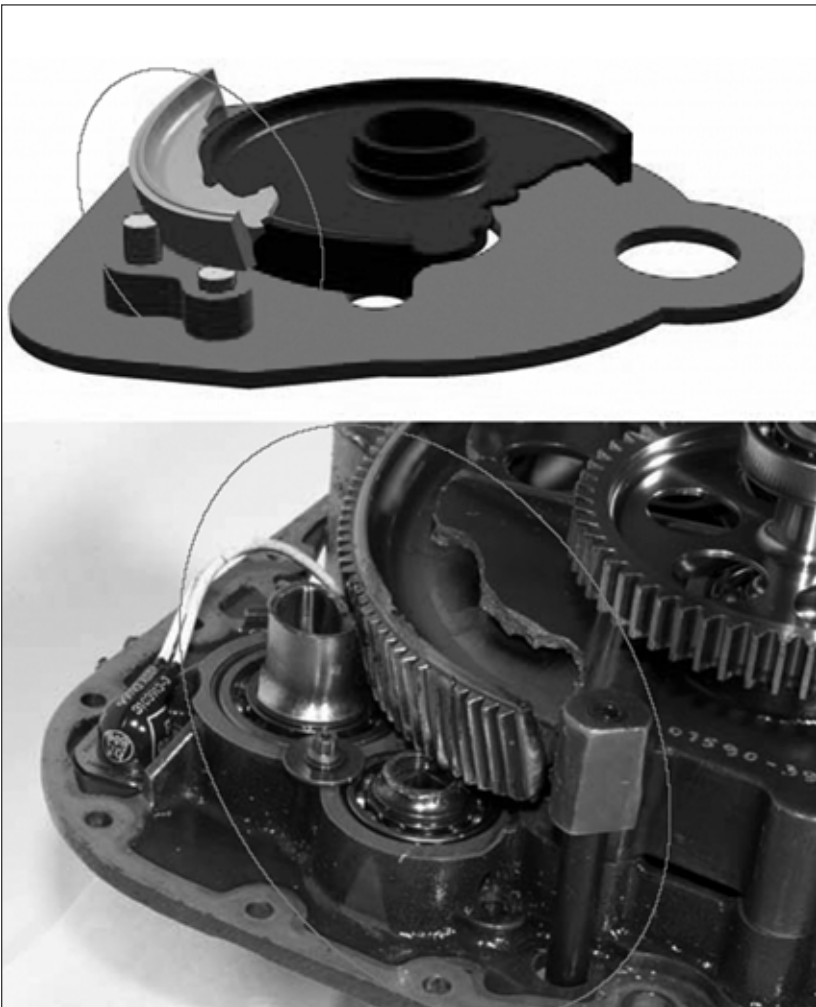
Analysis of a three-dimensional computer model of the bull-gear failure showed that the separated rim segments did not prevent continued rotation of the portion of the bull gear that remained attached to the engine (see photo page 8).

Momentary disengagement of the pinion from the bull gear, due to the partial rim separation, unloaded the engine shaft and caused the engine to accelerate rapidly. The report said that the pinion gear teeth then sheared instantaneously when the pinion re-engaged the remaining portion of the bull-gear rim. At the same time, the engine shaft sheared from the pinion coupling.

Investigators concluded that the severe vibration resulted from rotational imbalance when the fractured bull gear was back-driven by the windmilling propeller. The pitch oscillations and roll oscillations encountered by the flight crew likely resulted from fluctuations of propeller-blade pitch caused by abnormal operation of the propeller-governing system and the negative-torque-sensing system. The vibration continued for approximately two minutes, until the propeller was feathered by the crew.

A computer model of the gearbox failure (top) showed that the separated segment of the bull-gear rim (bottom) did not prevent continued rotation of the portion of the bull gear that remained attached to the engine. (Photo: U.K. Air Accidents Investigation Branch)
