FLIGHT SAFETY FOUNDATION
Aviation Mechanics Bulletin

JULY–AUGUST 1995

**Repair of Aircraft Windows
Is Often Practical and
Cost-effective**

Repair of Aircraft Windows Is Often Practical and Cost-effective

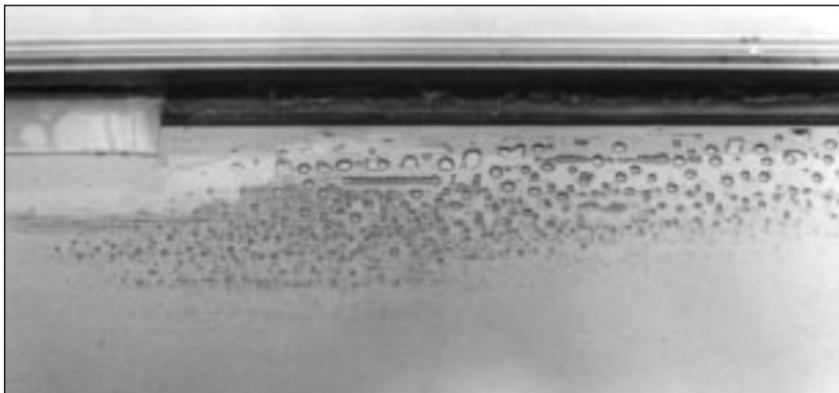
Bubbles. These are signs of delamination. A pattern of “champagne bubbles” — lots of little ones — indicates a possible thermal controller problem that causes overheating of the window. (See photo, page 4.)

Bubbles are an early warning of delamination, which is repairable if early action is taken.

Relamination. To eliminate bubbles indicating delamination, the window is disassembled, cleaned and relaminated in a large autoclave to new-window specifications. A log generated during the repair documents the time-temperature-pressure cycle for each step.

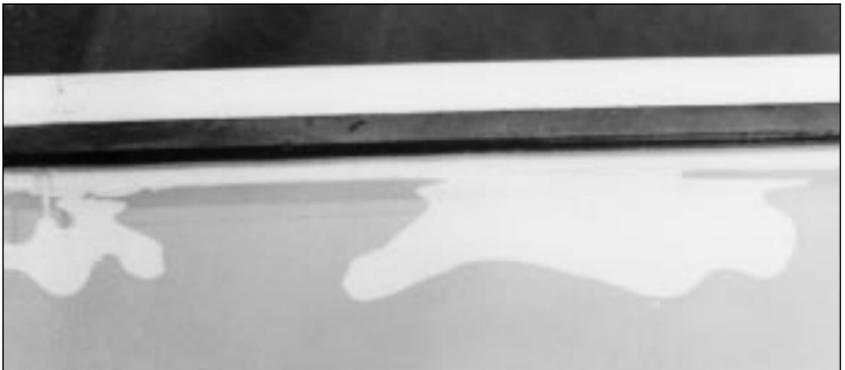
Large delamination bubbles at window edges indicate age and usage. (See photo, page 5.) These bubbles can reduce visibility, but the window can be repaired. The window should be pulled and repaired as soon as bubbles are noticed, before irreparable damage occurs.

Delamination is a common but repairable type of damage.

The relamination process is much like the original manufacturing cycle; a delaminated transparency is repaired and cured in a special vacuum package. Pressure and heat are applied in an autoclave.

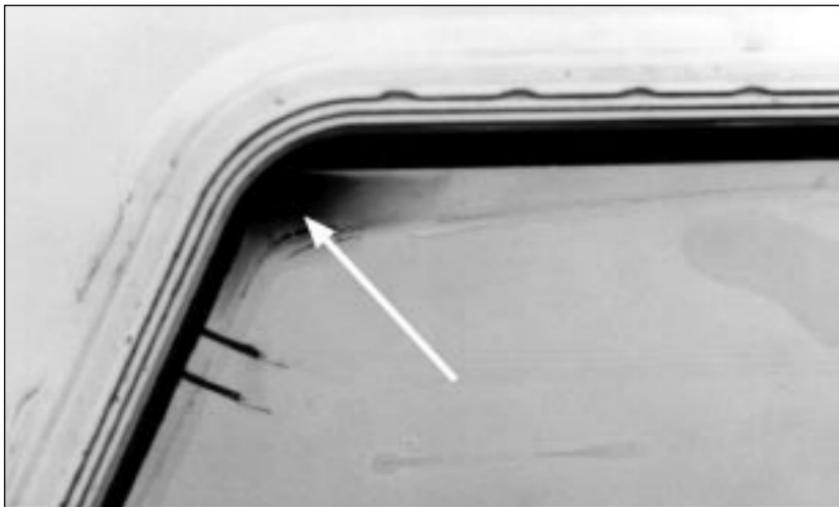
Milkiness. The indication is obvious. Milkiness, which is usually caused by moisture entering airspace that is caused by delamination, can

often be corrected. (See photo, page 6.)

Yellowing. Although the problem is primarily cosmetic, there is no known way to correct yellowing, other than replacing the pane. It is nonreversible.

Discoloration (shown by arrow) is a frequent problem in cockpit windows. Some discoloration, including milkiness, is repairable, but yellowing cannot be repaired.

Milkiness removal. The window is dried and, in most cases, relaminated to eliminate air spaces so that no new moisture can enter.
