FLIGHT SAFETY FOUNDATION  
**Aviation Mechanics Bulletin**

JULY–AUGUST 1996

**Uncontained Engine  
Fan-hub Failure Prompts U.S.  
National Transportation Safety  
Board Recommendations**

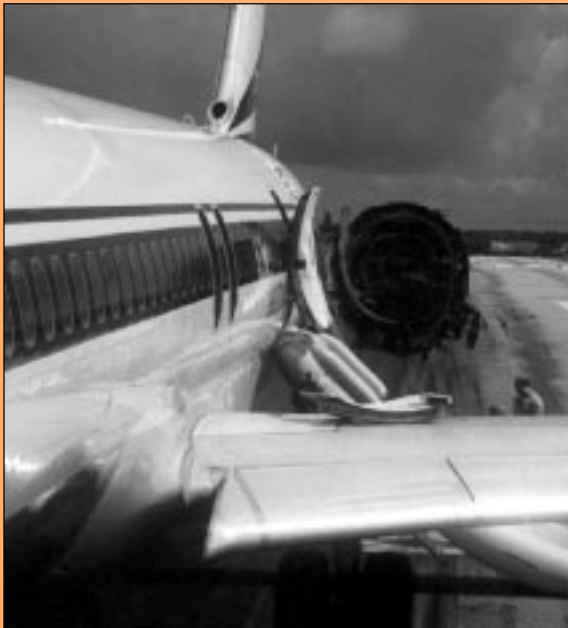
Cover photo: MD-88 uncontained engine failure. Photo: U.S. National Transportation Safety Board.

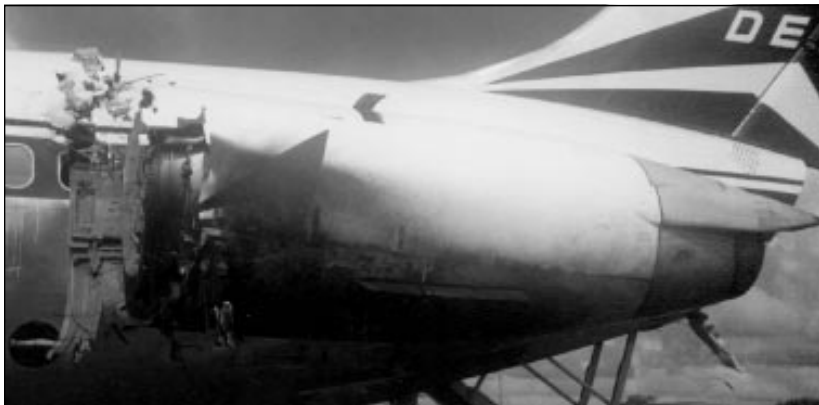
The investigation has determined that during the initial part of the takeoff roll, just as the engines were reaching peak thrust, the fan hub on the No. 1 engine separated into two large pieces. One piece was about two-thirds of the hub (containing 20 complete fan-blade slots) and the other was about one-third of the hub

*Pratt & Whitney JT8D-219 engine following uncontained fan-hub failure on McDonnell Douglas MD-88. Engine debris penetrated the cabin, killing two passengers.*

(containing 12 fan-blade slots). Other pieces of the fan hub, fan blades and other engine debris penetrated the aft cabin.

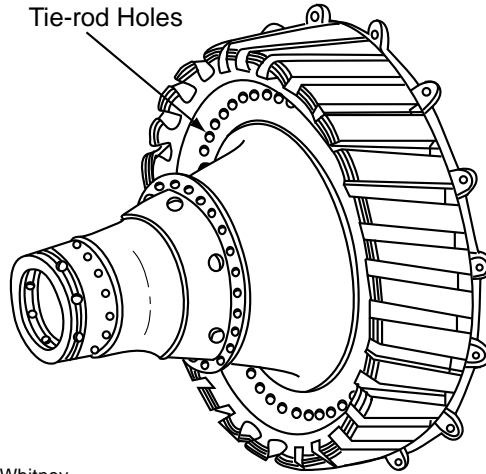
**Figure 1**

Metallurgical examination of the fan hub at the U.S. National Transportation Safety Board (NTSB) materials laboratory revealed that the fracture originated in one of the 24 tie-rod holes in the hub. The tie-rod holes, which are aligned parallel to the

engine shaft, are located around the circumference of the hub bore and alternate with 24 smaller-diameter stress redistribution (SR) holes (also called balance weight holes, cooling holes, lightening holes or shielding holes).

stemmed from low-cycle fatigue (LCF) cracking that originated from abusive machining (local surface hardening and cracking created when the holes were drilled). The LCF created ladder cracking and cold working of the underlying material in the microstructure inside one of the tie-rod holes about 0.5 inch (1.3 centimeters) from the aft face of the hub. A fatigue striation count using a scanning electron microscope disclosed a number of striations that was roughly equal to the total number of flight cycles for the fan hub.

on the aft face of the fan hub for a distance of 0.46 inch (1.2 centimeters) at the time of the last FPI. The length of the crack along the wall of the hole was about 0.9 inch (2.3 centimeters) at the time of the FPI.

- Require that, within 500 cycles of FAA approval of an engine “on-wing” eddy-current inspection process for Pratt & Whitney JT8D-200 series engine fan hub tie-rod holes, this inspection be performed on hubs that have accumulated more than 10,000 cycles since new; prioritize the inspections to ensure that fan hubs most at risk (those with 10,000 cycles to 15,000 cycles since new) are inspected first. This inspection can be superseded by the redundant inspection urged in safety recommendation A-96-75. (Class I, Urgent Action) (A-96-74);

- Require an inspection of all Pratt & Whitney JT8D-200 series engine fan hub tie-rod and SR holes by means of FPI and eddy current by a fixed number of flight cycles based on the risk of crack propagation from manufacturing flaws. (Class II, Priority Action) (A-96-75);
