FLIGHT SAFETY FOUNDATION
Aviation Mechanics Bulletin

JULY–AUGUST 1998

**Age-related Failures of
Aircraft Wiring Remain
Difficult to Detect**

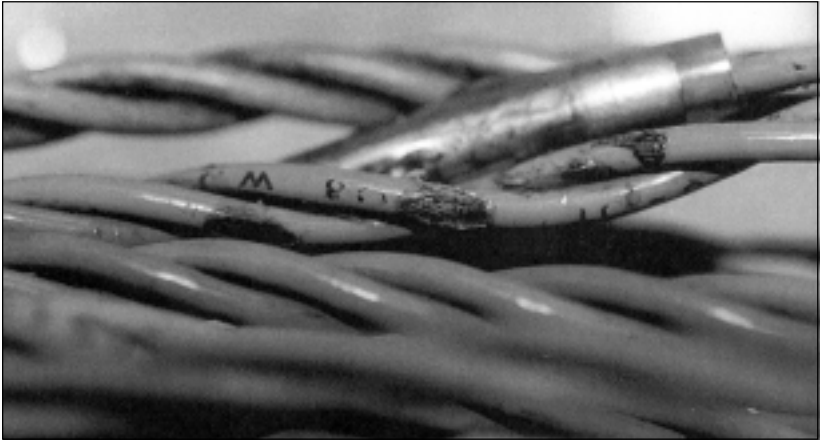
craft in which 20 percent of one-foot [0.3-meter] sections of 126 feet [38 meters] of flight-critical wiring [had] the types of trauma [illustrated in] the photograph on page 3. This aircraft was being used in flight.”

Trauma failure of wire insulation usually is detectable by visual inspection.
