FLIGHT SAFETY FOUNDATION
Aviation Mechanics Bulletin

MARCH-APRIL 2001

**Incorrect Installation of
Battery Cable Blamed for
Fire That Destroyed
Helicopter**

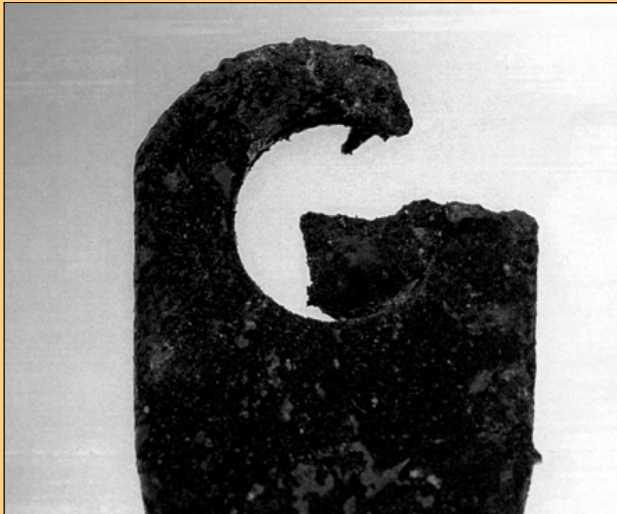
On the Cover: A close-up of the connector end of the unattached battery cable that was blamed for a fire that destroyed an Aerospatiale AS 355F1 helicopter April 28, 1999. (Source: Transportation Safety Board of Canada)

A post-accident examination of the nicad batteries showed that they were “severely fire-damaged” and that the paralleling cable had been attached to the positive post of the auxiliary battery but not to the positive post of the main battery.

A short length of unattached battery cable was found near the batteries in the fire-damaged wreckage. Visual [examination] and laboratory examination of the cable identified that the copper end terminal was arc-damaged and that there were areas in which the copper had alloyed with aluminum — an indication that contact was made at high temperatures for a long enough
