FLIGHT SAFETY FOUNDATION
Aviation Mechanics Bulletin

MARCH-APRIL 2002

Improperly Installed B-747 Panels Separate on Takeoff

Vol. 50 No. 2

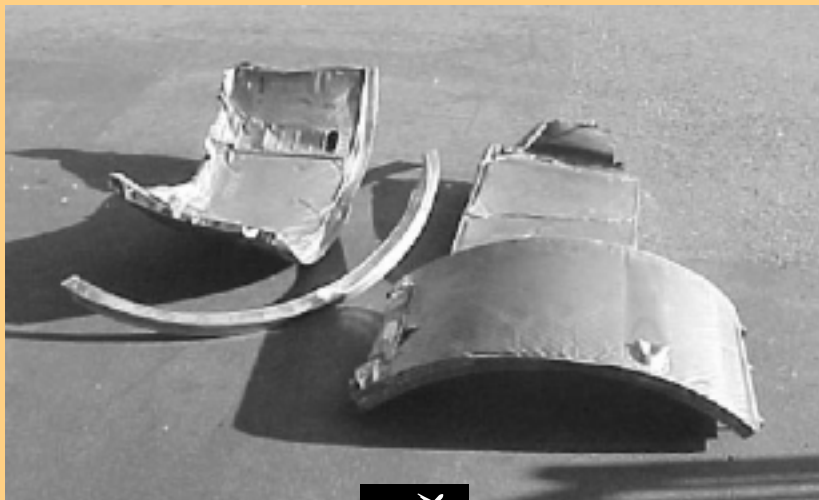
Cover photograph: Two combustion fairing panels (one broken into two pieces) from the no. 3 engine of a Boeing 747-438 were recovered from the Sydney Airport Runway 34L undershoot area the morning after the afternoon departure. (Photo: Australian Transport Safety Bureau)

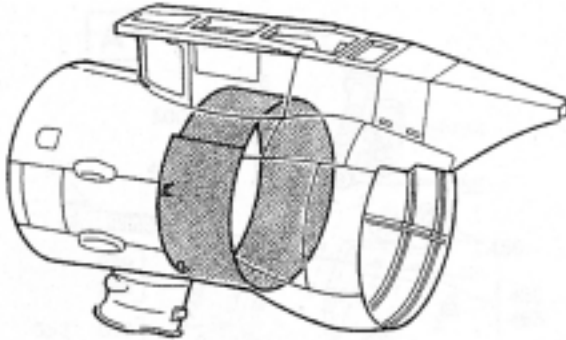
Figure 1

“Hooks on the right [fairing] panel were not engaged with the respective socket pins of the upper fairing

[panel],” the report said. “This then permitted the free movement of the fairing sections to a point where they were caught by the bypass airflow and forcefully ejected. The examination [by the ATSB Technical Analysis Unit] did not identify any defects in manufacture or maintenance of the fairing mounts or latches that could have contributed to the release.”

ATSB recommended that “Rolls-Royce expedite the development, trial and implementation of a suitable

engineering solution to prevent the [incorrect installation] of combustion fairings on RB211-524 and RB211-22B engines [Recommendation R20010230].” After this incident, Rolls-Royce distributed a brief instructional video that explains the correct methods for fitting the combustion fairing panels to these engines and says that maintenance technicians must check for correct installation after fitting the panels. [Rolls-Royce said that development fitting trials of the new fairing design are underway and plans include release of a service bulletin in the third quarter of 2002.]

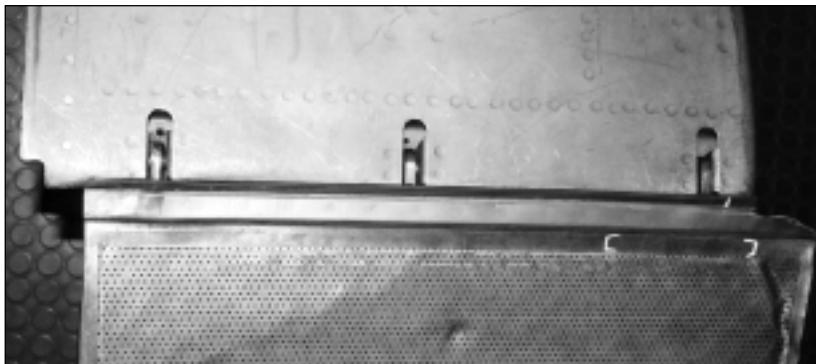
Investigators determined that inspection of the upper connection points was difficult for maintenance technicians because of “the restricted confines of the cold-stream duct surrounding the panels.” To inspect this area, Rolls-Royce maintenance-manual procedures — including requirements in manual revisions

No distinct gap is visible when the mounting hooks along the top edge of the right fairing panel are engaged correctly with the upper fairing panel. (Photo: Australian Transport Safety Bureau)

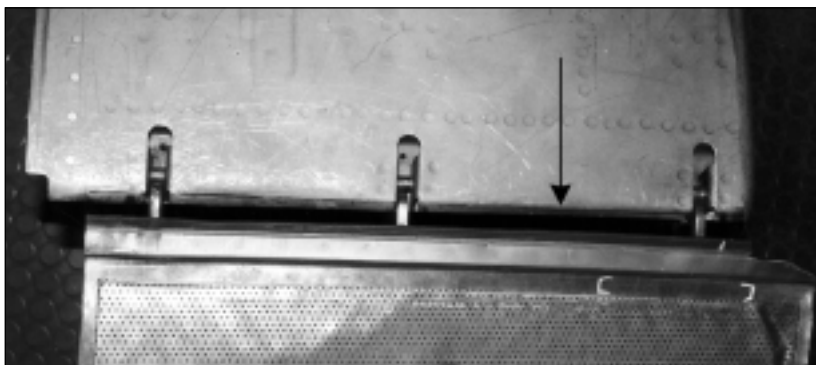
“The clamping action of the interlocking fire seal along the rear edge of the fairing panels allowed the [fairing panels] to stay in position without the support of the hooks,” the report said. “Latching action between the fairing panels was also unaffected. When the panels were installed incorrectly, inspection of the upper connection points clearly showed a large gap between the upper [fairing panel] and side [fairing panels].”

A distinct gap is visible between the upper fairing panel and the right-fairing-panel sealing strip (arrow) when the mounting hooks are engaged incorrectly. (Photo: Australian Transport Safety Bureau)

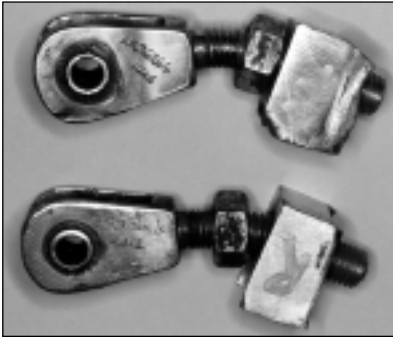
“All three mounting hooks [of the right panel were sound and] undamaged and showed no sign of having been forcibly pulled away from the upper fairing [panel] pins. In comparison, both latches and the forward hook from the left [fairing] panel showed damage consistent with the

connections being overloaded and pulled apart. The left [fairing panel] experienced heavy crushing on the forward edge [and structural distortion], consistent with the panel pivoting out sideways from its mounted position. The forward mounting hook on the upper edge of the left [fairing] panel showed clear evidence of having forcefully pulled out from the pin socket during the release. The three mounting hooks along the upper edge of the [left] fairing panel showed varying degrees of mechanical damage and distortion. The forward hook had opened extensively and showed backward and sideways bending. Both clevises from the panel latches had been bent and torn away in overload from the base of the left [fairing] panel — evidence that both were engaged and locked at the time of the [release of the fairing panels]. The pin sockets into which the hooks from the left and right fairing panels engaged were intact and undamaged.”

Damage to the recovered clevises and mounting blocks (see photo, page 6) and the absence of damage to the upper fairing panel also supported the sequence of fairing-panel release and ejection determined by ATSB investigators.

Clevis fittings and mounting blocks were torn from the fairing-panel structure and show the degree of bending overload on the clevis shafts.
