FLIGHT SAFETY FOUNDATION
Aviation Mechanics Bulletin

MARCH-APRIL 2003

Faulty Repair of Fuel-control Unit Cited in Engine Flameout

A report by the New Zealand Transport Accident Investigation Commission said that symptoms of engine overspeeding in the Hughes 369D helicopter were improperly diagnosed for more than 2 1/2 years before the accident.

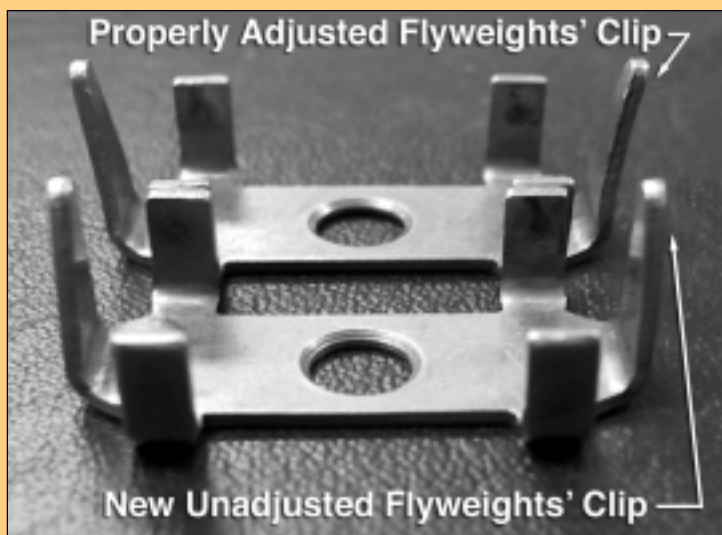
On the cover: Accident investigators compared a new unadjusted fuel-control-unit flyweights' clip with one that was properly adjusted. The accident report said that the flyweights' clip probably had never been adjusted in a Hughes 369D that was substantially damaged during a landing in a wooded area after an engine flameout. (Photo: New Zealand Transport Accident Investigation Commission)

Further tests of the FCU, however, revealed that the flyweights' clip was adjusted improperly, and as a result, the flyweights' movement was restricted to less than half of the required distance.

The report also said that the flyweights' clip probably had been replaced during

the 1998 repair and not adjusted. The clip weight stops resembled those of an "unadjusted new item," the report said. Maintenance records did not show that the flyweights' clip had been replaced, and entries in the records for the FCU overhaul and FCU repair both showed that the clip weight stop adjustments were appropriate.
