FLIGHT SAFETY FOUNDATION
Aviation Mechanics Bulletin

MARCH–APRIL 2004

Use of Incorrect Rivets Blamed for Separation of Engine Cowling

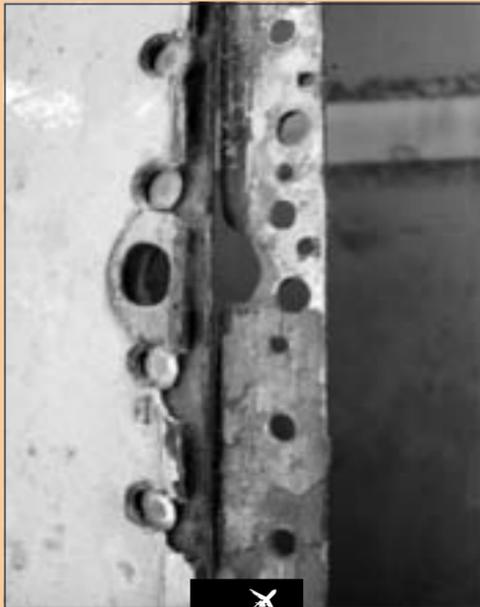
On the cover: Examination of the transcowling that separated from a Boeing 747 engine during landing in Manchester, England, revealed torn rivet holes and sunken rivet heads. The accident report said that the rivets were an incorrect type. (Photo: U.K. Air Accidents Investigation Branch).

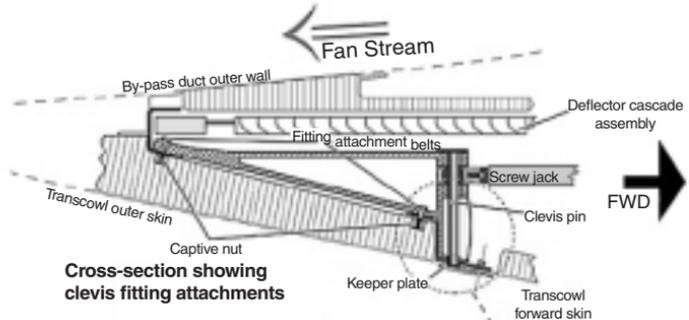
Cross-section showing clevis fitting attachments

Sections Showing Attachment of Lower Clevis Fitting to Transcowl

In the incident airplane, the degradation of the attachment of the lower clevis fitting to the transcowl meant that as the fitting moved, bolt holes gradually were enlarged until their nuts passed through the holes and the clevis fitting separated from the transcowl. This separation resulted in loss of positional control of the transcowl and led to the possibility that the transcowl could become misaligned and jammed, especially while the reverser was being stowed.

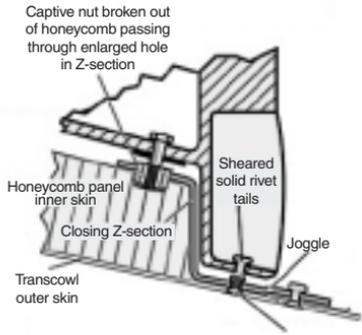
Detail section of fitting flange and forward bolt attachments before separations

The tails of the four attachment rivets remained in their holes in the flange of the lower clevis fitting, and an examination revealed that all four had failed “in shear, in a direction consistent with the fitting being pulled forwards relative to the transcowl,” the report said. “The two bolts immediately aft of the riveted flange were still attached to the clevis fitting, and their captive nuts, which had been bonded into the transcowl honeycomb skin structure, were still attached to the bolts. Of the two bolts [that] should have attached the tail of the fitting to the skin structure, one was completely missing, and only the threaded portion of the other remained in the captive nut.”

“The bond between the closing section and the honeycomb-panel inner skin had failed, allowing the honeycomb panel closing Z-section to flex forwards, tearing out the bolt holes in the inner skin to its forward free edge,” the report said. “The captive nuts at this location had also separated from the inner skin, allowing

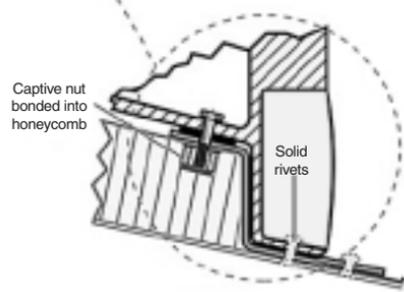
Detail of correct attachment of forward end of clevis fitting

Replacement blind rivets not attaching fitting to transcowl skin

fitting had been attached to the transcowl; the clevis fitting had separated without distortion. The heads of the four rivets, which should have attached the forward flange of the clevis fitting to the transcowl, appeared to be in place. Nevertheless, the report said that the rivets “appeared to be [of the] blind type, unlike all the other rivets in the area, which were countersunk alloy solids. The replacement rivets were all deeply set into the countersinks, and the metal between the holes and the forward edge of the transcowl skin section had been torn out.”

Although there was no shear distortion of the four rivets, the skin in front of the rivet holes “had been broken out,” the report said. “This indicated that the rivets had been installed with the holes already in this condition.”

Further examination of the failed clevis-fitting attachment points showed that the flange attachment had not been effective after the replacement rivets were installed and that the original solid rivets had failed in shear overload.

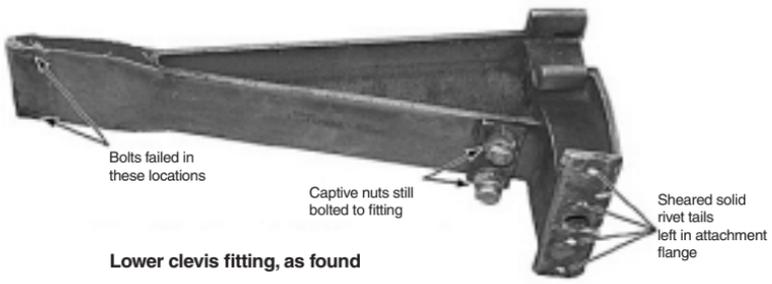
Lower clevis fitting, as found

The tails of the blind rivets left marks on the attachment flange of the clevis fitting, indicating that the fitting was “generally held against the rivet tails at a slight angle to its proper orientation and slightly forward of its proper position,” the report said. Other marks indicated that the fitting had been pulled forward repeatedly; the forward movement caused the clevis pin end to move out of its insertion hole and to strike the joggle (a notch designed to prevent slipping) in the forward flange, causing a fatigue failure around the joggle line. The report said that this fatigue indicated that the thrust reverser had been operated repeatedly with the inadequate attachment of the lower clevis fitting to the transcowl.

“The marking found on the lower clevis-fitting riveted-attachment flange and on the forward flange of the honeycomb panel closing Z-section indicated that the effective rigidity of the attachment of the fitting to the transcowl had been low and had degraded progressively over a period before the separation of the transcowl from the nacelle,” the report said. “It was clear that the flange-attachment riveting had failed in shear at some time in the relatively recent past and that the rivet holes in the skin had been refilled without restoring the joint.”
