FLIGHT SAFETY FOUNDATION  
**Aviation Mechanics Bulletin**

MARCH-APRIL 1995

**Boeing 747 Landing  
Accident Reveals Flawed  
Maintenance Procedures**

# Boeing 747 Landing Accident Reveals Flawed Maintenance Procedures

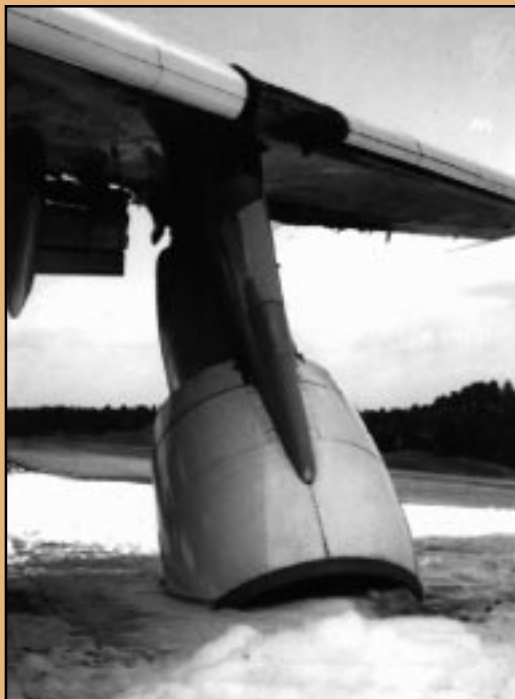
On March 1, 1994, a Northwest Airlines Boeing 747 arriving at New Tokyo International Airport, Narita, Japan, suffered a serious accident on roll-out after landing. The flight, touchdown and initial roll-out were routine. Reverse thrust was selected on all four engines, but when the flight crew moved the engine power levers out of reverse at about 90 knots, the No. 1 engine and pylon sagged, rotating about the midspar pylon-to-wing fittings, allowing the lower forward part of the nose cowl to contact the runway. The aircraft was stopped on a taxiway, with the front of the No. 1

engine contacting the ground (cover photo/U.S. National Transportation Safety Board). A large portion of the lower forward engine nose cowl had been ground away as it was dragged on the runway.

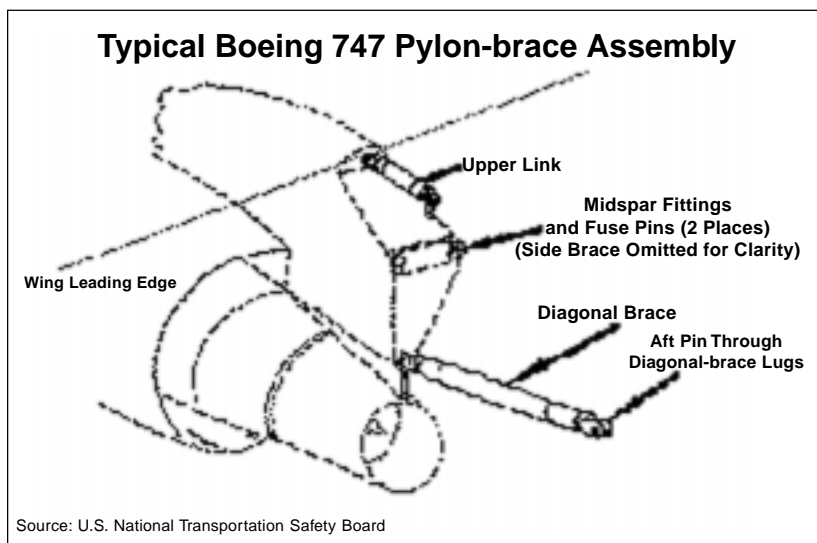
Figure 1

On the B-747, each pylon is attached to the wing structure at three points (Figure 1) — an upper link, the midspar fitting and the aft diagonal brace. At

an unknown time prior to this landing, the aft fuse pin on the pylon diagonal brace had worked its way out of the fitting. The pin was recovered intact and undamaged, with no evidence of preexisting defects. This hollow pin is normally retained by both a primary and a secondary retention device.

The last failure in the chain of events was the forward upper-link fuse pin in the No. 1 pylon-to-wing attachment structure. This pin failed in static overload, although there was no evidence of preexisting fatigue. When this pin failed, the pylon rotated on the single remaining midspar fitting, allowing the engine to contact the runway surface.

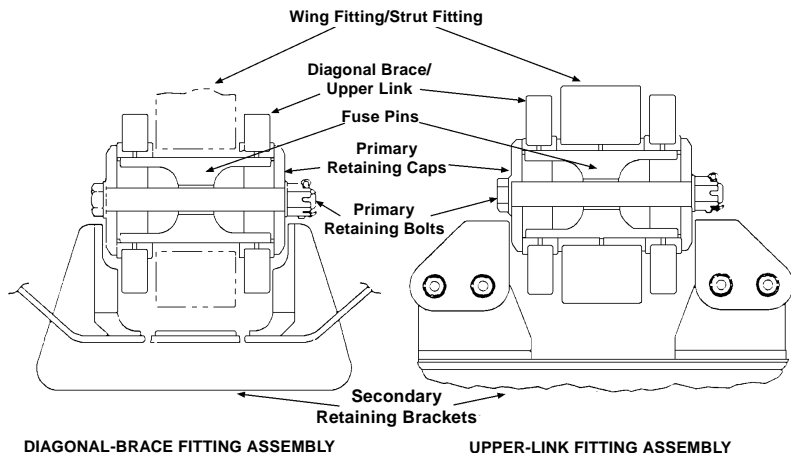
### Figure 2

The primary retainer consists of a large washer on each end that overlaps the pin and bushing. The washers are secured by a retaining bolt passed through the hollow pin, and the castellated nut on the through-bolt is secured by a cotter pin.

A secondary retainer consists of a U-shaped bracket surrounding the washers, keeping them in place over the end of the pin/bushing assembly (Figure 2).

Neither the primary retainer nor the secondary retainer were found in the area of the accident. The aircraft had completed 14 flight cycles since completion of a “C” check at the airline’s

main maintenance facility eight days earlier. The day following the accident, airline personnel advised the NTSB and the JAAIC that a small cloth bag, containing a set of the diagonal-brace fuse-pin primary retainers and secondary retainers, had been found in the maintenance facility on a work stand that had been used during the aircraft’s recent “C” check. It was later confirmed that these parts were not reinstalled on the aircraft during the check.
