FLIGHT SAFETY FOUNDATION
Aviation Mechanics Bulletin

MARCH-APRIL 1997

FAA Proposes Airworthiness Directives for Modifying Boeing 737 Rudder Control Systems

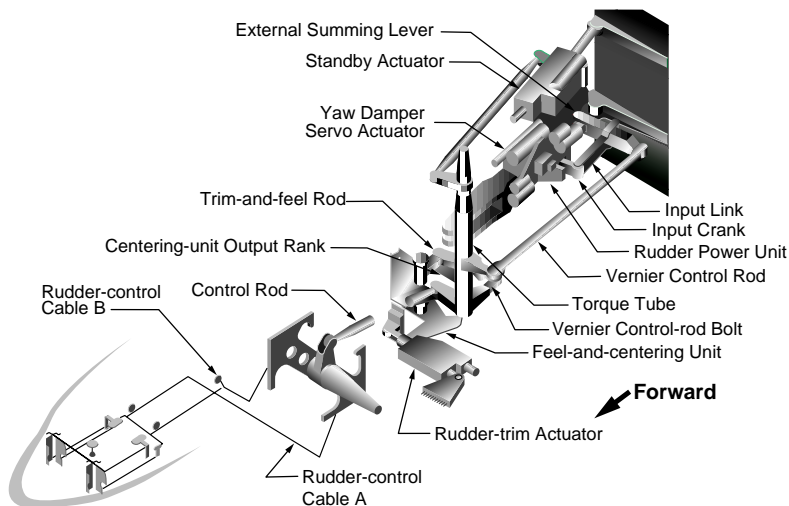
Figure 1

The U.S. Federal Aviation Administration (FAA) has proposed two airworthiness directives (ADs) that would require modifications to the rudder control system (Figure 1, page 2) of all operational Boeing 737 aircraft. Both proposed ADs are intended to reduce the risk of inadvertent rudder movements.

Docket No. 97-NM-29-AD, proposes an AD that would require replacement of the main rudder power control unit (PCU) and the fitting of redesigned bolts on the PCU vernier control rod. Both proposed ADs would apply to B-737-100 through -500 series aircraft.

“(1) Install a newly designed rudder-limiting device that reduces the rudder authority at altitudes above 1,500 feet AGL; [and]

“(2) Install a newly designed yaw damper system that improves the reliability and fault-monitoring capability.”

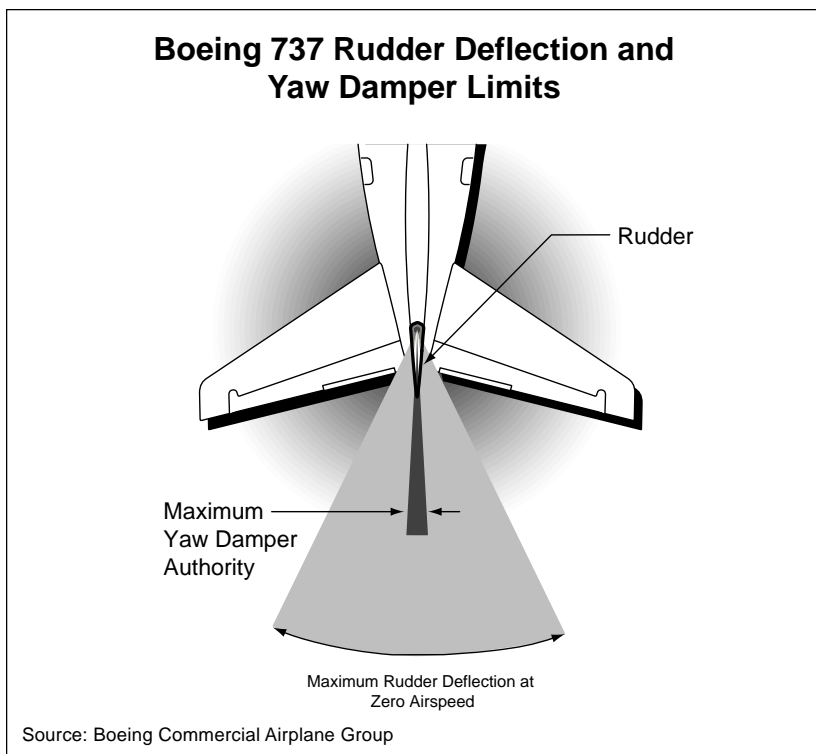
Figure 2

The rudder (Figure 2) is designed so that the degree of possible rudder deflection decreases as airspeed increases. Nevertheless, "... during certain combinations of flap settings and airspeeds," the FAA said, "the amount of rudder deflection available is greater

than needed for control of the airplane. A full rudder deflection (hardover) with such excessive rudder authority can result in a rolling moment due to sideslip that exceeds the maximum rolling moment available by control-wheel inputs." [The FAA issued AD 96-26-07 on Jan. 2, 1997, requires revisions to the FAA-approved airplane flight manual, adding procedures for flight crews to control the airplane during an uncommanded yaw or roll, and to correct a jammed or restricted flight-control condition.

“Installation of a rudder-limiting device is necessary to reduce the rudder authority at altitudes above 1,500 feet [458 meters] above ground level (AGL) so that, if any inadvertent hardover occurs, the resultant roll upset can be controlled with control-wheel inputs,” the FAA said. “Installation of a new yaw damper system is necessary to improve the reliability of the system and its fault-monitoring capability, which will prevent uncommanded yawing of the airplane.”

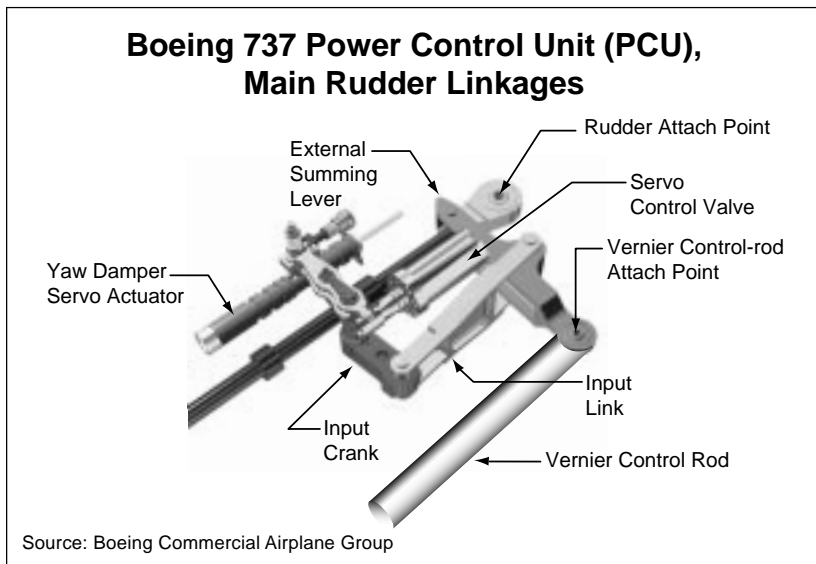
Figure 3

On Nov. 7, 1996, the FAA issued AD 96-23-51, applicable to all B-737 series airplanes, to require periodic tests to verify the proper operation of the main rudder PCU (Figure 3), and replacement of the

PCU with a new unit if necessary. “Tests of the PCU conducted by the manufacturer ... demonstrated another very remote potential failure scenario that was previously unknown,” the FAA said. That scenario involved rudder-pedal input causing deformation in the linkage leading to the primary and secondary slides of the servo control valve of the main rudder PCU. Under such a condition, a rudder-pedal command could also result in rudder travel in the wrong direction. The FAA described AD 96-23-51 as “an interim action.”

“(1) Replace any main rudder PCU having Boeing part number (P/N) 65-44861-() or P/N 65C37052-() with a new main rudder PCU that has been approved by the manager, Seattle ACO.

“(e) Perform a leak test of the main rudder PCU in accordance with a method approved by the manager, Seattle ACO, at the applicable times specified in paragraph (e)(1) or (e)(2) of this AD. If any discrepancy is found, prior to further flight, replace the PCU with a serviceable or newly designed unit
