FLIGHT SAFETY FOUNDATION
Aviation Mechanics Bulletin

MAY-JUNE 2001

Fractured Bolts Blamed for Loss of Control of Two Helicopters

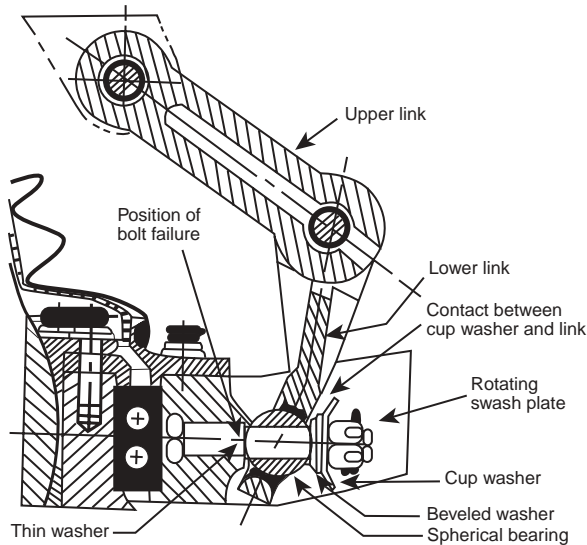
**Incorrect Orientation of Lower Scissors Link
Caused Contact Between Cup Washer and Link**

“[T]he bolt had failed in fatigue across most of its section, with the final 15 percent or so failing in overload,” the June accident report said. “The fatigue initiation area was centered on the 12 o’clock position on the fracture face and was the result of a simple bending mechanism. This was entirely consistent with the loads

that would have arisen as a result of installing the lower scissors link in the incorrect orientation. The loads would have been a combination of the spherical bearing running out of travel and the contact between the cup washer and the face of the link. Fretting damage on the link due to contact by the cup washer (which had become distorted as a result) was clearly visible.”

Inspection also showed that the beveled washer that should have been located between the cup washer and the lower link was missing and that in its place was the thin washer that should have been between the swash plate and the scissors link.

Agusta also issued technical bulletin no. 109EP-12 on July 24, 2000, which described the procedures to be used in visually inspecting the rotating-scissors assembly for correct installation and replacing any part that was not airworthy. The technical bulletin also said that, within 50 hours time-in-service, the rotating scissors assembly should be removed to inspect the attachment bolt for a crack or other damage (unless the bolt was replaced as a result of the initial inspection).
