FLIGHT SAFETY FOUNDATION
Aviation Mechanics Bulletin

MAY–JUNE 1996

**U.S. National Transportation
Safety Board Issues “Urgent”
Recommendations for
Hazardous Cargo**

U.S. National Transportation Safety Board Issues “Urgent” Recommendations for Hazardous Cargo

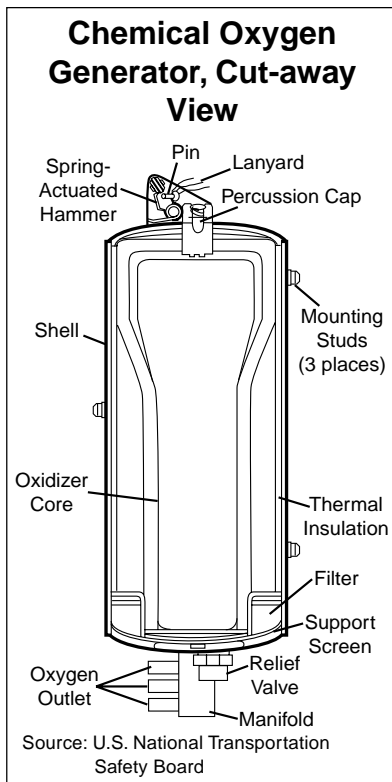
Figure 1

A chemical oxygen generator (Figure 1) is about the size of a can of spray paint (a cylinder 2.75 inches by 6.75 inches [6.99 centimeters by 17.15 centimeters]). The oxidizer core is primarily sodium chlorate mixed with less than 6 percent barium peroxide and potassium perchlorate, and trace amounts of other materials.

The chemical oxygen generators, which were manufactured by Scott Aviation Inc., produce oxygen when a pin is pulled, releasing a spring-loaded firing mechanism that strikes a percussion cap and starts a chemical reaction in the generator's solid oxidizer core. The reaction produces oxygen for at least 15 minutes. The chemical reaction of the oxidizer releases heat, and the heat of

reaction can result in external shell temperatures up to 547 degrees F (286 degrees C). (Manufacturer measurements of external shell temperature on oxygen generators during operational testing indicated maximum shell temperatures between 450 degrees F and 500 degrees F [232 degrees C and 260 degrees C].)

Although the origin of the in-flight fire on Flight 592 has not been determined, the presence of the chemical oxygen generators in the forward cargo compartment of the aircraft created an extremely dangerous condition. The chemical reaction of an oxidizer such as sodium chlorate in a confined space will generate heat, and the oxygen resulting from the reaction will sustain and intensify a fire. In addition, the ignition temperature of ordinary materials is lowered in an oxygen-rich environment.

The NTSB supports these actions but believes further action can and should be taken. Because chemical oxygen generators are not reusable and must be discharged before disposal, the NTSB believes that there is no need to transport expired and undepleted chemical oxygen generators as cargo on any passenger or cargo aircraft. Therefore, the NTSB believes that the FAA, in cooperation with the RSPA, should permanently prohibit the transportation of generators as cargo on any passenger or cargo aircraft when the chemical oxygen generators have passed their expiration dates and the oxidizer cores have not been depleted.

- In cooperation with the RSPA, permanently prohibit the transportation of chemical oxygen generators as cargo on any passenger or cargo aircraft when the generators have passed their expiration dates and the chemical cores have not been depleted (Class I, Urgent Action) (A-96-27); and,
- In cooperation with the RSPA, prohibit the transportation of oxidizers and oxidizing materials (e.g., nitric acid) in cargo compartments that do not
