FLIGHT SAFETY FOUNDATION
Aviation Mechanics Bulletin

Fatigue Crack Leads to MD-83 Left Main Landing Gear Collapse on Rollout

May–June 1997

Vol. 45 No. 3

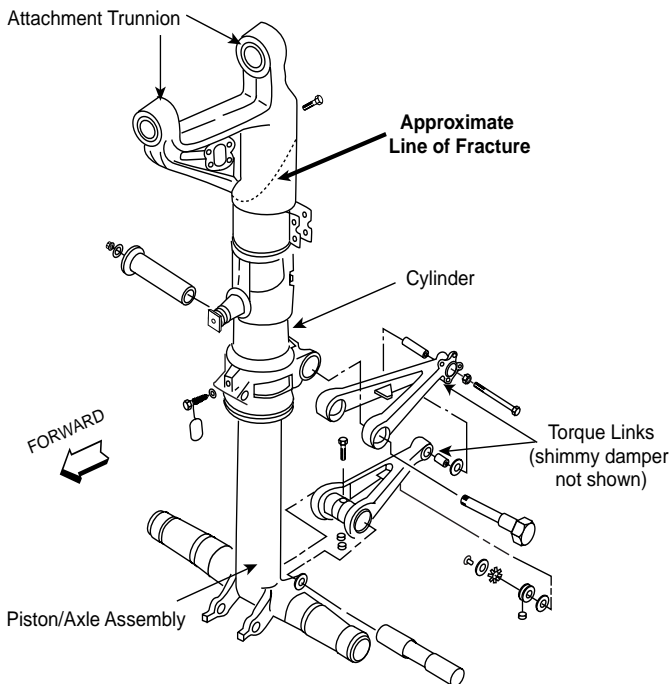
Figure 1

cylinder and piston (Figure 1, page 3). Torsional/lateral motion is prevented by a shimmy dampener (not shown). The cylinder, including the trunnions, is a single forging of 300M steel, as is the piston, which incorporates the axle. A critical cross-section occurs about 46 centimeters (18 inches) below the centerline of the landing-gear trunnion, where a reduction in cylinder-wall thickness is found. The report said that McDonnell Douglas considered that the cross-section met normal stress requirements, and that its position close to the top of the leg provided an additional "break-away" safeguard against wing-tank rupture in runway-overrun situations.

The component that failed on the MLG was the left-hand cylinder. Inspection revealed a crack five millimeters (0.19 inch) long by 1.25 millimeters (0.049 inch) deep on the front face of an otherwise typical cylinder. According to the report, the crack almost certainly was not detectable visually.

The root cause of the fracture, the report said, “was multiple fatigue origins associated with the rough and uneven surface finish on the outside of the cylinder.” These surface flaws were the result of grit-blasting to prepare the steel surface of the cylinder for high-current density cadmium plating. Small particles of aluminum oxide, the grit-blasting agent, were found trapped in surface folds beneath the cadmium plating, and there were microscopic fatigue cracks

The weakness generated by grit-blasting was likely to have been increased early in the aircraft's life by gear walking.

As a result of this accident, and in view of the possibility that occurrences of gear walking may have gone unrecorded, the U.S. Federal Aviation Administration (FAA) and McDonnell Douglas required inspections of MD-80 series aircraft to check for cracking of the MLG cylinder in a critical area.

Alert Service Bulletin (ASB) MD-80-32A286, issued by McDonnell Douglas on Sept. 11, 1995, called for magnetic-particle and fluorescent dye-penetrant crack detection on the MLG cylinders on all MD-80 series

AD 96-01-09 subsequently mandated the fitting of in-line hydraulic restrictors on all MD-80 series aircraft MLG.

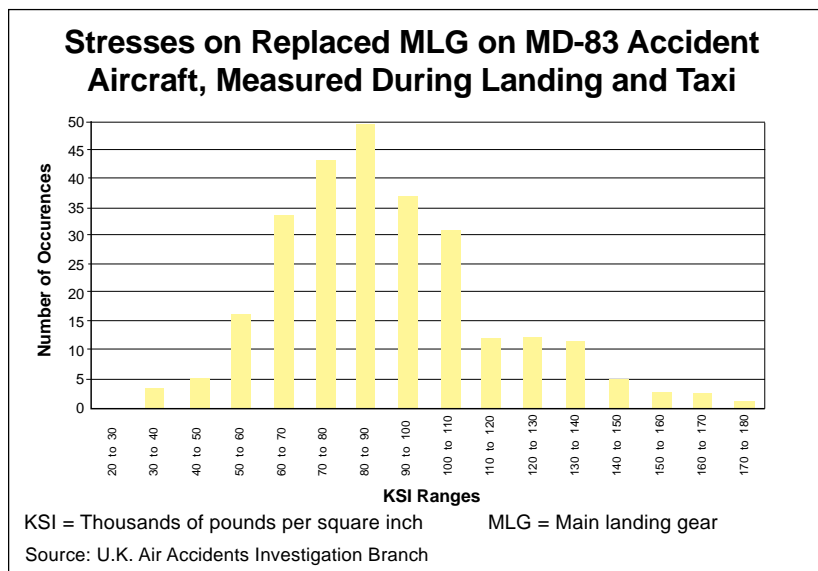
Figure 2 shows in-service MLG stress during landing and taxi of the MD-83, as measured by gauges fitted to the replaced left landing-gear strut of the accident aircraft. "The data ... show that stresses on the MLG were within the expected values," the report said, "apart from two excursions into the 160–180 KSI range."

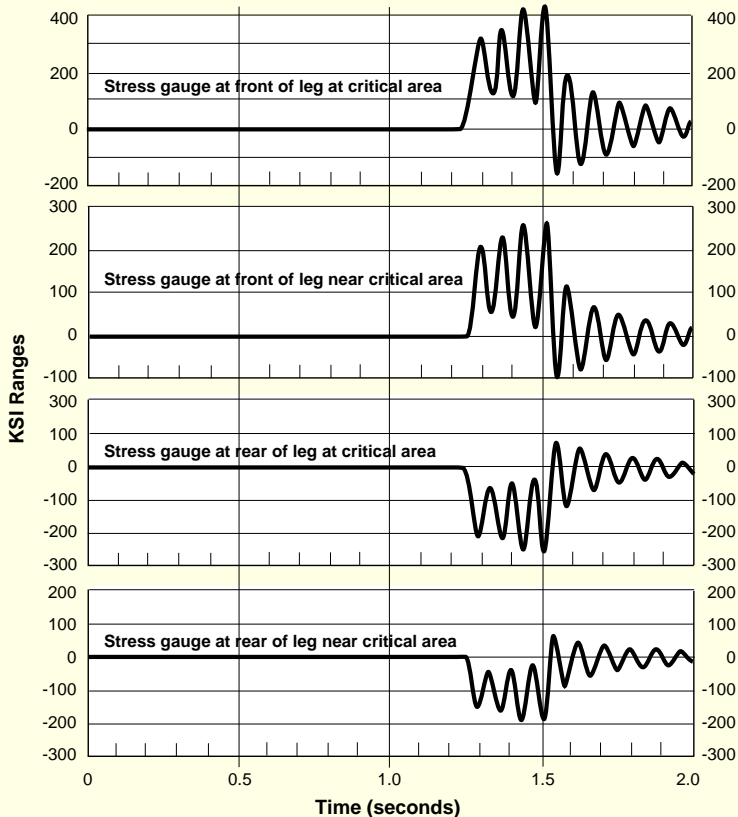
Stress on Test MD-87 MLG During Induced Gear Walking

Figure 3 depicts actual MD-87 test results. The four charts show stress readings against time for landing roll-out. In the top chart, the stress gauge

was fitted to the front of the leg at the critical (crack) area. As can be seen, gear walking was induced at about 1.3 seconds. It lasted for less than half a second, but during that time, stress on the MLG leg reached four times normal levels. The second chart shows the same data for a gauge slightly displaced from the critical area. The bottom two charts depict the results from gauges located at the rear of the leg.

catastrophic.” The tests also demonstrated that restrictors in hydraulic lines are successful in inhibiting gear walking.

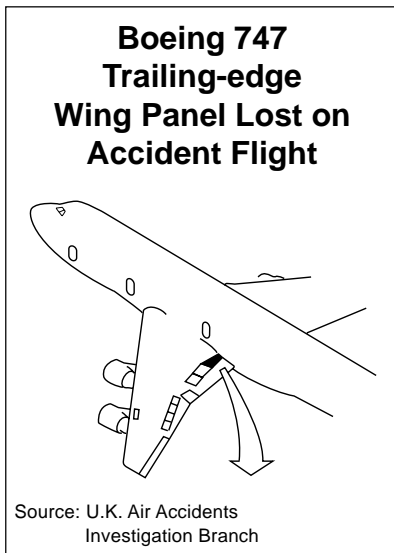
Figure 1

An inspection of the aircraft revealed that a large section of the left-wing trailing-edge upper inboard panel had broken away (Figure 1). This panel is sometimes referred to as the "flying panel" because it is deflected upwards

Examination of the recovered panel indicated that the failure had begun in the bond between the upper skin and the core and that the failure was associated with previous repairs. A closer examination of the section of the panel containing the repairs showed a spanwise wrinkle in the upper fiberglass skin, caused by a partially filled region of the honeycomb.

Filler had apparently been added to that region of the honeycomb, but had not penetrated to the full depth of the honeycomb cells. A subsequent repair had been made involving a honeycomb insert. But no attempt had been made to join the inserted plug to the surrounding core. All repairs had been carried out using cold-setting adhesives.

It was concluded by the U.K. Air Accidents Investigation Branch (AAIB) that the failure was the result of a localized change in stiffness in bending caused by the filler in the core. It is probable that pieces of the panel detached after the aircraft became airborne, and that additional minor damage occurred as the flaps were retracted and the forward edge of the

As a result of this incident, a special check was instituted by the carrier to inspect and repair, as required, all trailing-edge flying panels of all of its B-747 aircraft. Aircraft with *SRM*-based repairs were to be inspected within one month; all other aircraft were to be inspected as soon as possible. Deviations from the *SRM*

concerning the panel were discontinued and the *SRM* was amended to permit no cracks.

The airline also publicized the problem of the damaged panels in its in-house technical newsletter and, considering that panel damage could also result from maintenance personnel walking on the panels during inspection and servicing, had all panels placarded "No Step."♦
