FLIGHT SAFETY FOUNDATION
Aviation Mechanics Bulletin

MAY–JUNE 1998

Unrecorded Maintenance on Fokker 100 Lift-dumper System Leads to Wing- Surface Damage in Flight

Vol. 46 No. 3

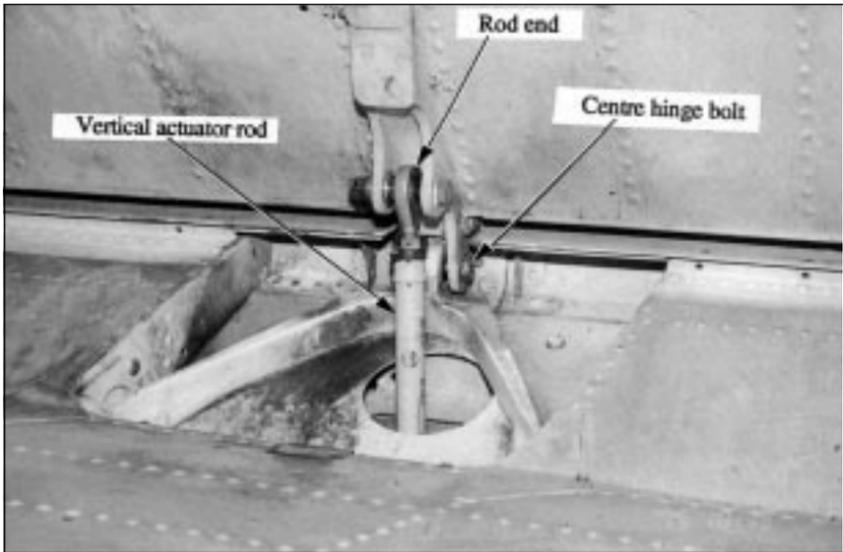
Upper-wing damage was found during the walk-around inspection of a Fokker 100 (F-100) that landed at London (England) Stansted Airport after a flight from Amsterdam, Netherlands, on Oct. 12, 1995. The edge of the no. 5 lift-dumper (spoiler) panel on the left wing was bent upward, said the U.K. Air Accidents Investigation Branch (AAIB).

Further inspection revealed that a bolt was missing from the center hinge on the lift-dumper panel. The AAIB said that the absence of the center-hinge bolt allowed abnormal loads to be applied to the lift-dumper panel by the hydraulic actuator. The actuator forced the panel upward, causing a bowing distortion of the panel.

The center-hinge bolt in the left-wing lift-dumper system was not replaced before the Fokker 100 was returned to service after a major inspection. Subsequent activation of the system caused damage to the lift-dumper panel.

“At this point, and this is the crucial point around which the whole incident revolves, I was so busy and concerned to get the panel serviceable again that I inexplicably forgot to record the removal [of the center-hinge bolt] on the work card,” said the maintenance engineer.

The maintenance engineer and his co-worker then reinstalled the left-wing lift-dumper panel; however, they did not reinstall the actuator rod-end bolt and the center-hinge bolt because the replacement bushings had not yet been delivered to the maintenance hangar.
