FLIGHT SAFETY FOUNDATION
Aviation Mechanics Bulletin

Greasing Errors Cited in B-747 Landing Gear Fires

May–June 2005

Vol. 53 No. 3

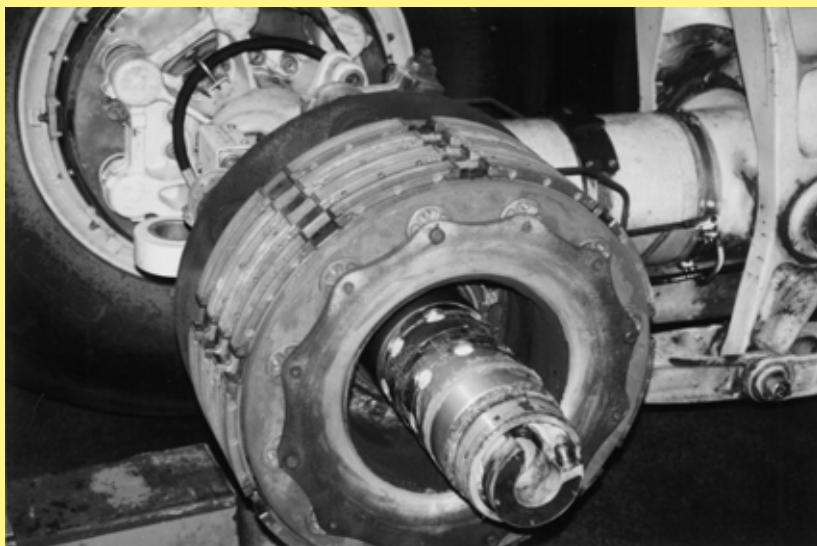
On the cover: Post-accident examination of this Boeing 747 wheel axle revealed that an incorrect type of grease had been used. (Photo: Australian Transport Safety Bureau)

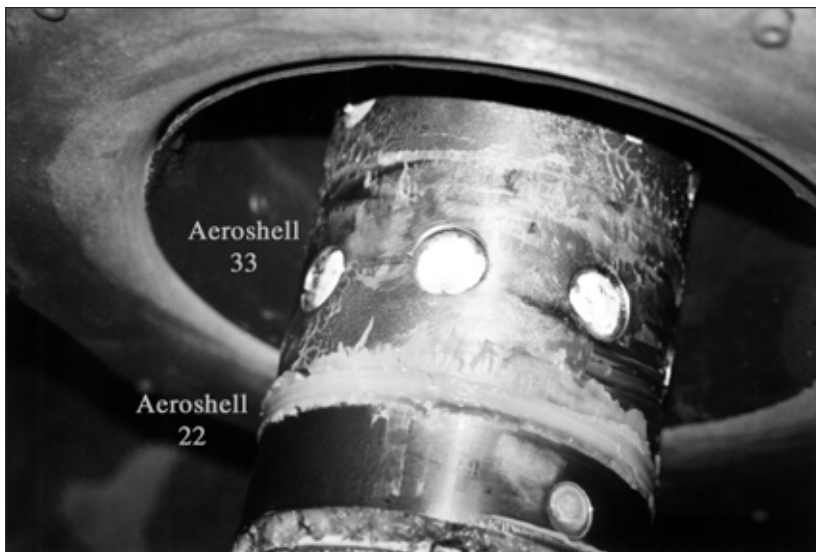
In addition to Aeroshell 22, the correct grease, which is amber in color, a green-blue grease, later identified as Aeroshell 33, also was found.

“Although not recommended for use in the high-temperature axle area as it had a lower flash point than the approved Aeroshell 22 grease, Aeroshell 33 was an approved lubricant for other areas of the landing gear,” the report said.

Most of the Aeroshell 33 grease was found on the inboard area of the axle; Aeroshell 22 was visible on the outer area.

An examination of this wheel axle from the accident airplane revealed two different types of grease — near the top of the photo, Aeroshell 33, not approved for use in this part of the landing gear; and near the bottom of the photo, the approved Aeroshell 22. (Source: Australian Transport Safety Bureau)

“The most likely event would have been during scheduled lubrication maintenance, not during individual wheel/brake replacement,” the report said. “The location of the Aeroshell 33 grease on the inner area of the axle suggested it had been present for some time.”
