Aviation Mechanics Bulletin

NOVEMBER–DECEMBER 2003

Faulty Wire Installation Cited in A320 Control Problem

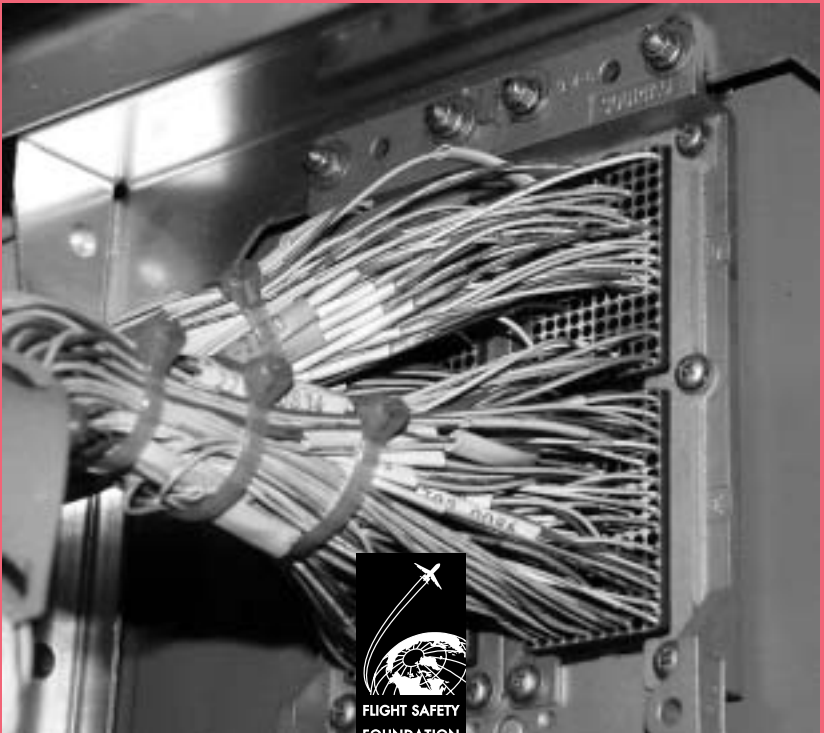
On the cover: Two pairs of wires were reversed on the plug of the elevator/aileron computer during maintenance before the March 21, 2001, incident. (Photo: German Federal Bureau of Aircraft Accidents Investigation)

- “During repair work on the plug of the elevator/aileron computer (ELAC; part of the A320 fly-by-wire control system) no. 1, two pairs of wires had been [reversed];
- “The error remained undetected; [and,]
- “The error was not recognized by the flight crew during the flight control check.”
