FLIGHT SAFETY FOUNDATION
Aviation Mechanics Bulletin

NOVEMBER–DECEMBER 1995

**U.K. CAA Cites Inadequately
Defined Inspection Procedures
For Human Errors in
Aircraft Inspection**

Vol. 43 No. 6

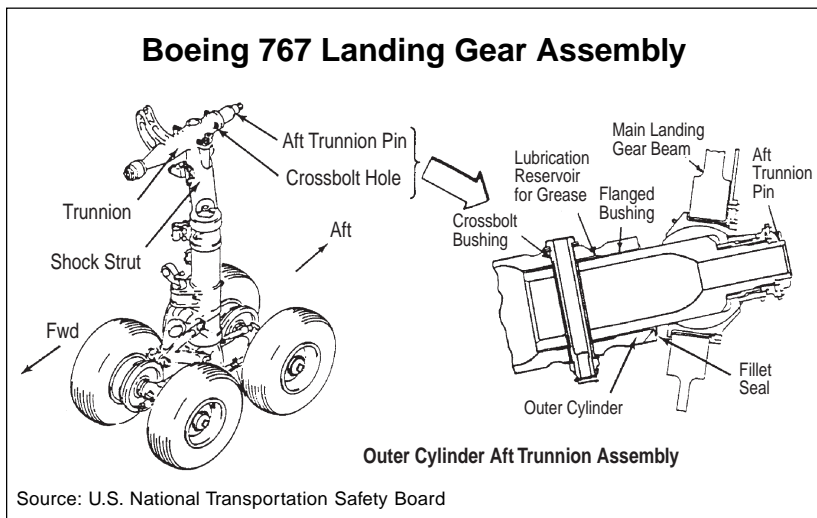
Figure 1

The outer edges of the bushing flange and the cylinder are covered by a putty-like flexible fillet seal intended to prevent moisture from entering under the bushing flange and cylinder chamfer area. The trunnion cylinder bore has a five-inch-(12.7-centimeter-)wide increased-diameter section along the inner circumference of the cylinder that serves as a lubrication reservoir.

The U.S. National Transportation Safety Board (NTSB) laboratory examination of the failure fragments revealed that the aft trunnion had six areas of stress corrosion cracking (SCC). The largest area of SCC originated at a corrosion-pitted area on the inside corner of the crossbolt hole, extending through to the

outside diameter wall approximately five inches (12.7 centimeters) in the aft-and-up direction. Other SCC cracks were as small as 0.04 inch (one millimeter) deep by 0.1 inch (2.54 millimeters) wide.

The inside surface of the outer cylinder aft trunnion was heavily corroded in two distinct circumferential bands. The corrosion bands were located at the forward and aft edges of the lubrication reservoir. The reservoir contained a layer of dried grease that covered the lower half of the reservoir. After it was cleaned, examination of the reservoir surface disclosed severe corrosion damage under the dried grease. Three of the SCC areas emanated from these corrosion-damaged areas.

The manufacturer and other operators are developing nondestructive inspection (NDI) techniques to detect internal corrosion and cracks in the trunnion bore area, but such developments may require a significant amount of time. Until an effective and definitive NDI technique is established, the NTSB recommends that the entire MLG outer cylinder aft trunnion surfaces be inspected frequently, and in detail, for cracks and corrosion.
