FLIGHT SAFETY FOUNDATION
Aviation Mechanics Bulletin

NOVEMBER–DECEMBER 1997

**FAA Airworthiness
Directives Focus on
Ignition Sources in
Boeing 747 Fuel Tanks**

Vol. 45 No. 6

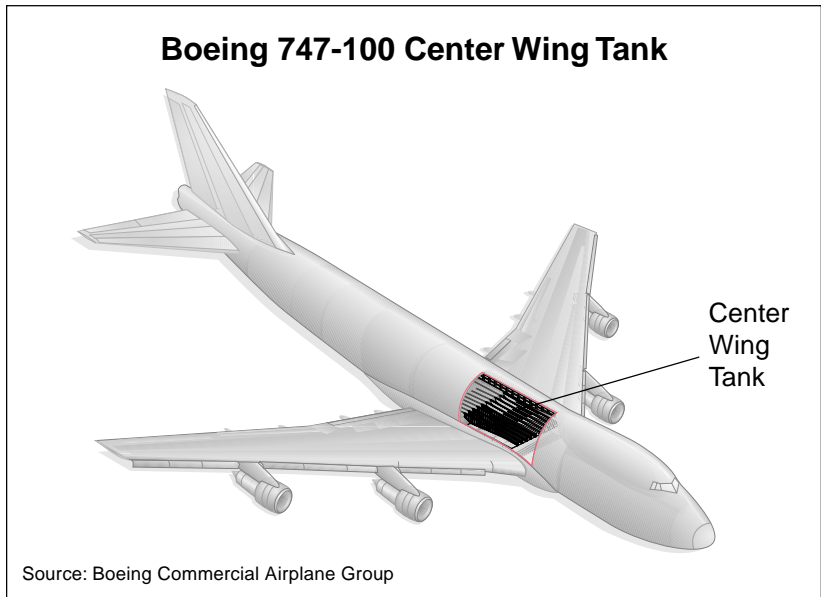
Figure 1

The NTSB investigated a number of scenarios in which excessive current to the probes that measure the fuel level in the CWT could have ignited the fuel/air fumes in the tank. These scenarios included: corrosion in the wiring in the tank caused by sulfur in the fuel; a fuel leak through the scavenger-pump connector into the main landing-gear wheel well that caused a fire; explosive vapors in the empty portion

of the CWT; and a series of failures after an electrical short circuit somewhere else in the airplane that sent a surge of power through the low-voltage system of the scavenge pump.
