FLIGHT SAFETY FOUNDATION  
**Aviation Mechanics Bulletin**

**Inadequate Shot Peening  
Cited in Two Failures of  
Left-main Landing Gear on  
Fokker 100**

**Vol. 49 No. 5**

*The Australian Transport Safety Bureau said that the two incidents, which occurred three months apart in the same airplane, involved cracks in parts of the landing gear that had been repaired and in areas where shot peening was faulty.*

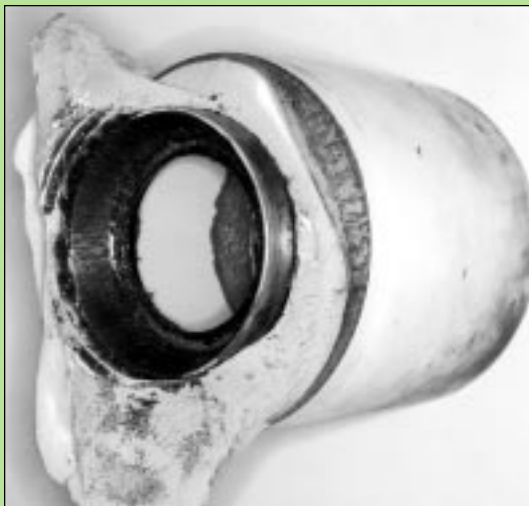
**On the cover:** A close-up of the fractured left-main landing-gear outer wheel on a Fokker 100. Left-main landing-gear components on the airplane failed during two landing incidents in Australia. (Source: Australian Transport Safety Bureau)

The technical report said that a comparison of the surface of the repaired area and the original surface of the wheel hub revealed a “markedly different” intensity in the shot peening of each area. The intensity of shot peening was lower on the repaired surface, the report said.

“This variation would be expected to lower the resistance of the wheel to fatigue cracking,” the air safety occurrence report said. “The lower level of compressive residual stress associated with the less intense shot-peening process applied to the repaired [area] would also increase the likelihood of fatigue failure under normal loading conditions.”

The ATSB air safety occurrence report on the July 4 landing incident said that the wheel failed because of fatigue cracking that began at the surface of the metal in the repaired area of the wheel hub.

“No single stress point concentrator had started the cracking,” the report said. “It had begun at numerous

closely spaced points around the circumference of the hub, known as ratchet marks. This was consistent with sideways flexure of the wheel web and with crack growth from the repaired surface of the hub. There was no indication the growth had started at any crack that had been present prior to the repair.”

Both air safety occurrence reports included a recommendation to the U.K. Civil Aviation Authority (U.K. CAA) to review the repair process and the overhaul process for the failed wheel and for the failed torque links that were identified during the ATSB investigation of the second landing incident to ensure that the processes conform to airworthiness requirements.

The technical report also included a recommendation for an audit of the company responsible for the repair and overhaul of the left-main landing gear

“to establish why the repaired surface of the wheel hub differed from the ‘as manufactured’ condition.”

The report said, “In particular, it should be established if the specification of the repair was adequate, or if repair instructions were followed. The reasons for any inadequacy or lack of compliance should be established.
