FLIGHT SAFETY FOUNDATION
Aviation Mechanics Bulletin

Fluid Line Mismatch Leads to Fuel Exhaustion During Oceanic Flight

Vol. 53 No. 5

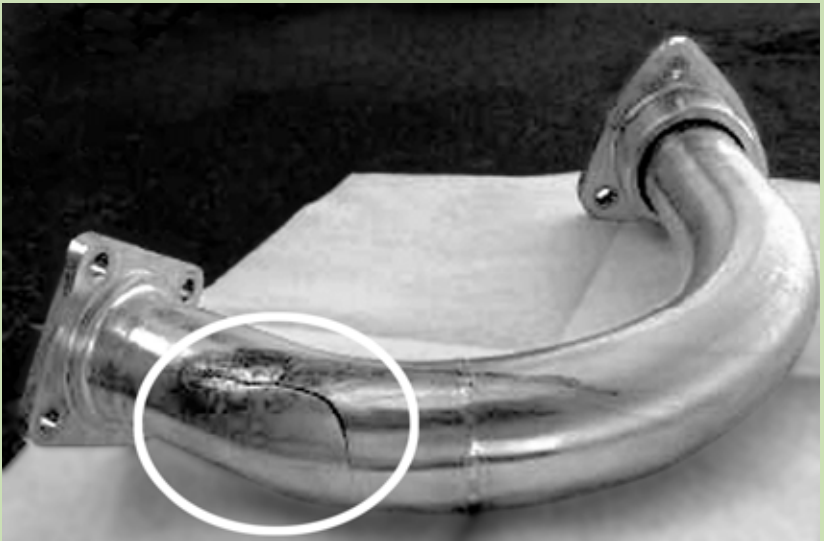
On the cover: Contact with a hydraulic line caused a 3.0-inch (7.6-centimeter) crack in a high-pressure fuel line aboard an Airbus A330. (Photo: Portuguese Aviation Accidents Prevention and Investigation Department)

An initial examination of the right engine found an L-shaped crack in the fuel line. The crack was approximately 3.0 inches (7.6 centimeters) long and 0.13 inch (0.33 centimeter) wide.

- “The mismatched installation of the pre-mod[ification] hydraulic [line] and the post-mod[ification] fuel [line] resulted in the [lines] coming into contact with each other, which resulted in the fracture of the fuel [line] and the fuel leak, the initiating events that led to fuel exhaustion;
