FLIGHT SAFETY FOUNDATION
Aviation Mechanics Bulletin

SEPTEMBER–OCTOBER 1997

In-flight Engine Fire Caused By Uncapped Fuel Drain, Prompts NTSB Safety Recommendations

Vol. 45 No. 5

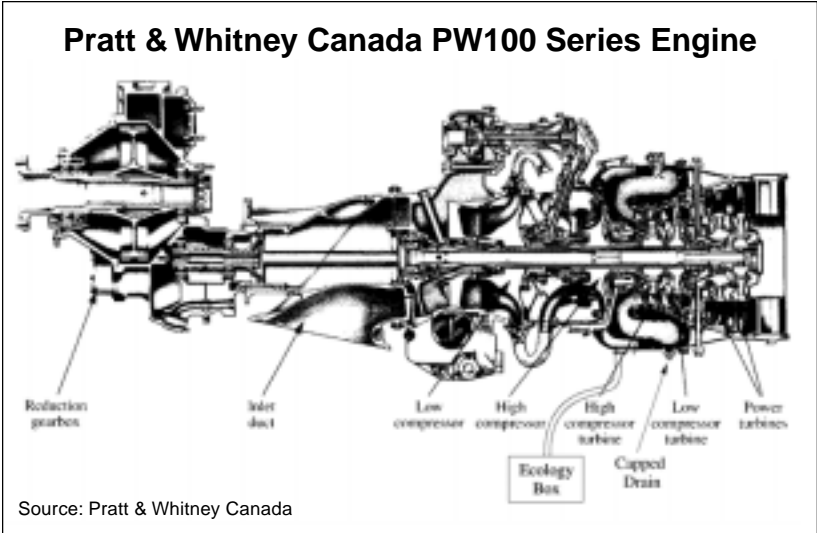
Figure 1

The gas-generator case on the PWC PW100 series engines has two drain plugs (Figure 1, page 3) — one at the

front of the case and one at the rear of the case — to drain from the fuel manifolds the unburned fuel that has drained back through the lowest fuel nozzles into the gas-generator case. The drains are intended to prevent pooling of fuel in the bottom of the generator case, which could cause internal engine fires or hot starts.

The SR said, “During the disassembly of the engine, it was noted that the forward drain plug had the drain line that would have been routed to the ecology tank. But the aft drain plug did not have the cap attached, and the threads of the plug were not damaged. Thus, the [NTSB] concluded that the cap had not been installed before the engine failure.

“Therefore, when the engine failed and shut down because of the oil-fed fire, the unburned, residual fuel in the fuel manifolds would have drained back

through the fuel nozzles into the gas-generator case and then out through the drain plugs at the bottom of the case. Because the airplane was climbing in a nose-high attitude, the fuel would have drained rearward through the [uncapped] aft drain plug and onto the deck under the engine ... [where it] could have been ignited by the heat from the hot exhaust pipe in the aft section of the engine nacelle.”

- “Issue an [AD] to require an immediate one-time inspection of all Pratt & Whitney Canada PW100 series turboprop engines to ensure that the gas-generator

case drain line and the plug are correctly installed. (Class I, Urgent Action) (A-97-38);

The FAA responded to NTSB Safety Recommendation A-97-38 by issuing AD 97-17-05, requiring a visual inspection of the two gas-generator case drain ports to ensure that they are connected to drain lines or capped in accordance with the procedures set forth in PWC Service Information Letter no. PW100-003, dated June 18, 1997.

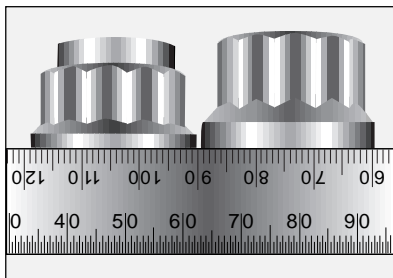
After an examination, the flight engineer discovered that the nut was missing on the rear engine-mount cone bolt. The engine was still supported

Wrong nut (left) and correct nut (right) for Boeing 707 engine mount

by the forward engine mount, but the aft end of the engine was resting on the nacelle, on the floor of which were found the two broken halves of the missing nut. A nearly complete part number was legible on the nut parts. It read, "NAS 1804-[?]2." The parts of the broken nut were sent to a laboratory for analysis.

said, "Several crack sites, apart from the primary fractures which split the nut, were typical of embrittlement effects. In this case, the cadmium plating had undergone transformation under the influence of excessive heat and interacted with the steel nut to reduce the original properties of the parent material.

"[The testing laboratory] was unable to determine the timing factor for failure other than to say that it could happen fairly quickly when [the nut] was subjected to temperatures above 230 degrees C [446 degrees F]. Cadmium-plated components are not designed for use above this temperature. The nature of the failure was clearly defined by metallurgical evidence."

As a result of this incident, the operator has replaced all nonconforming engine mount nuts on fitted JT3D engines. All stocks of part NAS 1804-12, which could contain additional nonconforming nuts, have been quarantined.

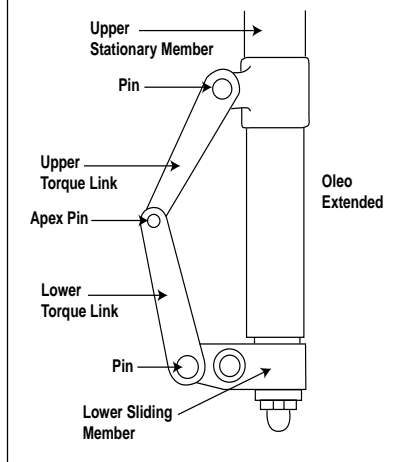
Figure 1

Fokker F-28-1000 Landing gear Oleo (Hydraulic) Section

Investigation revealed that the upper torque link (Figure 1) on the landing gear had failed within the first 61 meters (200 feet) of landing roll and that the left main wheels separated from the airplane about 458 meters (1,500 feet) beyond touchdown.

It was later reported that a former operator of the aircraft had used an overhaul procedure not authorized by the manufacturer for about two years, in which the bushings were actually reamed to create an intentionally loose fit for the torque link pins.
