FLIGHT SAFETY FOUNDATION  
**Aviation Mechanics Bulletin**

SEPTEMBER–OCTOBER 1998

**F-117A Accident during  
Air Show Flyover Caused by  
Omission of Fasteners in  
Wing-support Structure**

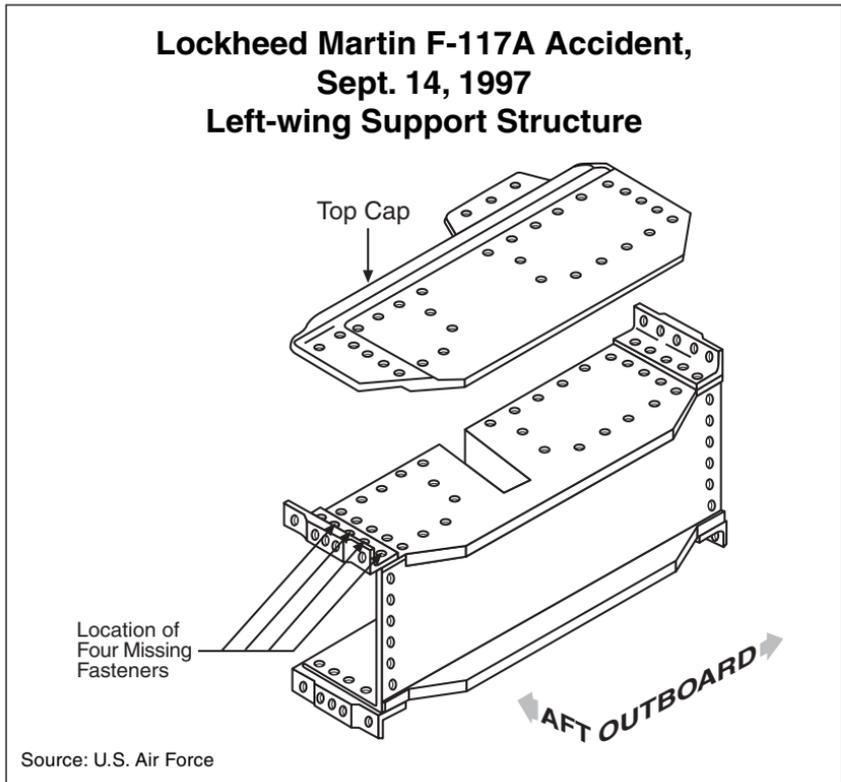
**Figure 1**

The Air Force said, in its investigation report, that the accident was caused by the omission of four fasteners, which resulted in failure of the brackets that attach a wing-support structure to ribs in the left wing.

The aluminum wing-support structure, informally called a Brooklyn Bridge, measures 18 inches by 5 inches by 5 inches (45.7 centimeters by 12.7 centimeters by 12.7 centimeters). The structure spans the outboard-elevon integrated-servo-actuator (ISA) bay. The structure braces the wing and serves as a platform for attachment of the outboard-elevon ISA. (An elevon

Figure 1 shows the wing-support structure. Figure 2, page 3 shows the location of the wing-support structure.

The Air Force said that four Hi-Lok fasteners (bolts) were omitted from one of the support structure's attachment brackets. Omission of the fasteners resulted in reduced structural

The Air Force said that when the structural-repair personnel reinstalled the wing-support structure in the left wing, they apparently failed to install four Hi-Lok fasteners on the upper inboard L bracket that attaches the structure to the no. 14 rib.

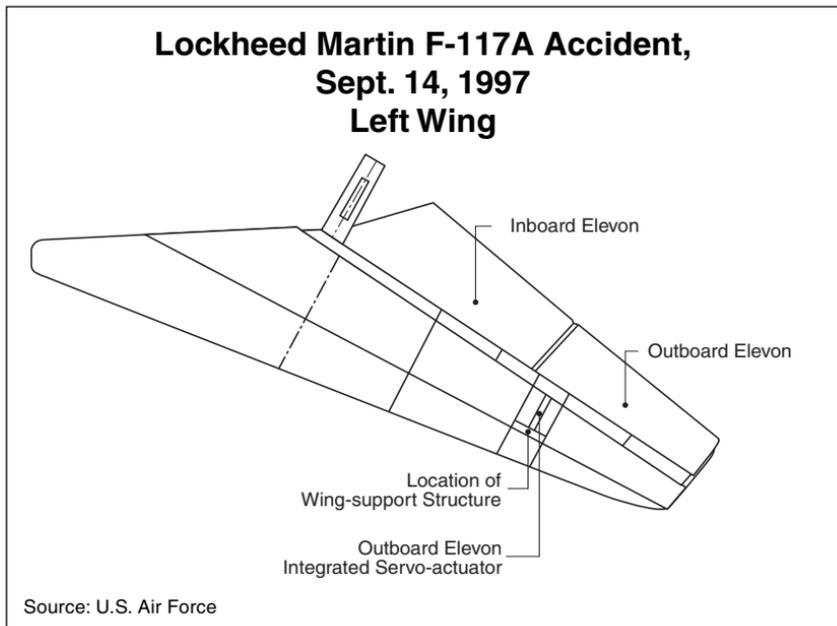
**Figure 2**

Two T brackets, four "L" (L-shaped) brackets and several fasteners affix each wing-support structure to the no. 14 wing rib and the no. 15 wing rib in the ISA bay. Fasteners also affix

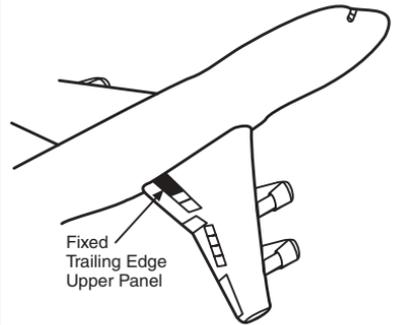
**Figure 1**

Several hours later, at the destination airport, an inspection found that a large area of the right-wing fixed trailing-edge upper panel (Figure 1), also known as the “flying panel,” was missing. Inboard areas of the upper surfaces of the fore- and mid-trailing-edge wing flaps were badly damaged.

Investigation revealed that the flying panel showed signs of hammering against the fore-flap upper surface, producing two deep grooves. Underneath the flying panel, the inboard diagonal tie-rod at the no. 1 rib was bent and bowed laterally outboard in compression and had fractured across the lower drain/vent

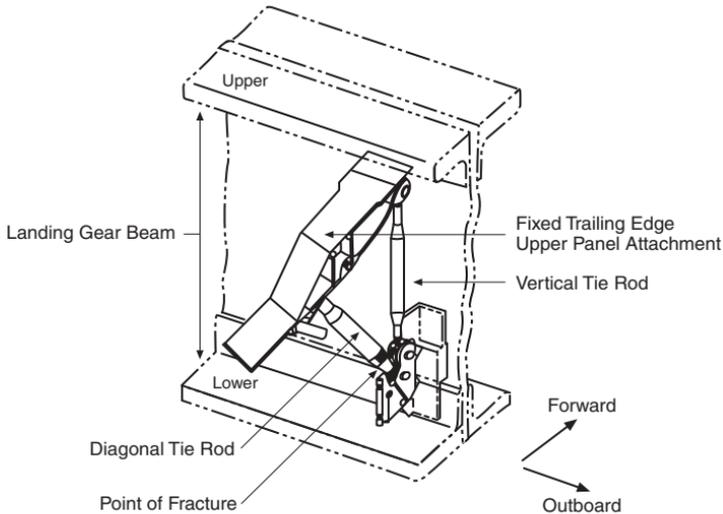
**Figure 2**

holes. Metallurgical examination showed that the tie rod had failed because of low-cycle and high-stress bending fatigue, indicating that a cyclic force had been involved in the failure.

An investigation determined that about 160 cycles to 240 cycles had occurred from the start of the crack until failure. It was further determined that the tie rod had been adjusted to extend its length, and that the adjustment appeared to have been accomplished using a “Stilson/pipe wrench”

tool on the larger diameter of the tie rod, resulting from the lengthening adjustment (Figure 2).

The investigation concluded that the inboard diagonal tie-rod failure occurred from compression forces acting repeatedly to bend the rod until fracture occurred after about 160 cycles to 240 cycles. This allowed the flying panel to lose its rigged form and strike the upper surface of the fore flap. These abnormally high forces resulted from incorrect adjustment to the tie rod, possibly while the aircraft was on jacks. If so, when the aircraft was later placed on the ground, the landing-gear beam may have induced higher loads than the tie rod was designed to absorb. The tie-rod fatigue-fracture striation suggested that the incorrect adjustment had occurred during the last major maintenance.

3. A strap wrench, not a pipe wrench, should have been used during the adjustment. It is very disturbing that a maintenance worker would use a pipe wrench when it should have been obvious that a pipe wrench damages the surfaces that it engages. (W,S,H,T)
