FLIGHT SAFETY FOUNDATION
Aviation Mechanics Bulletin

SEPTEMBER–OCTOBER 2000

Improperly Installed Trim Actuators Blamed for Takeoff Accident

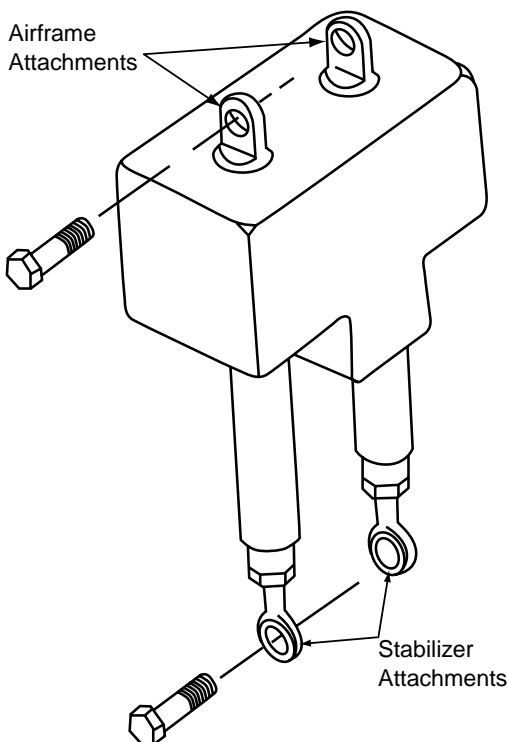
Figure 1

Thunder Airlines is an approved maintenance organization (AMO), whose maintenance personnel worked on the elevator and rudder controls of the aircraft during the weekend before the accident flight. To remove the rudder, the primary horizontal pitch-trim actuator and secondary horizontal pitch-trim actuator were disconnected from the airframe. (Normally, a bracket, in the shape of a double “U” with the primary-trim motor and alternate-trim motor in the middle, is attached to the airframe and the leading edge of the stabilizer with four bolts [Figure 1, page 3]).

“After the occurrence, investigators found that the top of the actuators was not attached to the airframe,” the report said. “The two bolts did not pass through the actuator holes when reinstalled — only through the attachment holes in the airframe. When the bolts were tightened during installation, they squeezed the ends of the actuators to the attachment points on the airframe. Without the actuators attached to the airframe, the stabilizer was free to rotate to a full up or [full] down position on its own.”

Pitch Trim Actuators
