FLIGHT SAFETY FOUNDATION  
**Aviation Mechanics Bulletin**

SEPTEMBER–OCTOBER 1999

# Simultaneous Engine Maintenance Increases Operating Risks

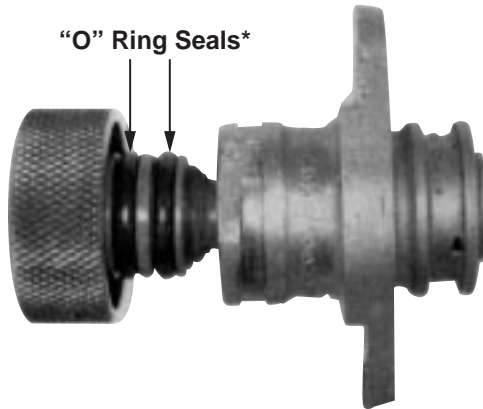
## Magnetic Chip Detector Plug and Housing

\*Installation of plugs without seals has caused engine failures.

On the cover: O-ring seals omitted from magnetic chip detector plugs during simultaneous maintenance of all engines on a Lockheed L-1011 caused the precautionary shutdown of one engine and the flameout of the other two engines on May 5, 1983. The crew restarted one engine and landed the airplane.
