Inadequate Weather Communication Cited In B-737 Microburst-downdraft Incident

The Australian Transport Safety Bureau said that, among other factors, air traffic controllers did not advise the flight crew — nor did the crew request — details about the lateral limits, direction of travel and groundspeed of a thunderstorm approaching the destination airport.

—
FSF Editorial Staff

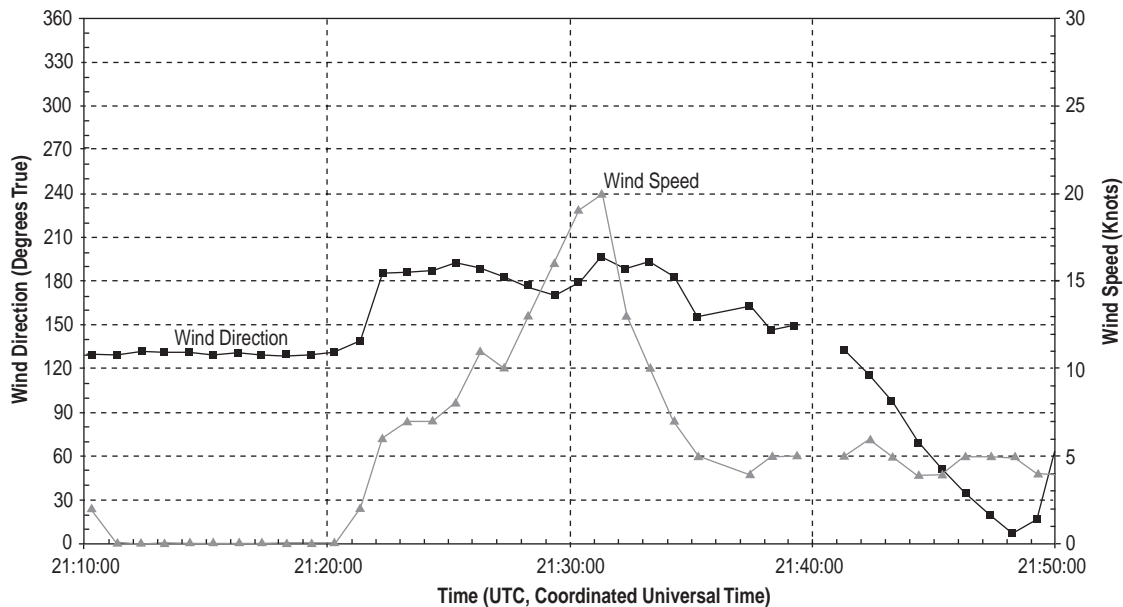
Figure 1

- At 0725, BOM issued another TTF SPECI for Brisbane Airport, which said that thunderstorms with hail had been observed. An associated TTF METAR forecast thunderstorms and rain showers until 0900; and,
- At 0730, BOM issued another TTF SPECI for Brisbane Airport, saying that thunderstorms with hail had been observed and the wind was from 180 degrees magnetic at 10 knots gusting to 26 knots (Figure 1).

Australian Bureau of Meteorology Anemometer Data Brisbane Airport, Queensland, Jan. 18, 2001

Note: Data from the digital flight data recorder on a Boeing 737 showed an encounter with a microburst downdraft at 0729 local time (21:29 coordinated universal time) and correlated with anemometer data recorded at Brisbane Airport, Queensland, Australia, by the Australian Bureau of Meteorology. High-resolution data from other anemometers at the airport supported air traffic control operations but were not recorded.
