FLIGHT SAFETY FOUNDATION
Airport Operations

Vol. 27 No. 4

July–August 2001

Traffic Conflict Near Australian Airport Prompts Call for Airborne Collision Avoidance Systems

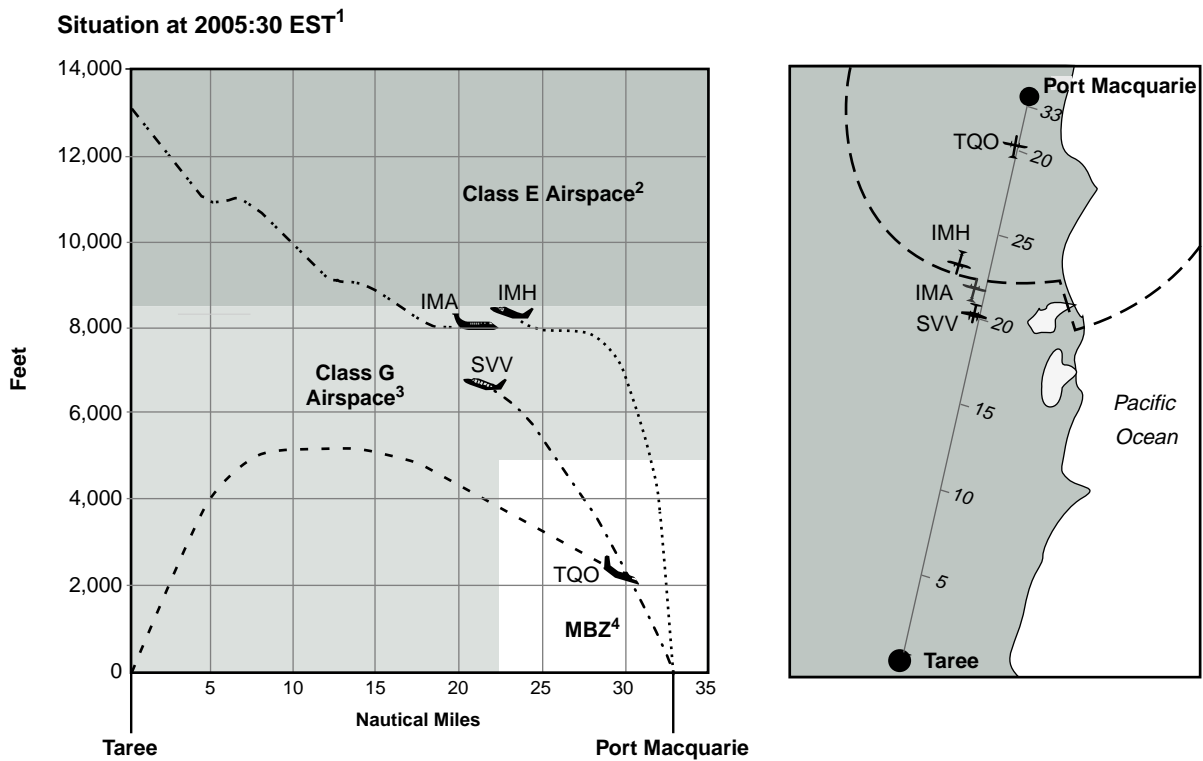
The traffic conflict involved the two Beech 1900s at 2005:30, while they were being operated in instrument meteorological conditions. Figure 1 (page 3) shows the positions of the four aircraft at this time. The crew of IMA was maintaining 8,000 feet, and the crew of IMH was leaving 8,200 feet in a climb, which they had initiated from 8,000 feet about five seconds earlier, after the ATC sector controller — responsible for

“Vertical separation was established between TQO and all aircraft, and between SVV and IMA,” said the report. Nevertheless, a second potential traffic conflict — as IMH was overtaking SVV in a climb with two nautical miles [3,704 meters] horizontal separation and 800 feet [244 meters] vertical separation — was averted by chance, the report said.

Traffic Conflict Near Port Macquarie, New South Wales, Australia April 28, 1999
