Propeller Injures Maintenance Technician During Apron Check of Deicing Boots

Airport Operations

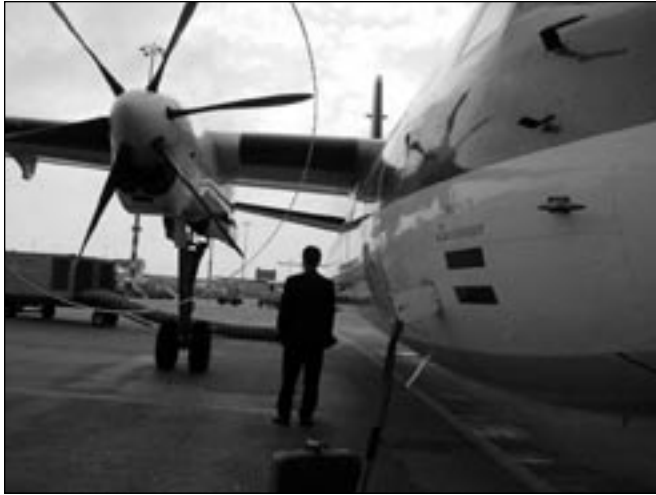
A superimposed arc shows the edge of rotating propeller blades on the Fokker 50. (Source: Dutch Transport Safety Board)

The headset jack was located 4.04 meters (13.25 feet) from the six-blade propeller, which had a diameter of 3.66 meters (12.01 feet) and a minimum clearance to the fuselage of 0.59 meters (1.94 feet). The propeller’s approximate ground clearance was 1.13 meters (3.71 feet).

If the rotating propeller of the accident aircraft had been lighted from the front, the yellow tips of the black propeller blades would have created a readily visible yellow arc.

“Shadows caused by the aircraft fuselage, dorsal fin, vertical tail, right wing and right stabilizer were considered as relevant,” the report said. “Looking from this position [the interphone panel] towards the deicing boot on the fin, he would have looked from the shaded area against a brightly lit background with high contrasts. If he had moved sideways into the light to look at the tail, he would have looked straight into the sun.”
