FLIGHT SAFETY FOUNDATION Airport Operations

March-June 2001

In Aircraft Fueling, Fire Prevention Requires Strict Compliance With Routine Procedures

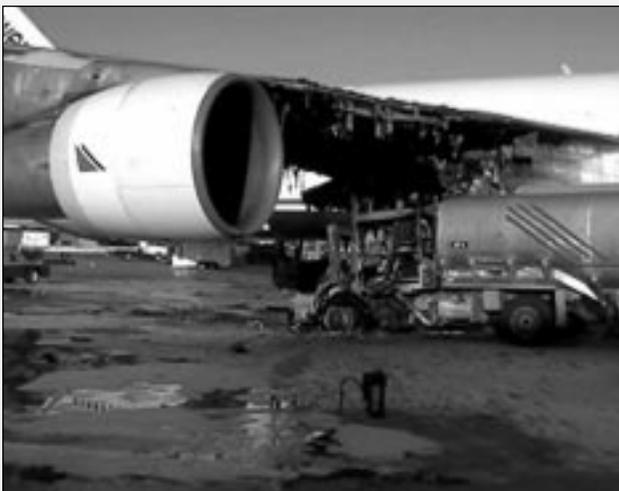
A Boeing 747-259B received substantial fire damage to the right wing during refueling Dec. 1, 1998, at Miami International Airport, Florida, U.S. (Photograph by Timothy Swick)

"A hole was found in the fuel line from the pump to the hose, directly above the area of the most intense fire damage," the report said. "The truck was burned in the engine [area], passenger [area] and pump area. Severe fire damage to the area between the cab and tank was found. The fuel piping found in this same area had some severe damage. The fuel meter and other metal parts had been completely consumed by fire [or] melted. Fire damage to the engine was to the rear and on the top."

The airplane fire damage was concentrated on the right wing.

"The leading edge of the right wing, between the no. 3 [engine] and [no.] 4 engine, was [burned] completely through," the report said. "The leading-edge flaps were melted as were numerous panels. The trailing-edge flaps between engines [no.] 3 and [no.] 4, plus the underside skin, [were burned]. The no. 3 engine had a large section of the strut and pylon burned away. The cowling on the no. 4 engine was scored and burned."
