B-747 Collision With Airbridge Follows Apparent Brake Failure

Passenger behavior — described by the chief cabin attendant as a ‘riot’ prompted by observations of wing-tank fuel venting — complicated the flight crew’s return to the gate in response to a failed engine instrument. Failure to manually connect an auxiliary hydraulic pump rendered the aircraft brake system inoperative for taxi.

Airport Operations

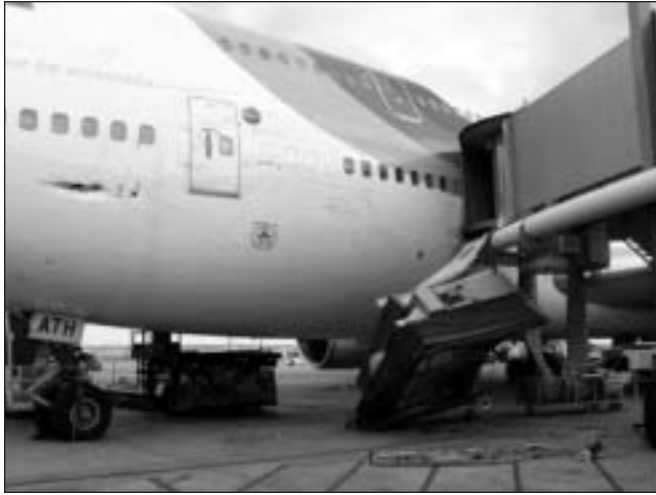
The Spanish Air Accidents and Incidents Investigation Commission (CIAIAC), in its final report, said that the probable cause of the incident was “that the electrically driven hydraulic pump (ACP) was not manually connected again after its switch automatically released as a result of the initiation of the starting process of engine no. 4 and once that starting process had not been completed.” Neither visibility nor weather was a factor in the collision, the report said. The

The Boeing 747-300 decelerated in about 12 meters (39 feet) after striking the T1 airbridge at Madrid-Barajas (Spain) Airport, and the rotating roof of the airbridge was embedded in the fuselage. (Spanish Air Accidents and Incidents Investigation Commission photo)

In the collision, the left side of the fuselage struck the airbridge operator’s cabin.

“The fuselage then impacted with the [airbridge] structure and came finally to a stop, with the circular metal part that forms the floor of the [airbridge] at the end of the [airbridge] tunnel

[penetrating] the fuselage just before the frame of door 2R,” the report said. ARFF personnel at the T2 gate saw the collision, went to the collision location and stopped ground traffic in the vicinity. Three more ARFF vehicles, ambulances and police vehicles arrived at the collision location. ARFF personnel did not observe any indications of fire.

The report recommended additional training of pilots on emergency procedures for brake failures in the B-747 and on announcements to passengers explaining excess-fuel leakage.

Among other CIAIAC recommendations were: review by the airline of line-repair procedures and maintenance procedures to ensure that work on engine-instrument indicators is checked for adequate completion; establishment by Spanish Airports and Air Navigation (AENA) of clear boundaries between the maneuvering areas and apron areas of Madrid-Barajas Airport; assignment of traffic control responsibilities for the apron to an identified department; and introduction in the aeronautical information publication (AIP) of Madrid-Barajas Airport of requirements and procedures for mandatory use of marshallers or visual docking guidance systems before and during aircraft taxi toward an airbridge.♦
