Miscommunication Leads to Three Fatalities During Ground Deicing of Aircraft

FSF Editorial Staff

AIRPORT OPERATIONS

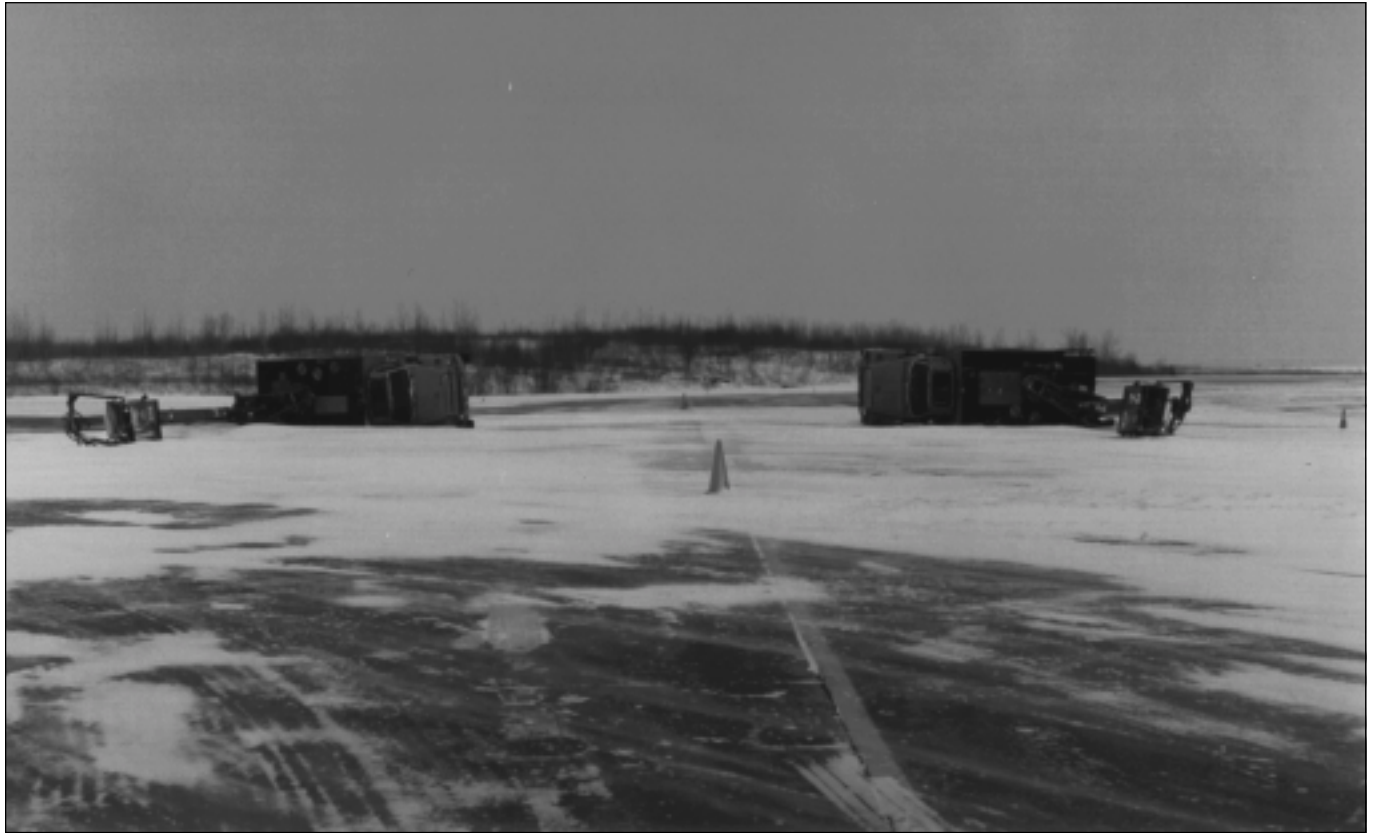
Hearing a fraction of a radio communication in which one deicing crew member asked another to notify the apron controller when deicing was completed, the flight crew of the Boeing 747 believed that deicing had been completed. The miscommunication became part of the chain of errors that led to the B-747 being taxied with two deicing trucks still in place, resulting in three operator fatalities. (Photo: Transportation Safety Board of Canada)
