## Airline's Five Unrestrained-cargo Incidents in Four Months Reveal Loading-procedure Deficiencies

*The official investigation found factors that breached Air New Zealand's defenses against errors in cargo loading. One incident investigated in detail involved reduced time available for loading, a modification to the automatic loading equipment, a loading team reduced in number and a busy loading foreman who delegated his oversight duties.*

FSF Editorial Staff

Editorial note: This article is based on New Zealand Transport Accident Investigation Commission Aviation Occurrence Report 97-018, *Various Boeing 767 and 747 Aircraft, Unrestrained Cargo, 17 October 1997 to 12 January 1998*.

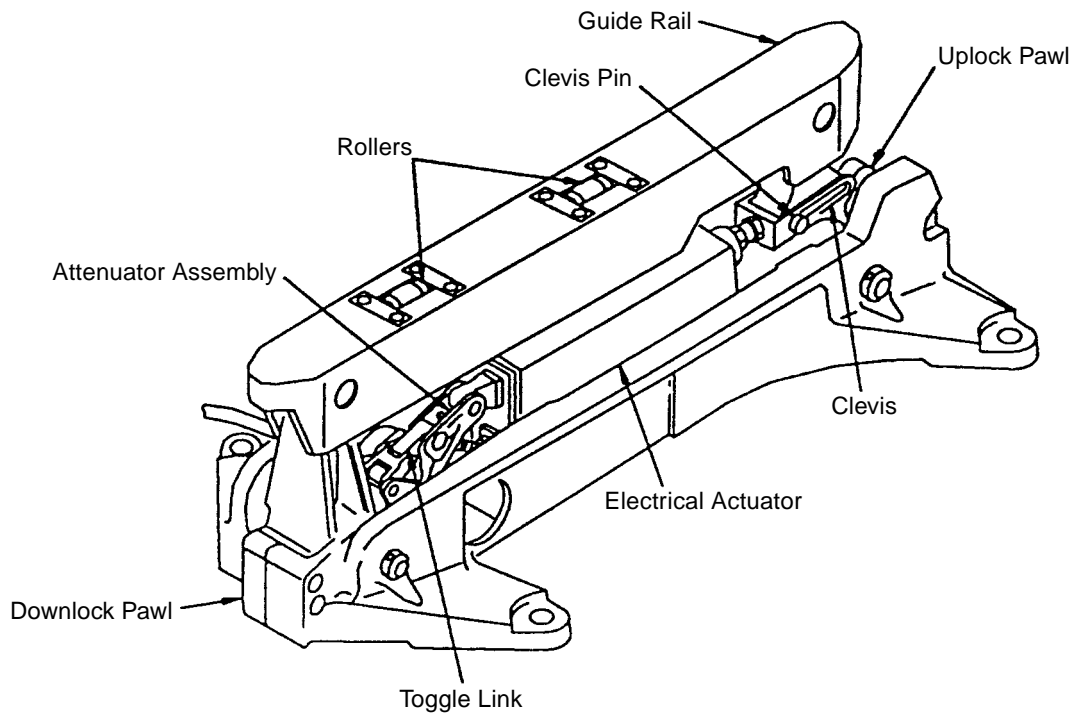
**Figure 1**

The report said, “The containerized compartments are equipped with restraints for guiding ULDs into and within each compartment and for securing the ULDs in flight. These restraints include lateral guides [Figure 1, page 3] and partial load stops.

“The lateral guides were devices to keep the ULDs aligned as they moved into the hold and to re-erect automatically after the load had passed over them. ... The guides in each hold were in two rows of three, one forward and one in the center of the forward-hold doorway compartments and one row on either side of the rear-hold doorway compartment.

## Lateral Guide, Cargo Hold, Boeing 767

Note: Guide rail is shown in extended (up) position.

Routine maintenance revealed that on some Air New Zealand B-767s, all of the manually operated lateral guides were unserviceable because of distortions in the latches that were intended to retain them in the raised position.

“Examination of the damage to the latches indicated [that] it was unlikely to have occurred in normal usage,” said the report. “The bending of the component to disable the lateral guides was effected in a position which was not vulnerable to damage by cargo passing over the guides.”

- “There was some evidence that the removal of the actuators from the lateral guides led to interference with the manual latches to prevent the guides being used. Some aircraft were found during routine maintenance

to have all of the lateral guides deactivated in a similar manner. The acceptance of aircraft for loading with all of their lateral guides inoperative removed the defense against insecure loads provided by one set of locks ... [and] indicated an uncritical approach to the serviceability of in-hold equipment by loading [crews] and engineers alike;

- “Consider recommissioning the actuators in the lateral load guides on the B-767 in-hold loading equipment;
- “Amend all company manuals which refer to the operation of the actuators in the lateral load guides on the B-767 in-hold loading equipment to ensure [that] they describe the correct method of operation of the guides, i.e., that they are operated manually instead of the automatic operation detailed at present;

- “Consider introducing more frequent inspections of the lateral load guides on the B-767 in-hold loading equipment, or other appropriate measures, to ensure that any damage caused to these devices in the course of loading operations is detected and rectified promptly.”

- “Air New Zealand are reinstalling the automatic B-767 lateral-guide actuators, with a fleet completion date of March 1999; [and,]
- “The Air New Zealand B-767 maintenance manual has been changed to reflect the actual lateral-load [guide’s] mode of operation, and will be amended to reflect the changes as they are effected.”♦
