Crew Lands B-777 on Runway Section Closed for Construction

—
FSF Editorial Staff

Asiana Airlines Boeing 777; Auckland, New Zealand; Nov. 16, 2004

Airport Operations

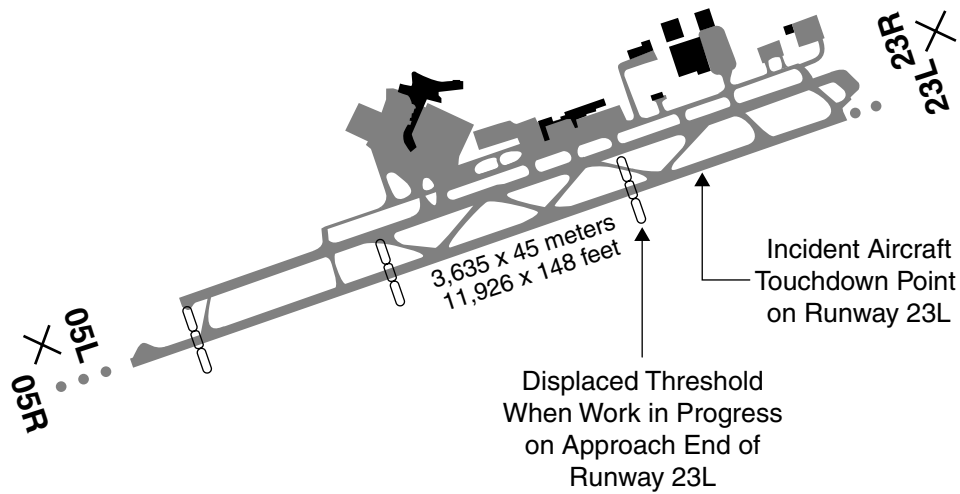
Figure 1

The B-777 touched down about 720 meters (2,362 feet) from the threshold of Runway 23L (Figure 1, page 4). The touchdown point was about 380 meters (1,247 feet) from the displaced threshold.

Note: Runway 05L/23R was closed and was being used as a taxiway.
