Sabreliner Strikes Mountain Ridge During Night Visual Approach

The flight crew did not brief a nonprecision approach procedure with several step-down segments and did not adhere to the published procedures while conducting the approach. The crew terminated the instrument approach and conducted a night visual approach over mountainous terrain in visual meteorological conditions.

Accident Prevention

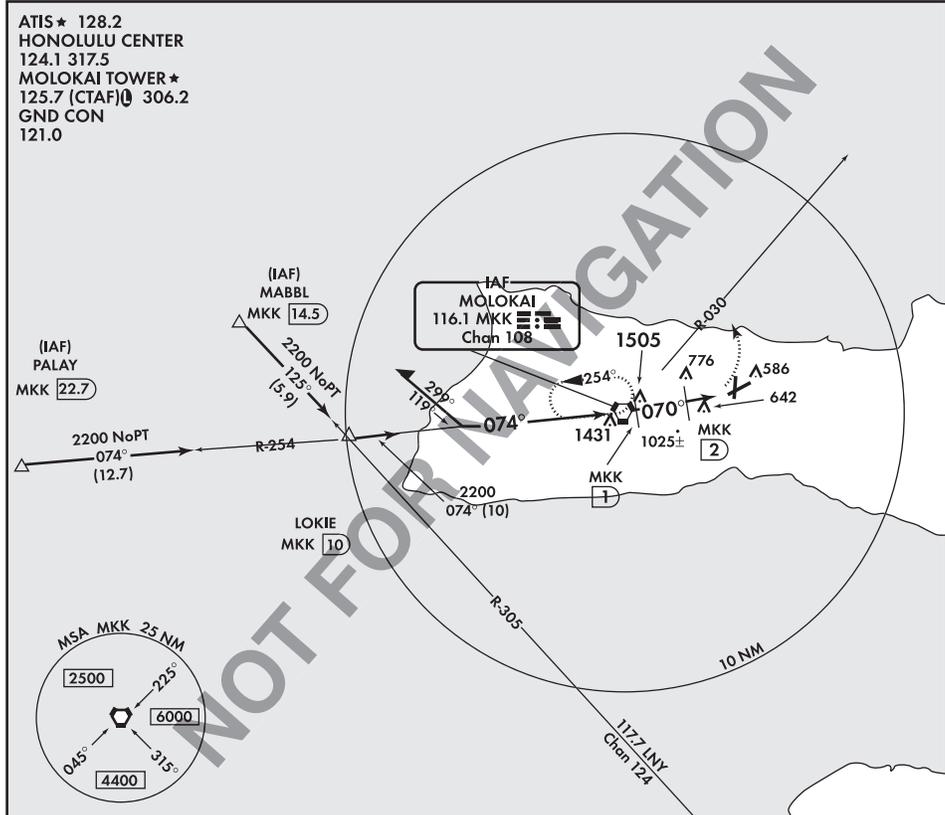
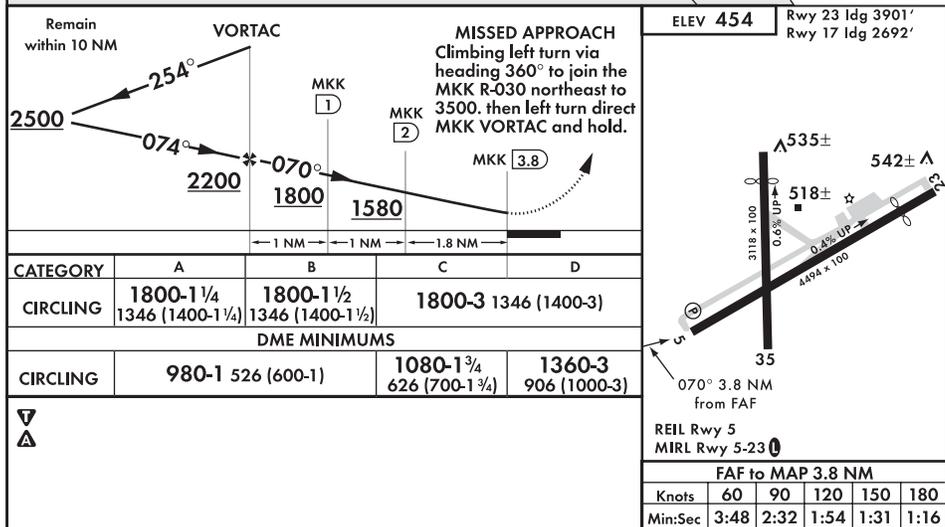
Figure 1

[The copilot referred to a requirement of the VOR/GPS (global positioning system) approach procedure that, after passing over the VOR from the northeast, an aircraft should be flown on an outbound course of 254 degrees for one minute before beginning the procedure turn, which comprises a right turn to a heading of 299 degrees, followed after a specific time by a left turn to a heading of 119 degrees; the minimum altitude for this segment is 2,500 feet (Figure 1, page 4). After intercepting the 074-degree inbound course to the VOR, the aircraft can be flown to 2,200 feet. After passing over the VOR inbound, a descent to 1,800 feet should be conducted after establishing the aircraft on the inbound course, 070 degrees. After passing the first step-down fix, which is 1.0 nautical mile (1.8 kilometers) from the VOR, a descent to 1,580 feet should be conducted. After passing the second step-down fix, which is 2.0 nautical miles (3.7 kilometers) from the VOR, a descent should be conducted to 1,080 feet, the published minimum descent altitude (MDA) for the Sabreliner, which was equipped with distance-measuring equipment (DME) and is a Category C aircraft. The missed approach point is 3.8 nautical miles from the VOR. The VOR/GPS approach is designated "Alpha" because landing requires a circling maneuver either to Runway 5-23, which is 4,494 feet (1,371 meters) long, or to Runway 17-35, which is 3,118 feet (951 meters) long.]

VOR-A Approach Procedure, Molokai (Hawaii, U.S.) Airport, May 10, 2000

The approach chart shows that the airport elevation is 454 feet.

"These cognitive task deficiencies included selection of the wrong frequency for pilot-controlled lighting, concluding that the airport was obscured by clouds despite weather information to the contrary, stating inaccurate information regarding instrument-approach headings and descent altitudes, and descending below appropriate altitudes during the approach," the report said. "This resulted in the crew's lack of awareness regarding terrain in the approach path."
