Charter Captain Chooses Not to Use ILS Glideslope, Misjudges Landing in Fog, Runs Off Runway End into Blast Fence

Investigators found that nonstandard parts had been used to attach some seat belts in the accident airplane, official U.S. report says.

ACCIDENT PREVENTION

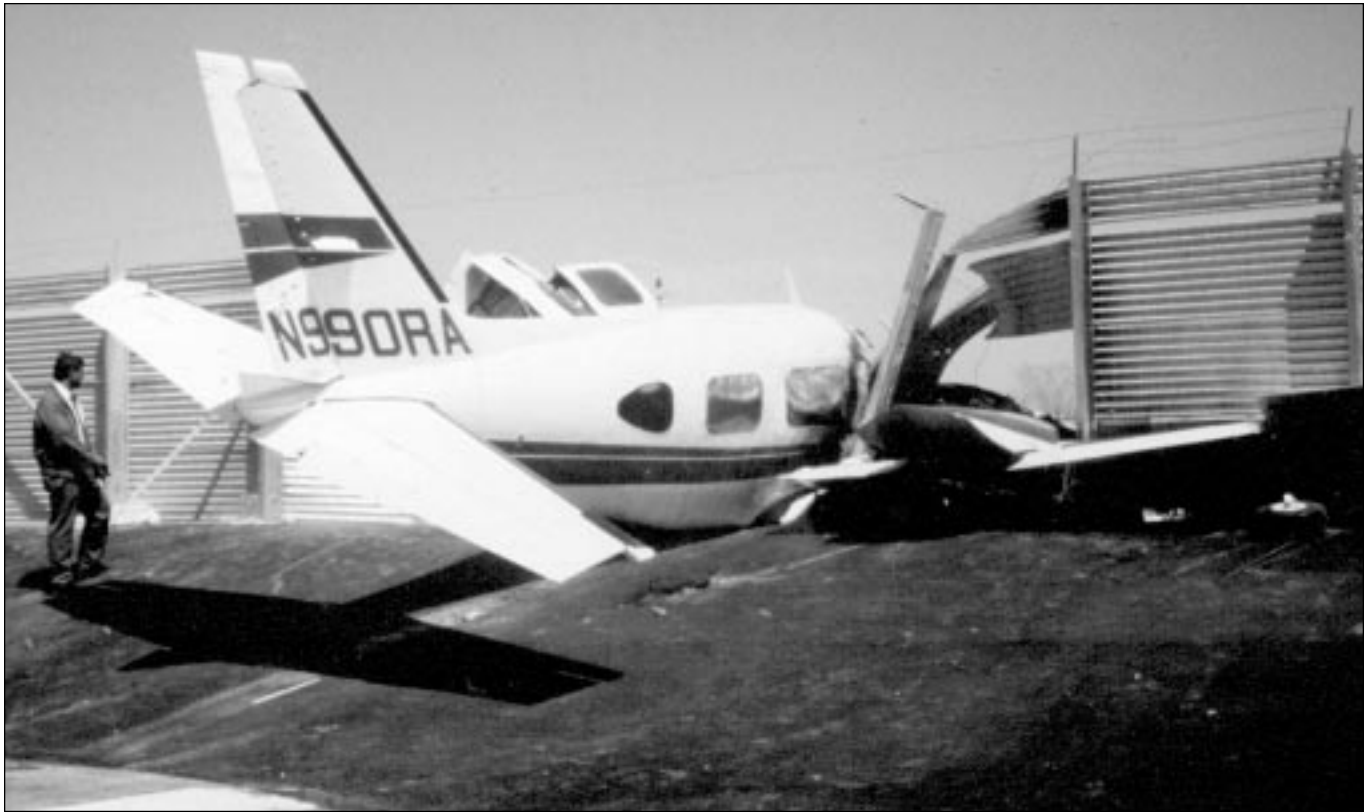
The crash of a twin-engine piston-powered Piper PA-31-350 Navajo Chieftain, owned and operated by Action Airlines Inc., in Stratford, Connecticut, U.S., has resulted in recommendations by the U.S. National Transportation Safety Board (NTSB) to the U.S. Federal Aviation Administration (FAA) regarding the inspection of U.S. Federal Aviation Regulations (FARs) Part 139—certificated airports for adequate runway safety areas and nonfrangible [resistant to breaking apart] objects. Eight of the nine aircraft occupants were killed, and the remaining occupant, a passenger, was seriously injured in the April 27, 1994, accident when the aircraft crashed into a jet-blast fence after landing (photo, page 2).

The accident aircraft, a Piper PA-31, impacted a jet-blast fence after landing long. The pilot had elected to make a visual approach despite reduced visibility. The end of the runway is visible in the lower-left corner. (Source: Robert Benzon, U.S. National Transportation Safety Board.)

The NTSB said that the probable causes of the accident were “the failure of the captain to use the available ILS glideslope, his failure to execute a go-around when the conditions were not suitable for landing and his failure to land the airplane on the runway at a point sufficient to allow for a safe stopping distance; the fatalities were caused by the presence of the nonfrangible blast fence and the absence of a safety area at the end of the runway.”

- “Inspect all [FARs] Part 139 certificated airports for adequate runway safety areas and nonfrangible objects, such as blast fences, and require that standard runway safety areas be upgraded to [FAA] Advisory Circular 150/5300-13 minimum standards wherever it is feasible; [and,]
- “Within 90 days, and in coordination with the City of Bridgeport and the Town of Stratford, implement a plan to resolve environmental considerations, and proceed with the installation of an approach lighting system on Runway 6 as soon as possible.”

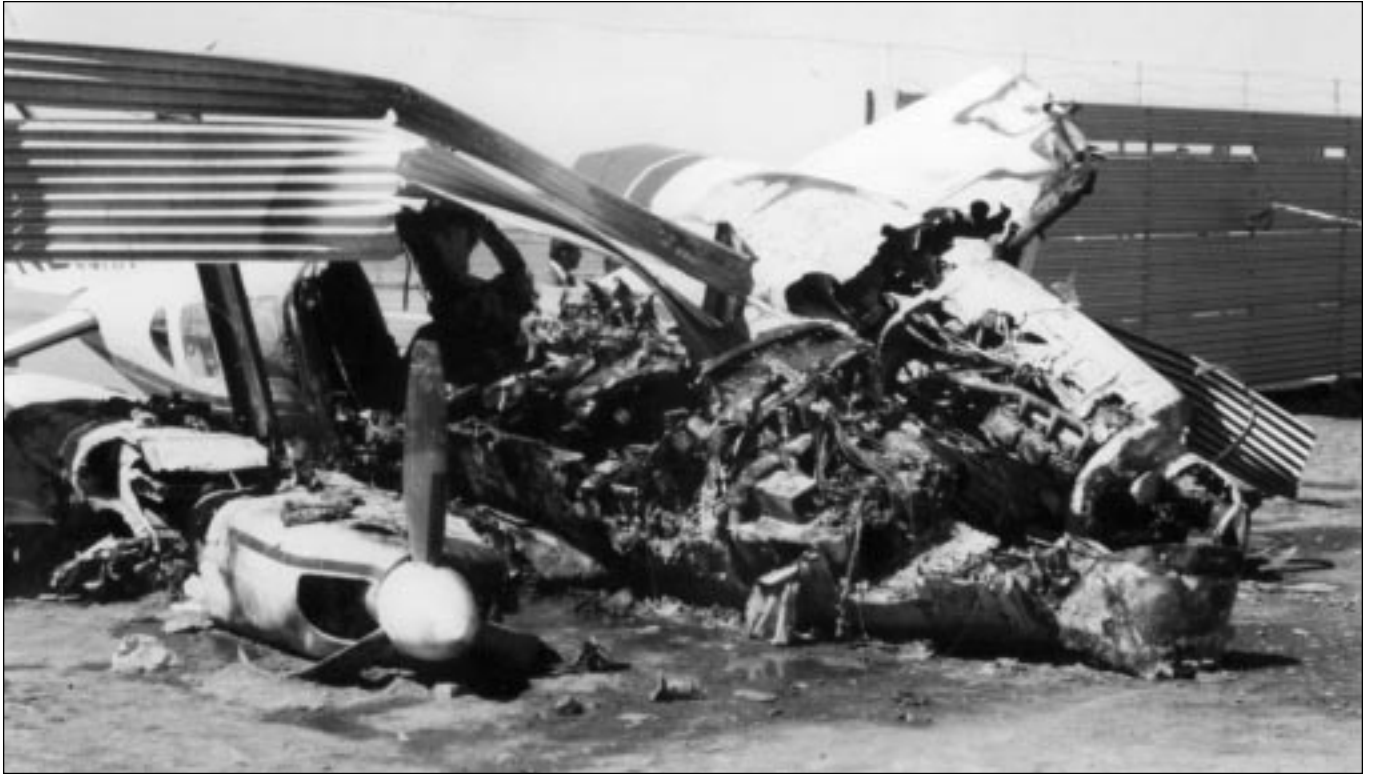
“After touchdown, the braking was initially hard. The survivor stated that his head was down at the time and that when he looked up, he saw the blast fence at the end of the runway. He thought that he and the captain saw it at the same time. The last thing the captain said at that time was ‘Oh no’ or ‘Uh oh.’ He stated that the impact with the ‘wall’ felt like ‘we hit it at 100 miles an hour [161 kilometers per hour]’ (photo, page 5).

The U.S. National Transportation Safety Board concluded that crash-impact forces were survivable, but an immediate postcrash fire was fatal for eight of the nine occupants. (Source: Robert Benzon, U.S. National Transportation Safety Board.)

- “Both engines were operating at low or idle power at impact with the blast fence;
- “Crash impact forces resulting from N990RA’s impact with the blast fence were survivable; however, the immediate postcrash fire created nonsurvivable conditions for occupants who remained in the front of the cabin;
