Jammed Elevator Prompts Twin-turboprop Rejected Takeoff, Runway Over-run

The investigating authority said that deficiencies in the Hawker Siddeley 748 flight control gust-lock system might have caused the elevator gust lock to re-engage when the flight crew checked the flight controls at the beginning of the takeoff.

Editorial note: This article, except where specifically noted, was based entirely on U.K. Air Accidents Investigation Branch Aircraft Accident Report 1/99: *Report on the Accident to HS 748 Series 2A, G-ATMI, at Liverpool Airport on 16 August 1996*. The 80-page report contains diagrams, photographs and appendices.

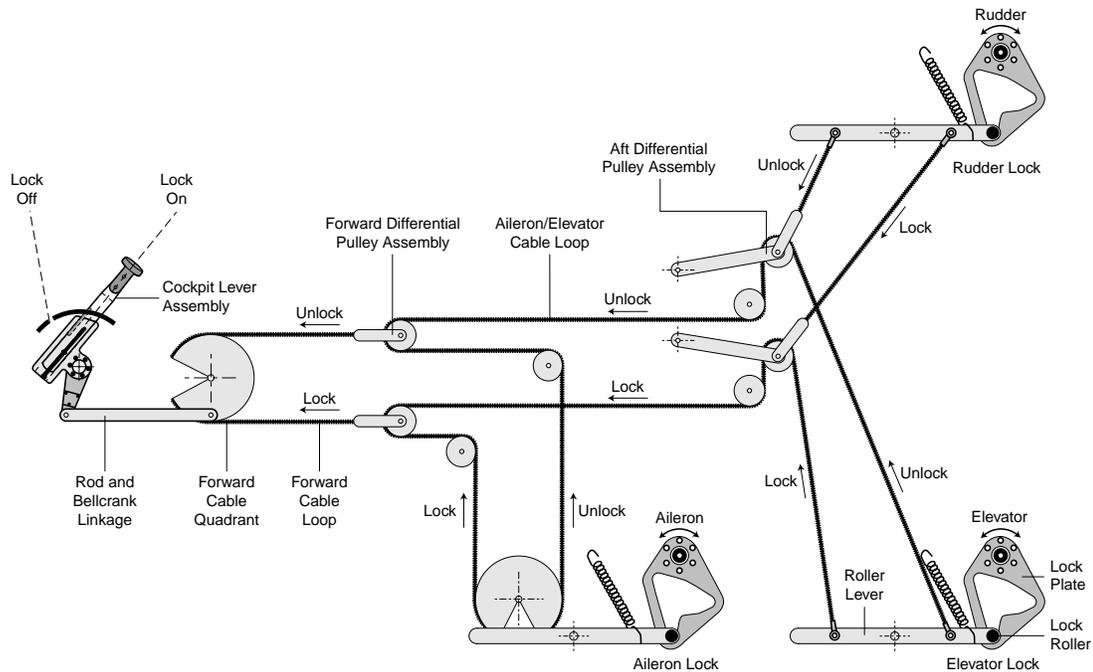
“The re-engagement of the gust lock was made possible by the condition of the gust-lock-lever gate plate and gate-stop strip.” The report said that nonstandard repairs had been conducted on the components, and component dimensions were not within the manufacturer’s tolerances. The result was that the gust-lock lever appeared to be in the “off” position but was not in the “off” position.²

Figure 1 (page 3) shows the gust-lock system in the locked configuration. The cockpit gust-lock lever is in the “on” position; the lock rollers are in the locking slots in the lock plates attached to the primary flight controls (rudder, ailerons and elevator).

The system is designed so that when the gust-lock lever is moved to the “off” position, the lock rollers move from the locking slots and into the wider portion of the open areas within the lock plates, allowing unrestricted movement of the flight controls.

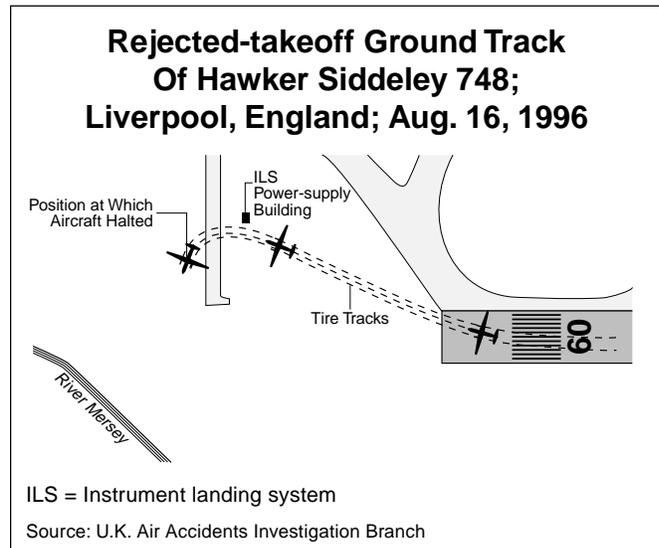
Figure 2

The airplane exited the runway at approximately 60 knots (Figure 2). When the ILS power-supply building became visible in the airplane’s lights, the commander maneuvered the airplane to the left to avoid striking the building.

“The right wing passed over the building but struck the support structure of a surveillance camera and relay unit mounted on its roof,” said the report. “The commander tightened the turn and deliberately entered a ‘ground loop’ to the left in order to stop the aircraft.”

The airplane was stopped approximately 250 m (820 ft) from the end of Runway 27 and 61 m (200 ft) right of the extended runway centerline.

“Aircraft damage consisted of substantial local deformation of the right wing structure, the outboard end of the right flap and the inboard end of the right aileron,” said the report. “The tire on the no. 3 wheel had rolled off the wheel rim and deflated.”

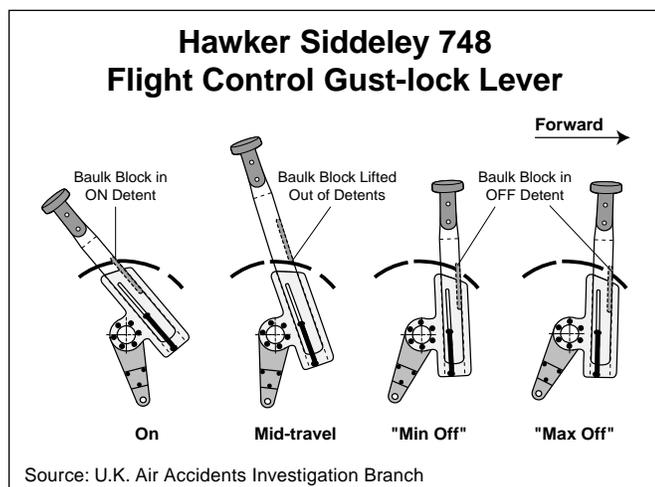
Investigators also found that movement of the gust-lock lever within the “off” detent caused proportionally much greater movement of the gust-lock system. Figure 3 shows that to unlock the gust locks, the lever is lifted approximately 3.5 in. (8.9 cm) to bring the baulk block out of the “on” detent and then is moved forward until the baulk block drops into the “off” detent. The lever is spring-loaded to facilitate engagement of the detents.

The lever could be moved 0.12 in. (0.3 cm) within the “off” detent — between positions (labeled only for purposes of this accident report) “min off” (minimum off) and “max off” (maximum off). Lever travel from “min off” to “max off” represented 5 percent of total lever travel from “on” to “max off,” but caused the aft differential pulleys to move a distance proportional to 24 percent of their total travel, the forward differential pulleys to move 12 percent (of their total travel) and the rudder gust-lock roller to move 21 percent (of its total travel).

“The substantial effect on the system of pushing the lever fully forwards was reportedly not known to the manufacturer, operator or maintainer at the time of the accident,” said the report.

“It was considered that minimal combined travel of the gust-lock roller levers associated with an apparently adequate selection of the flight deck lever assembly to ‘min off’ may well have been a significant factor in allowing the elevator gust lock to re-engage.”
